## BLUE MOUND STATE PARK

Richard Otten  
Certified Energy Manager, #16973  
Association Energy Engineers  
608 North Freeman  
Luverne, MN 56156  
(507) 227-5103  
[richaradaotten@yahoo.com](mailto:richaradaotten@yahoo.com)

## CONTENTS OF REPORT

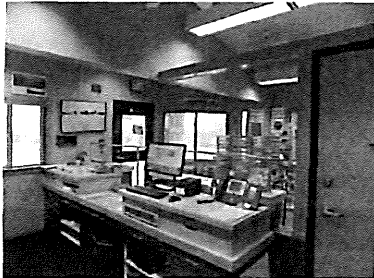
Front entry of contact station with view. The ceiling is vaulted in this area. According to the employees, this area is drafty in the winter.

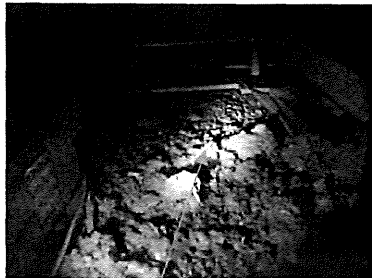
This is the attic area above the front entry. The insulation is deficient above the vaulted ceiling where the previous roof is exposed in the attic.

The attic needs additional insulation. I recommend blown cellulose fiber. Install 3" rigid insulation to attic hatch and weather-strip around the ledge.

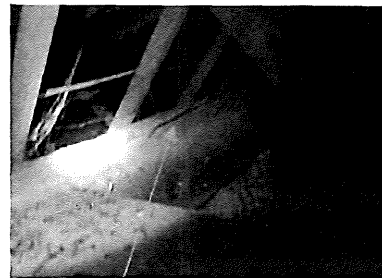
The duct work insulation is opening and should be repaired. Duct work should have additional insulation as possible.

The attic ductwork could have additional insulation added with boxing around existing insulation. The payback is higher because of the increased temperature difference from the ductwork air and the ambient air in the attic. I recommend 1 1/2" thermax with the joints and seams taped.

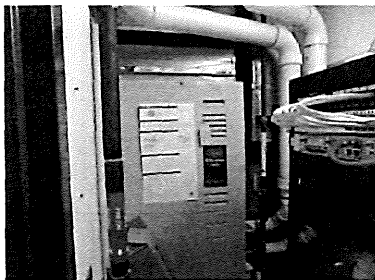
The furnace is a 1997 weather maker brand 92% efficient unit.

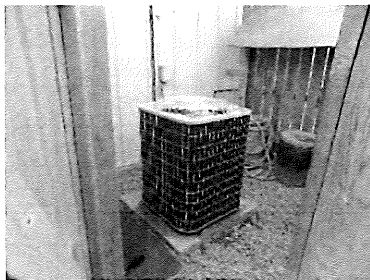
The air conditioner is a 3.5 ton, designed seer of 10, built in 1997. A seer of 14 or 15 will result in a 30 to 40 percent in air conditioning costs. Note that the unit is over sized by about 1 ton. Oversizing results in less run time which reduces dehumidification.

The existing air conditioner is a designed seasonal energy efficiency (SEER) of 10, but is likely running closer to SEER 9. A SEER 14 will improve efficiency 40 to 50 percent.

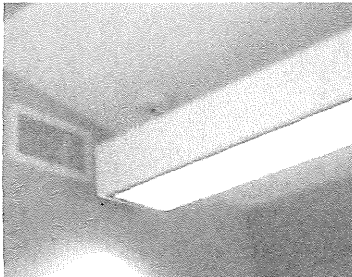
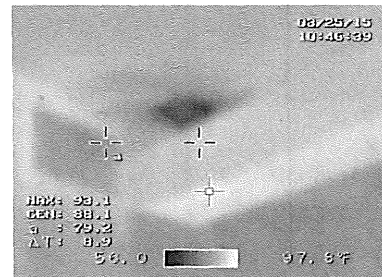
Front entry infrared photos indicate ceiling bypasses where electrical boxes are located in the attic.

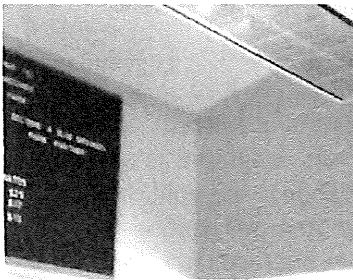
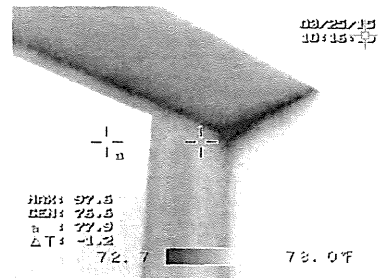
Infrared photos show typical cold corners where insulation is deficient and access to these areas is difficult.

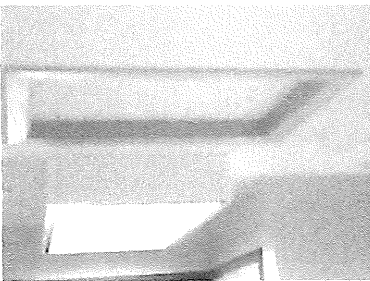
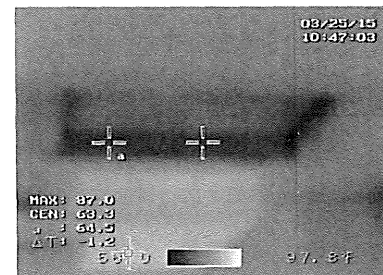
Attic hatch should be insulated with 3" foam insulation board and be weather-stripped around the ledge, along with caulk between the stop and frame.

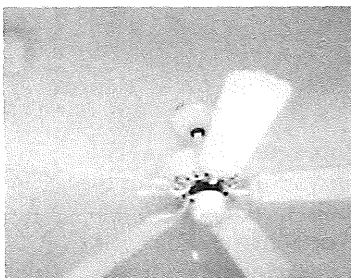
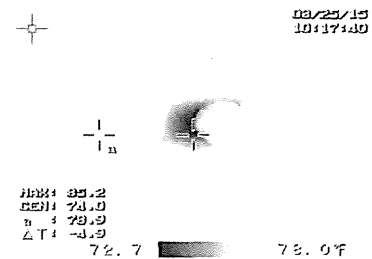
The ceiling bypasses can be caulked if fixture is removed.

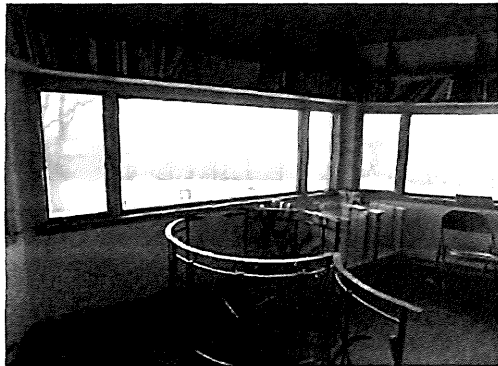
The lookout tower should be sealed off during the winter to avoid air flow into this area.

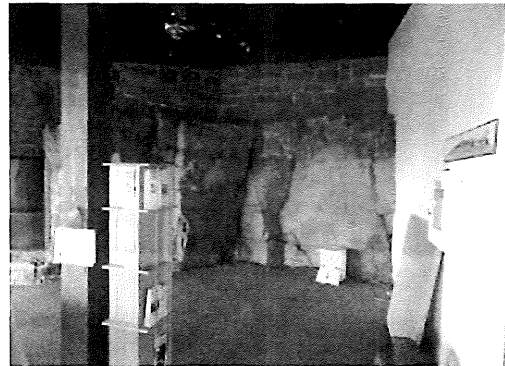
North wall consists of native red quartzite which was integrated as part of the structure when it was built. This provides some geothermal heating and cooling properties but tends to increase humidity levels in summer.

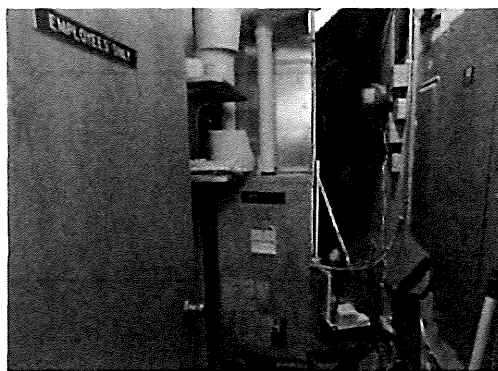
A Lennox 92% efficient propane furnace is the heating source for the building. The ductwork is located in the ceiling area.

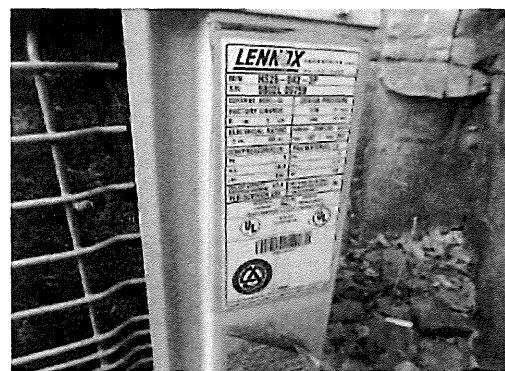
A Lennox 3 1/2 ton, seer 10 air conditioner is the cooling source for the building. A modulating air conditioner with a seer of 14 or above could result in 30 to 40 percent savings in cooling costs.

A large amount of dehumidifying is done by 2 dehumidifiers which run many hours during summer. I would recommend down sizing the 4 ton SEER 10 unit to a 2.5 ton modulating unit. This will run more but do a better job of dehumidifying the area.

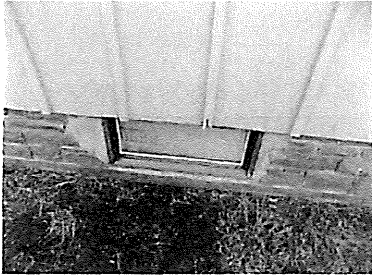
The residence foundation windows are in poor condition and leaking air.

Reducing the air infiltration is done by dense packing the walls, possible replacing the windows. Sometimes the windows can be caulked but I believe that these windows are beyond caulking. Sealing the attic bypasses is also important. The rim joists are still leaking air with fiberglass installed and foam insulation is recommended in the rim joist areas.

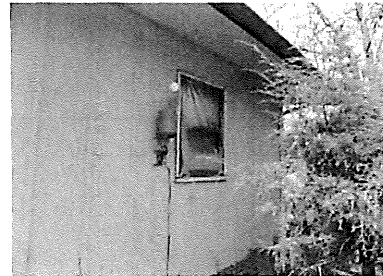
The siding is board and batten and perimeter windows are single pane with storms.

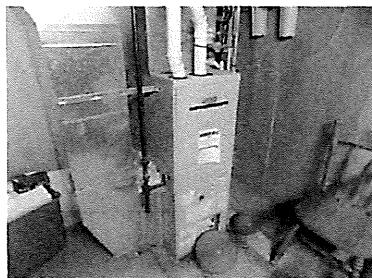
The residence heat source is a 75,000 btu Lennox 92% efficient furnace that is located in the basement.

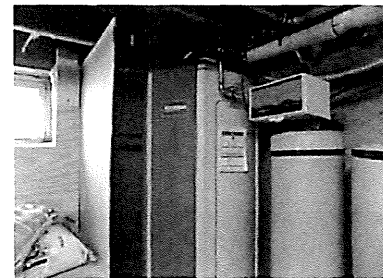
The domestic water heating is an electric Marathon water heater located in the basement.

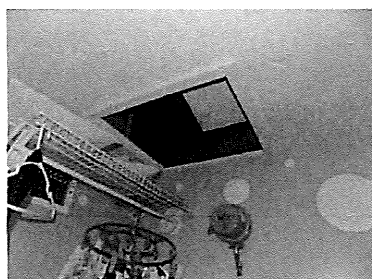
The attic hatch is located in closed storage. This should be insulated with 3" foam and weather-stripped around the frame.

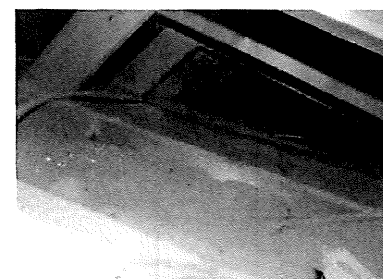
The attic has some blown cellulose fiber insulation. An additional 10" of blown cellulose should be added to the attic.

Attic insulation should be blown cellulose fiber which will reduce air flow through attic bypasses. The attic hatch should be insulated with 3" rigid foam and weather-stripped around the ledge of hatch.

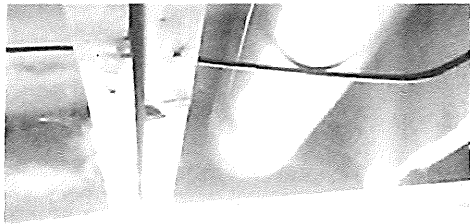
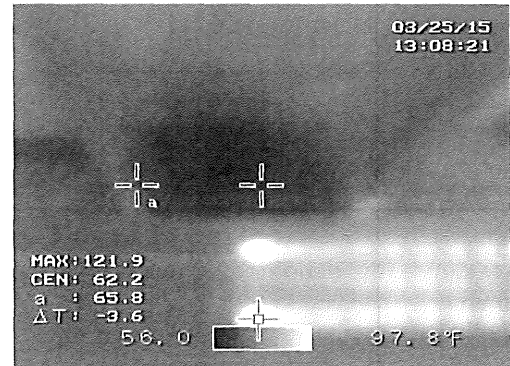
The rim joists are insulated with fiberglass, but the infrared showed that they are leaking air during the blower door test.

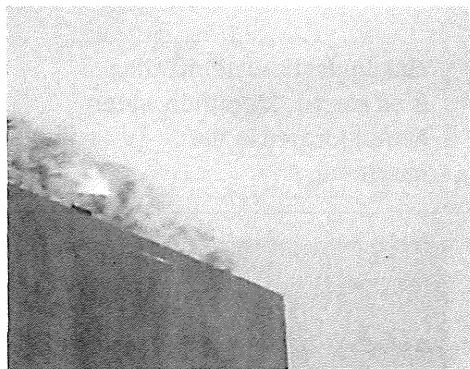
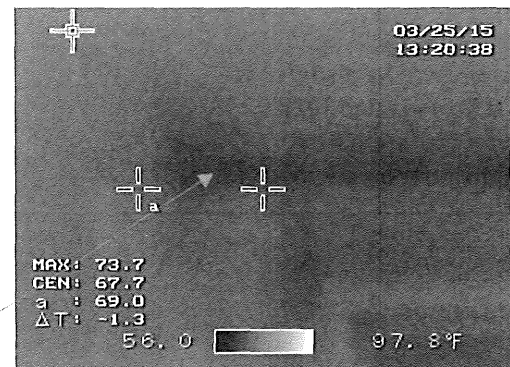
Infrared photos show cold corner and wall which is likely caused by some air infiltration into the wall from the attic.

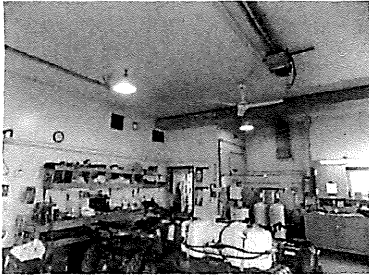
The shop lighting could be more effective with linear LED lamps positioned where tasks and work is performed.

LED lighting will create better lighting in the shop area. Install motion sensors where possible.

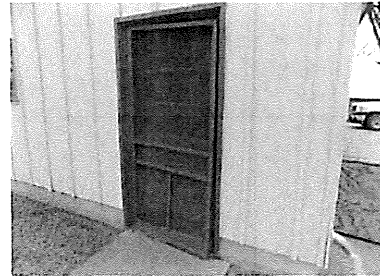
Original wood door could be replaced with a steel insulated unit which would provide additional security. Original windows should be replaced with double pane units.

Existing walk doors and overhead doors could use a tune up. Seal around the windows with caulking.

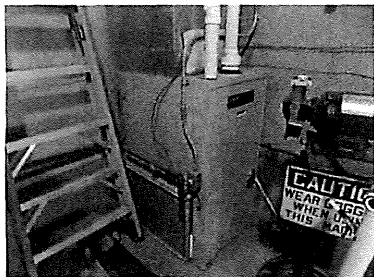
The gas forced air furnace was not used much in 2014.

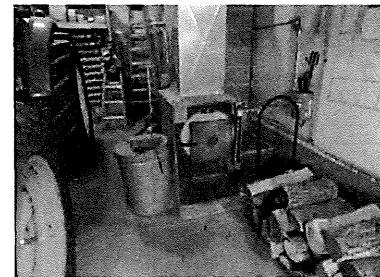
The primary heating source is a burner which makes use of locally cut wood.

Bringing a controlled source of fresh combustion air will improve the performance of the wood burner by not pulling out heated air. This should be done with an air trap to ensure that air is not "free flowing" into the shop when it is not needed.

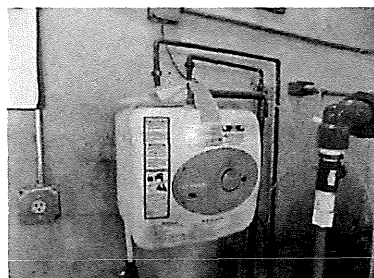
The hot & cold pipes should be insulated on this 3 gallon electric water heater for the shop.

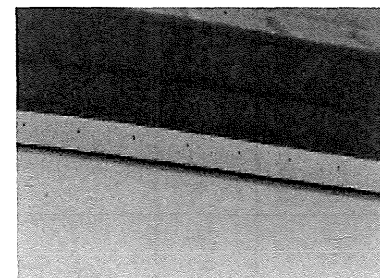
Move the top weather-strip to the door on the overhead doors would be efficient.
