TEN YEARS OF SCULPTURE AND MONUMENT CONSERVATION ON THE MINNESOTA STATE CAPITOL MALL

Paul S. Storch

Senior/Lead Objects Conservator
Daniels Objects Conservation Laboratory
Minnesota Historical Society
St. Paul, MN

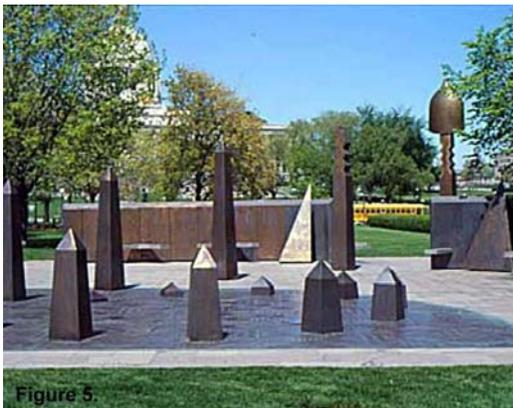
Figure 5. View of the Roy Wilkins memorial plaza, “Spiral For Justice” in 2002 showing dark weathering surfaces.

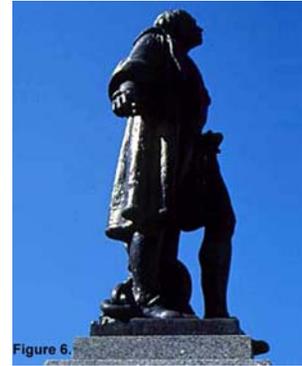
The first project of the State Capitol Mall Sculpture Conservation Program was in 1991 with the donation of money from the Italian-American Society to the MHS for the conservation and preservation of the Christopher Columbus statue located on the northeast side of the Mall (Fig. 6). Sculpted of bronze by Charles Brioschi and dedicated in 1932, the statue had never been properly maintained. It had weathered and corroded from its original “Roman bronze” patination to a dull, mottled greenish-tan.

Figure 6. Christopher Columbus monument.

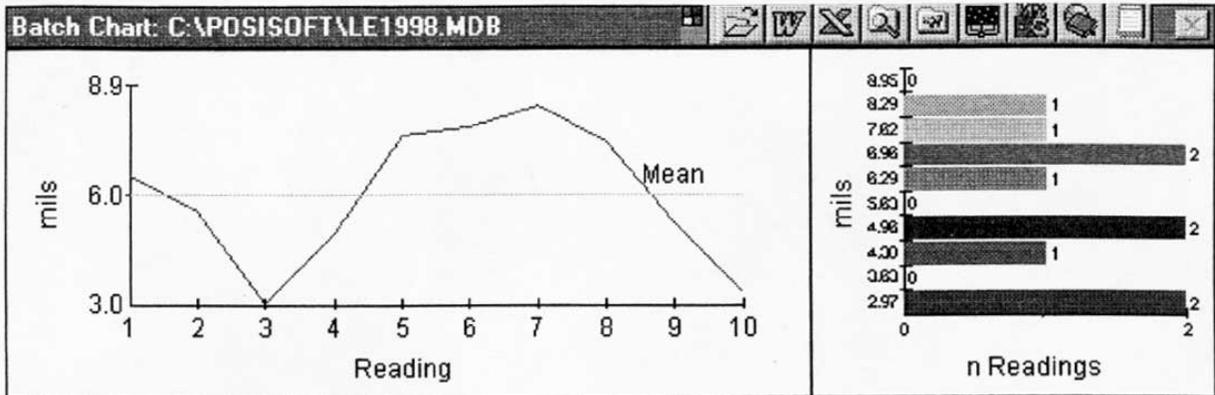
Annotation:
 PR Drapery by Bicep. The readings were taken by P. Storch and Chris, CTA, 9/16/98 as part of the 2nd year's CTA maintenance contract. The coating thickness varied from 1.5 to 2.0 mils.

Figure 16. Graph of Positest instrument thickness testing data of Leif Erickson Sculpture.

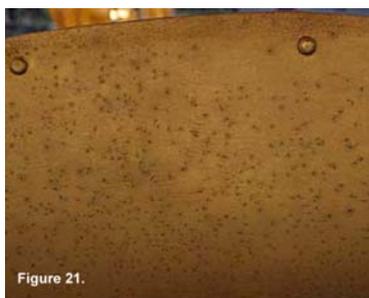
Figure 21. Detail of the corroded surface on the rear of the chariot, 2001.

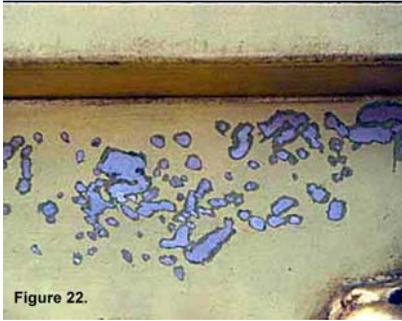
Figure 22. Detail after mechanical removal of the spot corrosion down to the metal surface as part of the re-gilding tests, rear of the chariot, 2001.

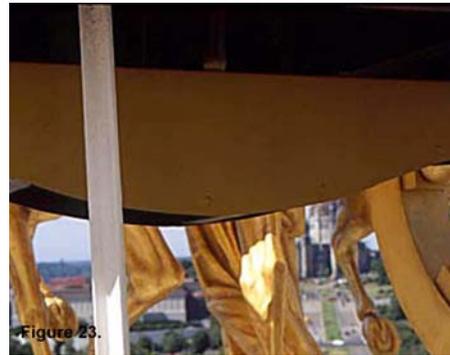
Figure 23. Rear panel of the chariot after priming and re-gilding during re-gilding tests, 2001.
