Re: Facility Asset Preservation Study
Minnesota Correction Facility - St. Cloud
St. Cloud, Minnesota

Architects Project No. 1618
RECS Project ID: 78SC0053

Facility Asset Preservation Study

State Of Minnesota
Department of Corrections

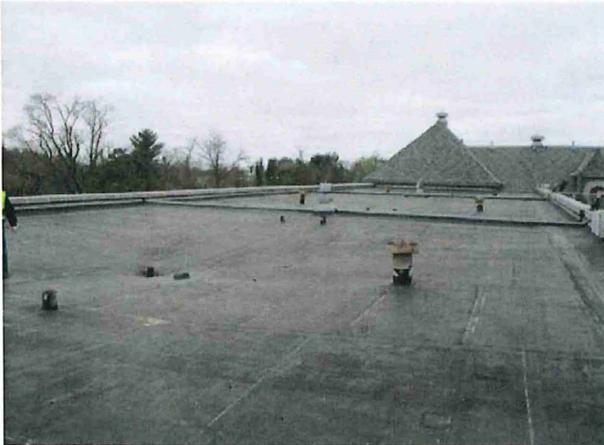
Overall view of roof looking West

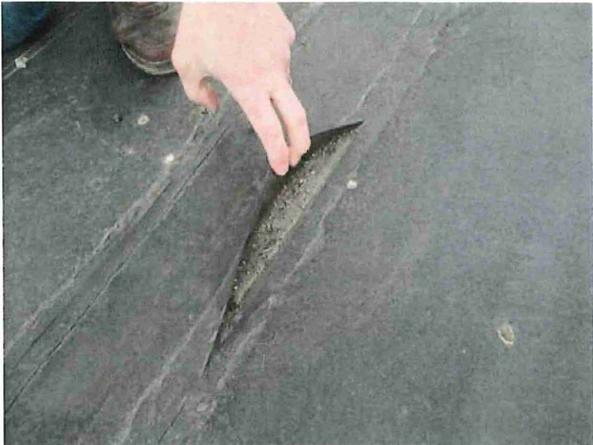
Close up view of failed seam

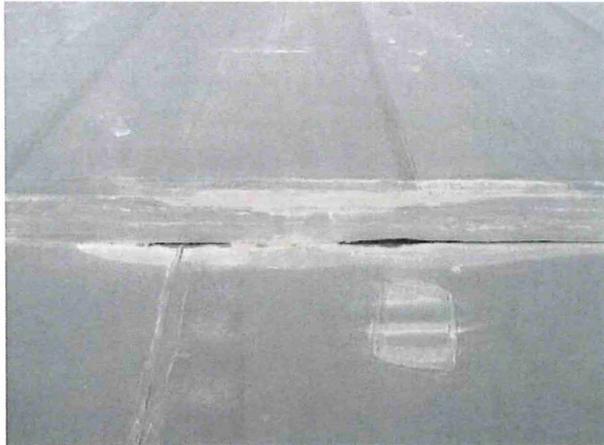
View of failed seam

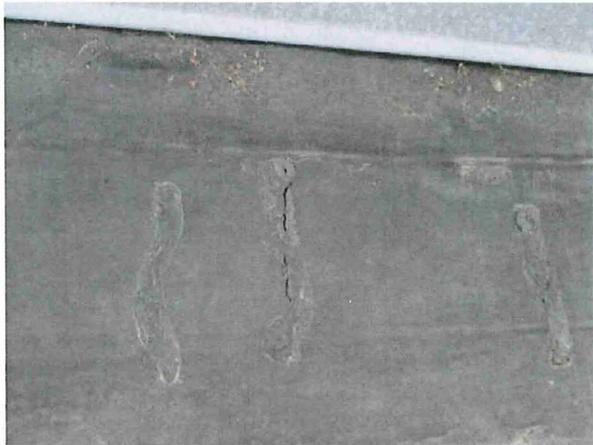
view of failed patches

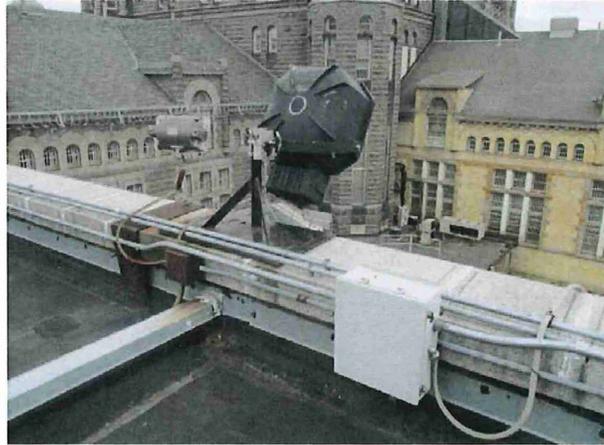
View of items mounted to North wall

brackets, camera control raceway, and other appurtenances will need to be temporarily raised/loosened to accomplish this work, and resecured. All penetrations thru the parapet cap flashing will be sealed with butyl sealants.

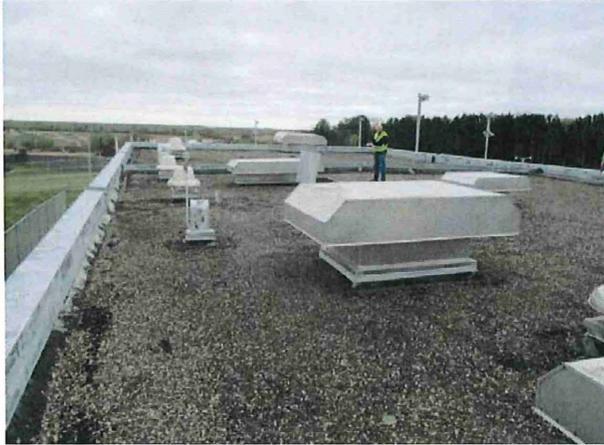
Overall view of roof looking East

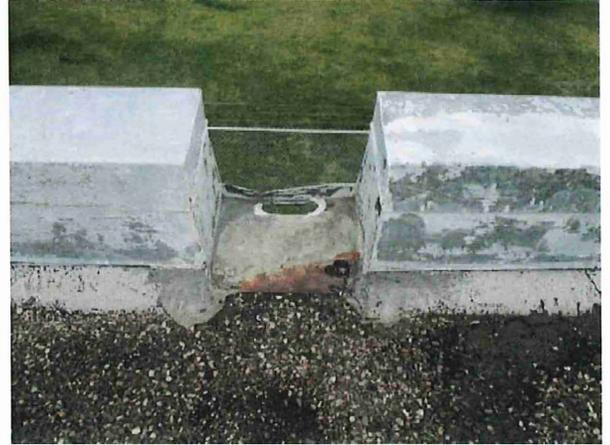
View of typical scupper

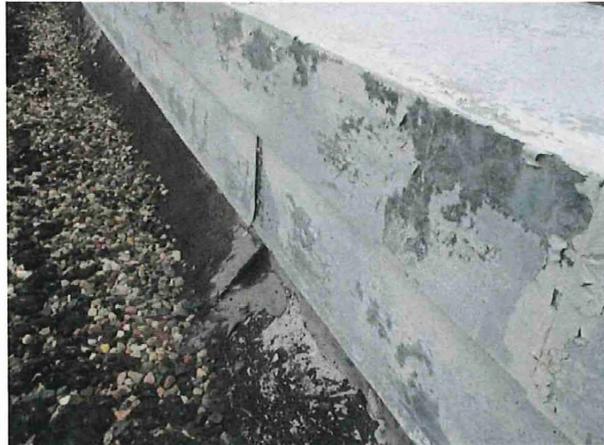
View of failing parapet flashing seam and finish

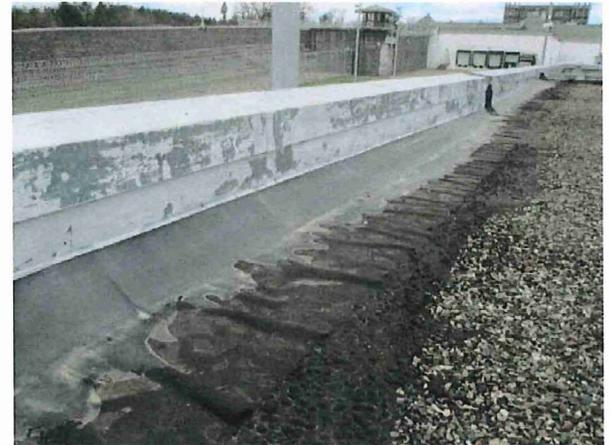
View of typical flashing roof to parapet transition

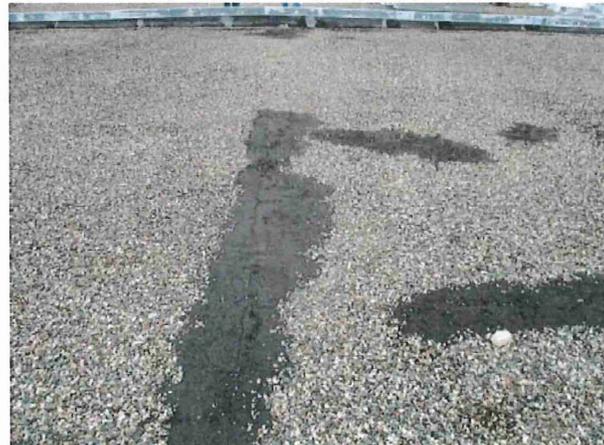
View of failing roof patches

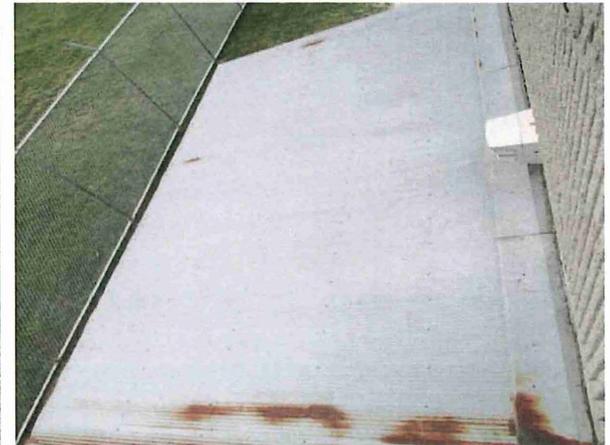
View of shed roof on North side of building

1. Remove the existing corrugated metal roofing and underlayment at the lower roof. Inspect the existing wood roof sheathing condition and replace deteriorated sections as required.
2. Install self-sealing, self-adhering roof underlayment.
3. Install new corrugated metal roofing with exposed fasteners with neoprene washers.

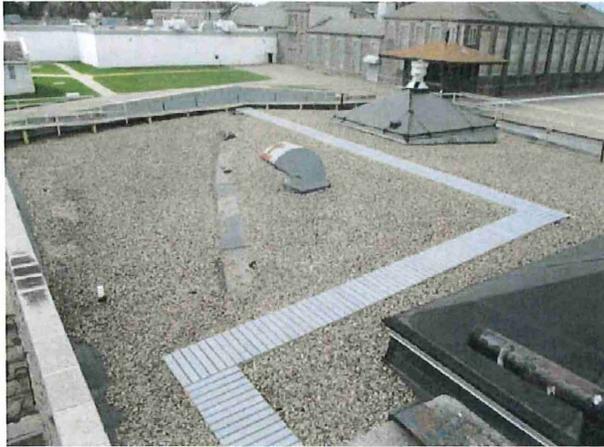
Overall view of lower roof looking Southwest

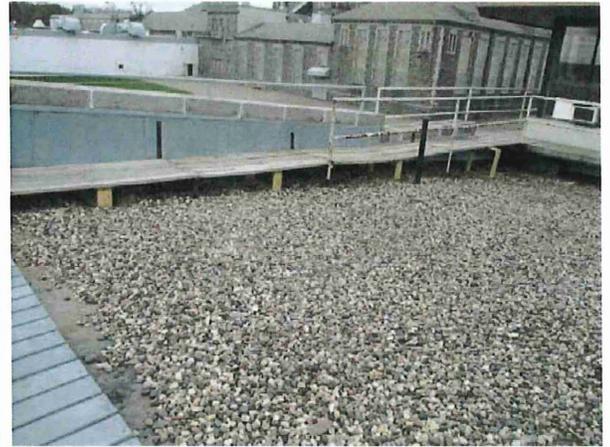
View of elevated wood walkway at South wall

1. Remove the existing ballasted EPDM roofing system, including the following; plumbing vent frost flashing, ventilation system roof mounted equipment, membrane flashing, all roof insulation, metal counter flashing, and metal flashing and scuppers. Remove existing wood catwalks and supports, and existing wood walkways.

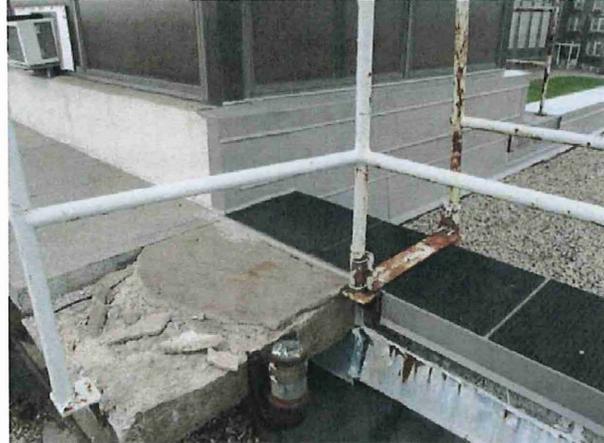
View of failing walkway slab

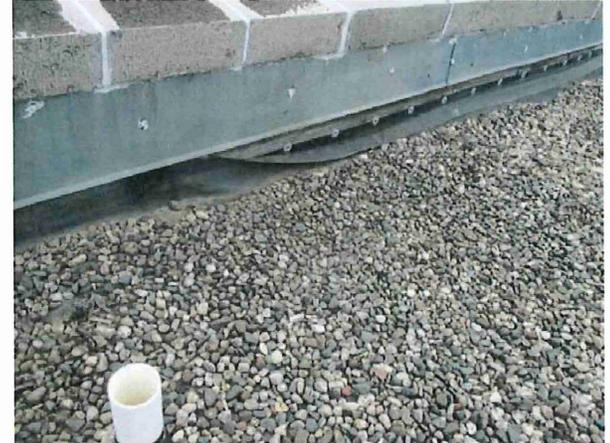
View of failing roof to parapet transition

9. Install 60 mil EPDM flashing over the vertical and horizontal faces of existing stone parapets and secure. Install prefinished sheet metal flashing to protect parapet EPDM flashings. At the north end of the west parapet, install new walkway pads over the metal cap flashing. Existing electrical conduit, hoist brackets, and guardrails will need to be temporarily raised/loosened to accomplish this work, and resecured. All penetrations thru the parapet cap flashing will be sealed with butyl sealants.

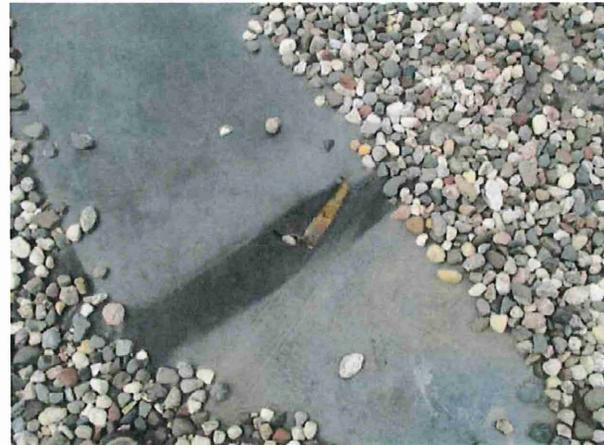
View of hole in roof membrane

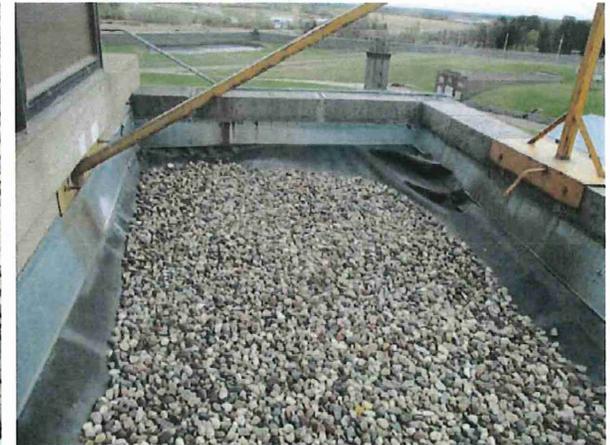
View of upper roof with hoist

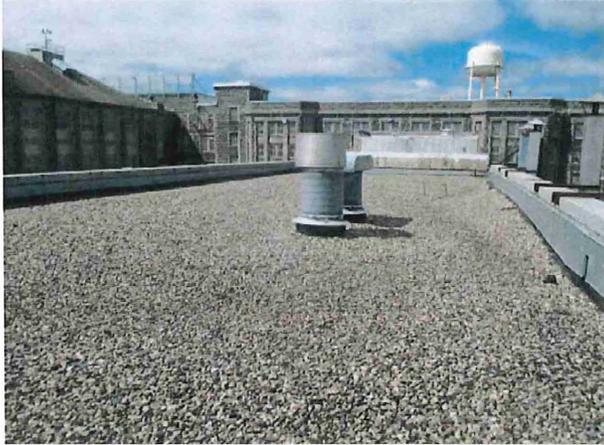
Overall view of roof looking West

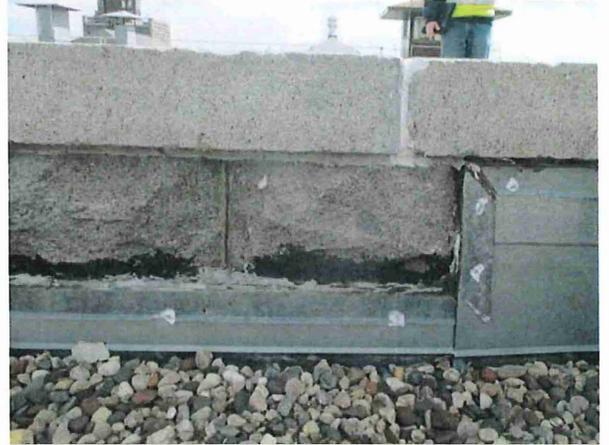
View of East parapet flashing condition

8. Install 60 mil EPDM flashing over the vertical and horizontal faces of existing stone parapets and secure. Install prefinished sheet metal flashing to protect parapet EPDM flashings.

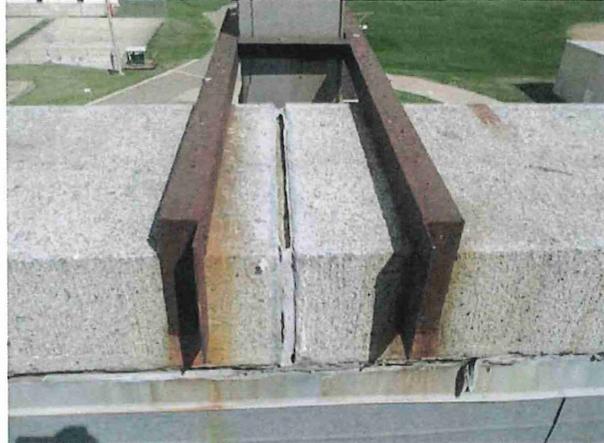
View of ductwork brackets and failing parapet joints

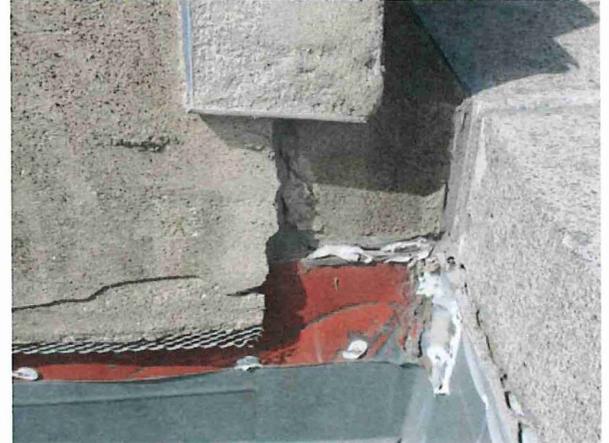
View of parapet transition at Northwest corner

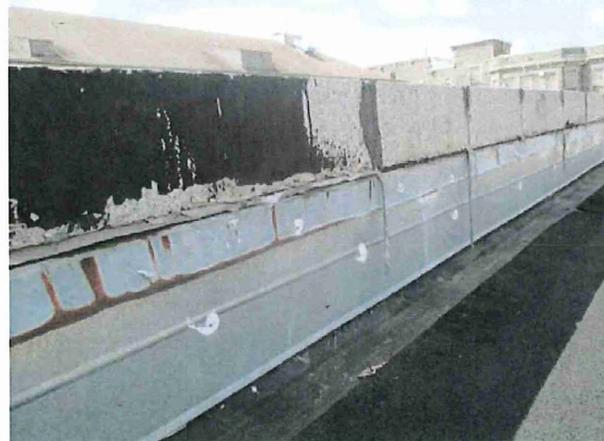
Typical view of parapet condition

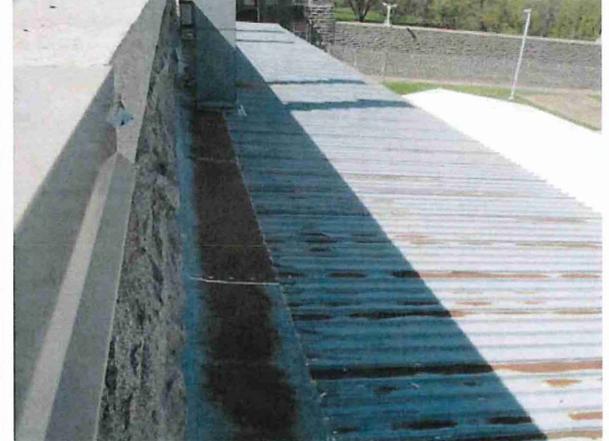
View of shed roof on North side of building

1. Remove the existing corrugated metal roofing and underlayment at the lower roof. Inspect the existing metal deck condition and replace deteriorated sections as required.
2. Patch 2 holes in the roof as a result of removing 4 chimneys. 2 chimneys did not penetrate the lower roof.
3. Install self-sealing, self-adhering roof underlayment.
4. Install new corrugated metal roofing with exposed fasteners with neoprene washers.
5. Install new insert and counterflashing at the intersection with the adjacent wall. Seal all joints.
