A Minnesota Department of Public Safety
State Fire Marshal Division Report

LESSONS LEARNED: The November 2019 Minneapolis High-Rise Fire

Narrative Report

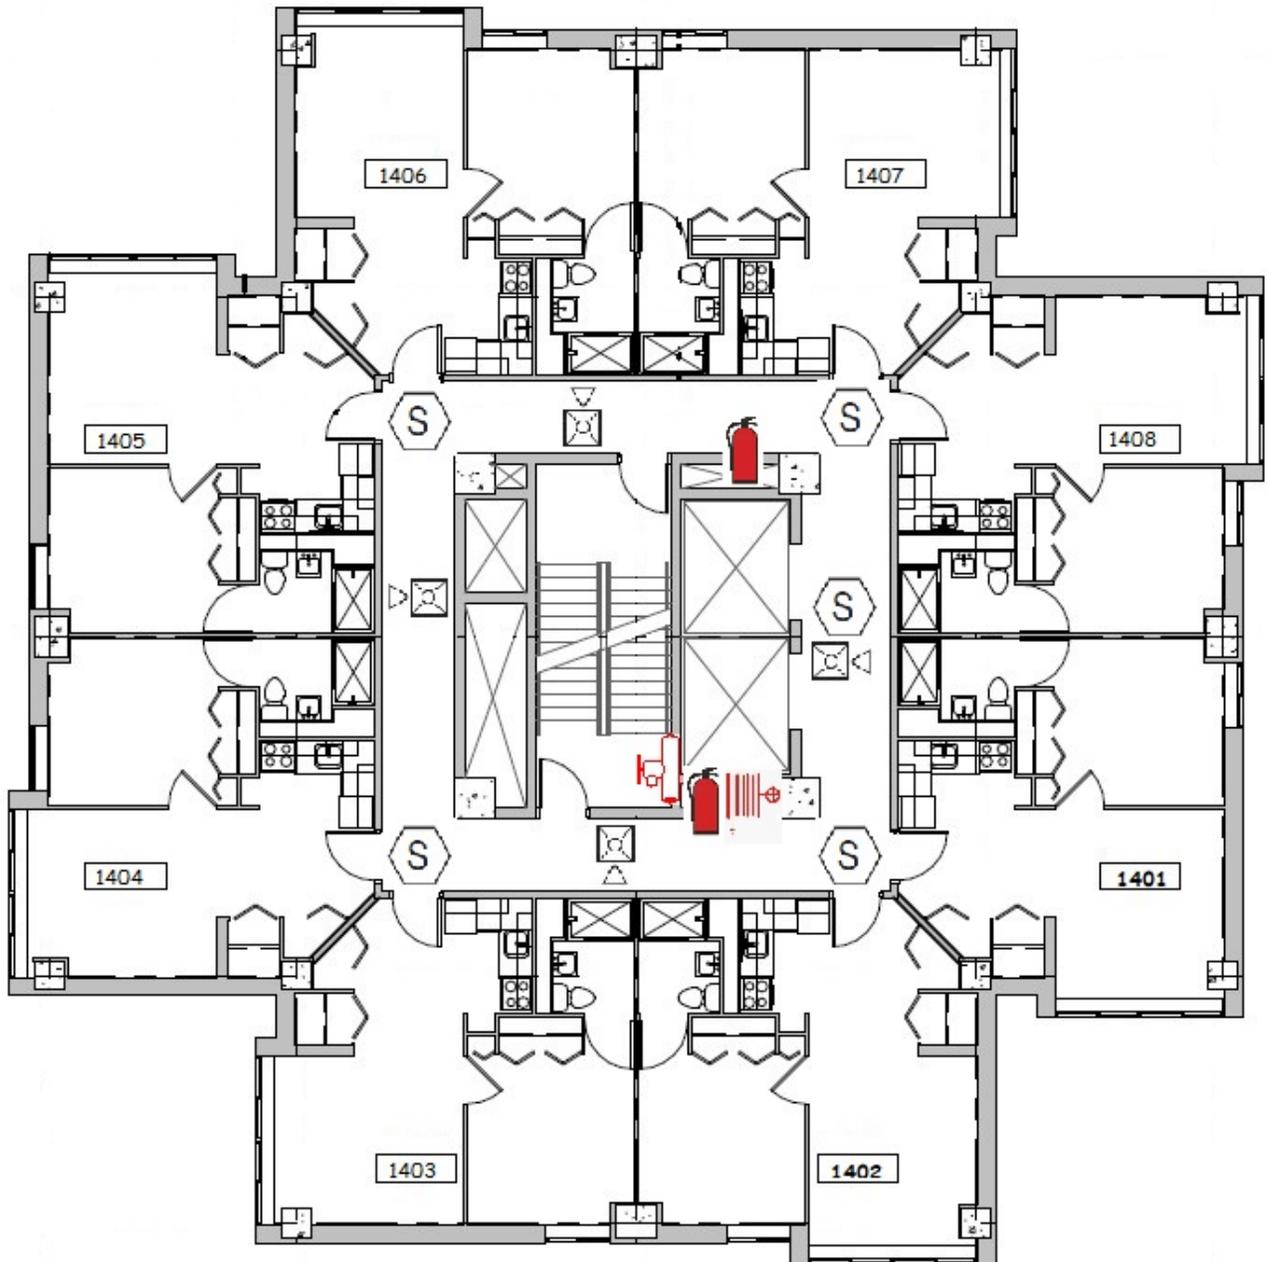
Figure 3: 14th story - Location of fire protection equipment and devices (approximate / not to scale)

Figure 3 shows the approximate location of the fire protection features on the 14th story.

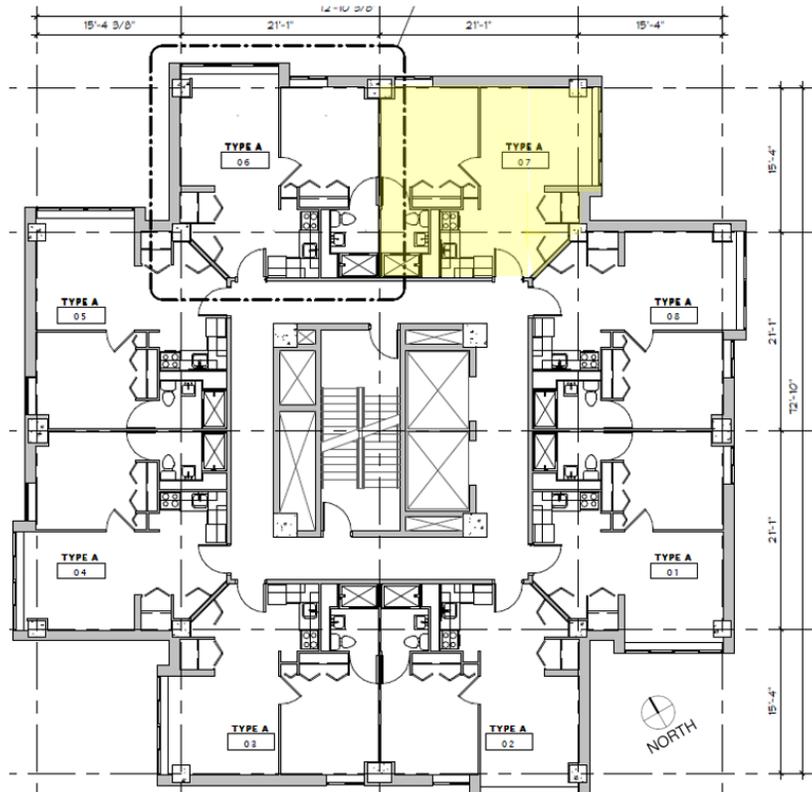
The fire started in apartment 1407, located near the east corner of the northeast wall (highlighted in yellow in Figure 4). State and local fire investigators determined that the fire's origin was in the bedroom of apartment 1407.

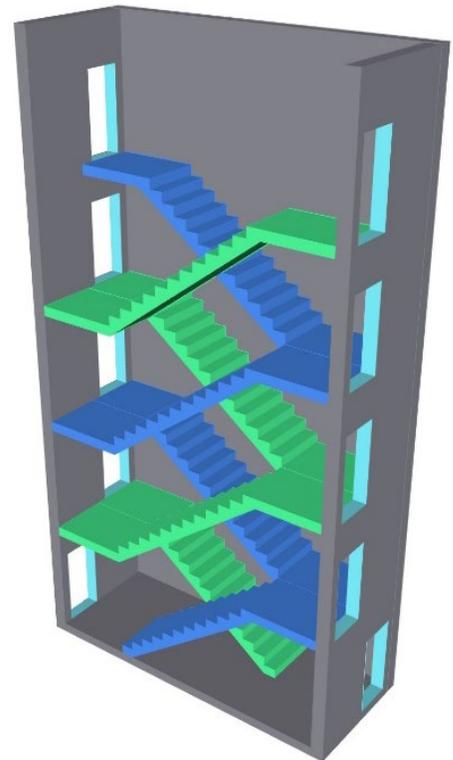
Figure 6: Example of a scissor stair
(drawing courtesy of SFMD)

The two stairways were arranged in a "scissor stair" configuration, where both stairways are located within the same enclosure. This was a design practice from decades ago – especially in high-rise buildings – to save space and the cost of building a second enclosure. Unfortunately, this practice was incongruent with the safe egress concept of having two ways out in an emergency. See Figure 6 for an example of a scissor stair.

Since both stairways are located within the same enclosure, or "shaft," a single open door can quickly compromise both stairs, which are the only paths of egress from the upper stories of the building. Doors get opened as occupants use the stairway(s) to egress or as firefighting operations take place from within the stair enclosure.

Modern building, fire, and life safety codes have not allowed scissor stairs for new buildings for several years. Since the majority of the heat released in a fire is convective heat, which tends to travel upwards or vertically, the use of scissor stairs is a significant fire and life safety risk to the building's occupants in a multi-story building.

The presence of scissor stairs in non-sprinkler-protected buildings is a significant life safety threat. The practice of building scissor stairs should be discontinued. Scissor stairs should be fire-separated into independent stair enclosures to provide distinct egress paths for occupants and to be congruent with the egress concept of having two separate ways out of a building in a fire emergency. If it is not feasible or possible to fire-separate the stair enclosures, the building should be sprinkler-protected throughout.

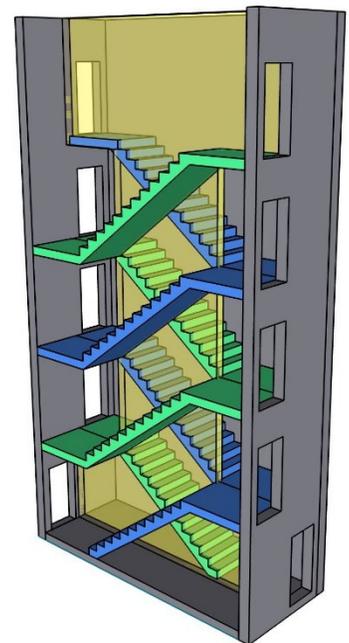
Figure 7: Scissor stairs with fire separation (drawing courtesy of SFMD)

The fire separation wall (shown in yellow) needs to separate the two stairs (shown as blue and green in Figure 7) on each story and completely separate the landings on the lowest and uppermost story to create separate compartments.

To correct the fire and life safety risks of having scissor stairs and both paths of egress in the same enclosure, a fire separation wall can be constructed to divide the space into separate compartments. Adding this fire separation wall divides the stair enclosure into two separate environments and provides a protected egress path if the other path should become contaminated with smoke or heat. Figure 7 shows one way this could be accomplished. The fire separation wall needs to be one-hour fire-rated in existing buildings (see MSFC 1103.4).

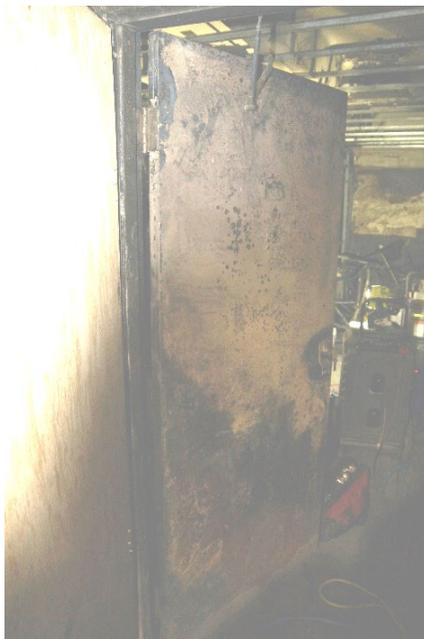
Figure 8: Door to apartment 1407

Steel doors with self-closing devices separated the apartments from the corridors. Although no listing tags were found on the doors, they likely would have satisfied the requirements of MSFC Section 1104.17.2.1 for fire-rated doors in existing buildings (20-minute fire-rated, 1-3/4 inch thick solid wood doors, or 1-3/8 inch insulated steel doors are allowed by the MSFC). Figure 8 is a photo of the door separating Apartment 1407 from the corridor.

The heaviest burn pattern on the door is shown in the lighter color moving upward from the latch side of the door to the hinge side of the door. This indicates that the door was in the open position and heat traveled from Apartment 1407 into the corridor. Had the door been closed, the smoke and heat spread from the apartment into the corridor and ultimately into the scissor stair enclosure would have been limited.

Although the corridor/apartment separation doors were equipped with self-closing devices, the closing feature was rendered ineffective by the placement of seals at the bottom of the doors that prevented the doors from closing. Although the exact reason for the seals is unknown, it is presumed that they were to prevent infestation spread or to prevent loss of heat from the individual apartment (see Figure 9). Other apartment doors on the 14th story were examined; the door bottom seal created friction against rugs or carpeting and prevented the door from closing.

The practice of placing objects under the apartment fire doors that prevent the automatic closing features of the door or the practice of propping doors open should be discontinued immediately. These practices have not been allowed by the MSFC for decades. Had the door between the corridor and apartment been able to close, it is the SFMD's opinion that the fire would have been contained to the apartment of origin and the loss of life would have been reduced and possibly only involved the occupant of that apartment.

- Discontinue the practice of propping fire doors open or placing objects in the path of the door that prevent it from closing in a fire. Not only are these practices violations of the MSFC, they pose life safety risks to occupants using the corridor, which is the only means of egress from the building.
- Install fire sprinklers throughout the building if existing doors to resident rooms from corridors must be held open or prevented from closing.
- Provide fire separations for existing scissor stairs to form independent stair enclosures to provide at least two distinct paths of egress.

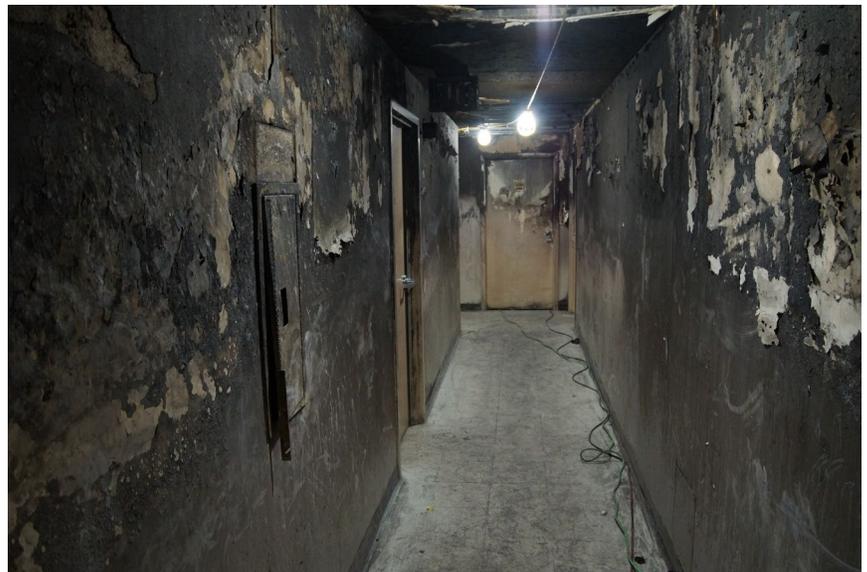
Figure 10: 14th story corridor (looking west from Apartment 1407)

Figure 10 shows the damage to the corridor on the 14th story. Figure 11 shows a typical corridor from another story.

The story of origin experienced significant heat and smoke damage; four of the fire's victims were found on this story. Within the first few moments of the fire, conditions were likely untenable. The 14th story corridor system was exposed to extreme heat and smoke conditions once the fire left the apartment of origin. Building occupants on the 14th story trying to use the stairway doors to exit that story would likely have had little time to do so.

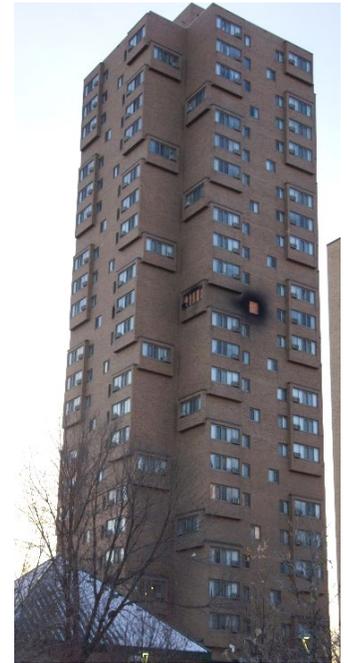
Figure 12: Exterior view from east side

Apartment 1407 was located on the northeast side of the building. At some point in the incident, the windows in the bedroom of Apartment 1407 failed (likely due to the heat of the fire) and the strong winds from the north created a “wind-driven fire.” This wind-driven fire, together with the apartment-to-corridor door being unable to close, contributed to the spread of fire throughout the 14th story. The living room windows were ventilated during fire department suppression activities.

Figure 12 is a view of the building from the east side showing the missing windows from the bedroom and living room of Apartment 1407.
