PolyMet Rail Car Modifications Evaluation

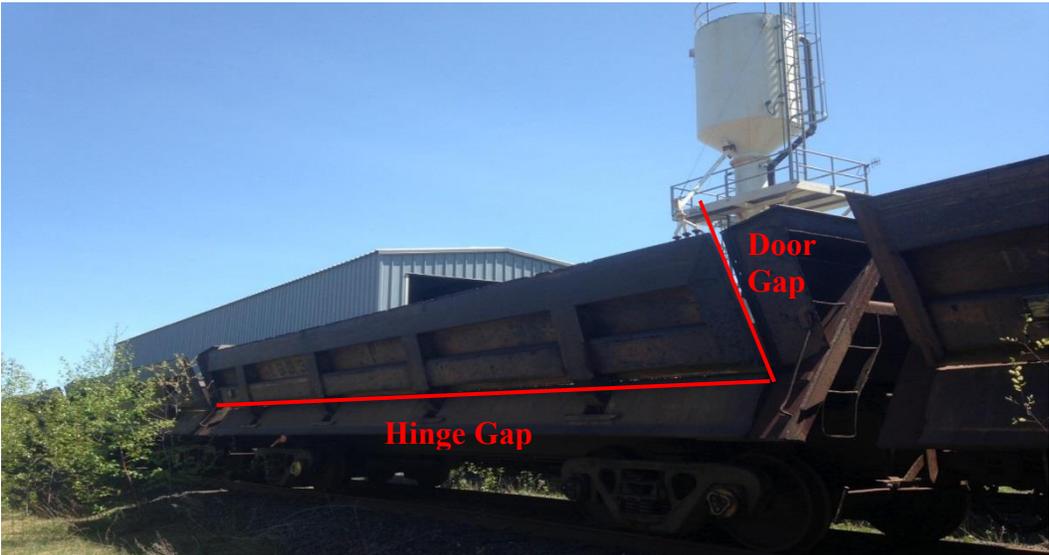
Ore will range in size from 48 inches down to small gravel and dust. Three potential ways that ore could be released to the environment during transport via rail car include: 1) ore spillage through the hinge gap, 2) ore spillage through the door gap, and 3) dust. Dust could be mitigated by spraying water on the loaded ore prior to transport, when necessary. The remainder of this document focuses on mitigating ore spillage from the rail cars during transit.

Figure 2. Photo of Side-Dumping Rail Car with Gaps Highlighted

Prior to use in operations, PolyMet will ensure that the rail car fleet be refurbished to reduce the sizes of the hinge and door gaps. This will greatly reduce the amount of potential ore spillage, and reduce any associated environmental impacts.

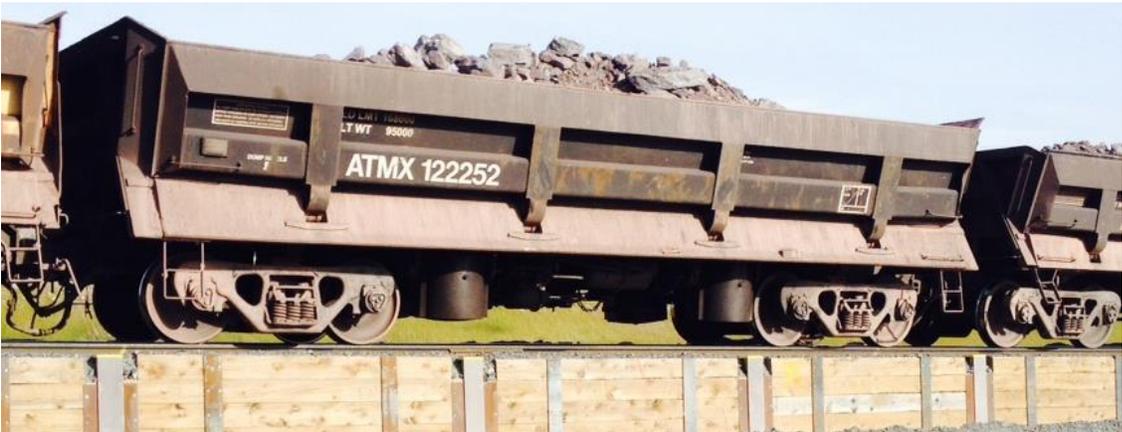
Having identified refurbishment of the rail cars as the best option, additional work was undertaken to quantify how much refurbishment would reduce potential environmental impacts. In the fall of 2014, PolyMet visited another mine site where side-dumping rail cars had been purchased from the same fleet as PolyMet's rail cars. This mine site had recently had these cars refurbished, and they were currently in use at the time of the site visit (Figure 3). During the site visit, PolyMet's representatives estimated that the size of the gaps on the refurbished rail cars measured 0.25" for the hinge gap and 0" for the door gap. If the same calculation is used to estimate potential rail car spillage (as was described in Section II above), with these new values (and keeping all other parameters the same), the quantity of ore that could potentially spill through the door and hinge gaps would be estimated at 0.20 tons per year. This is a 97% reduction from the originally calculated value of 6.14 tons per year.

Figure 3. Photo of Refurbished Side-Dumping Rail Car
