M.L. 201 4, Chp. 226, Sec. 2, Subd. 06d Project Abstract

For the Period Ending June 30, 2017

PROJECT TITLE: Northeast Minnesota White Cedar Restoration – Phase 2

Final Technical Report prepared for Environment and Natural Resources Trust Fund

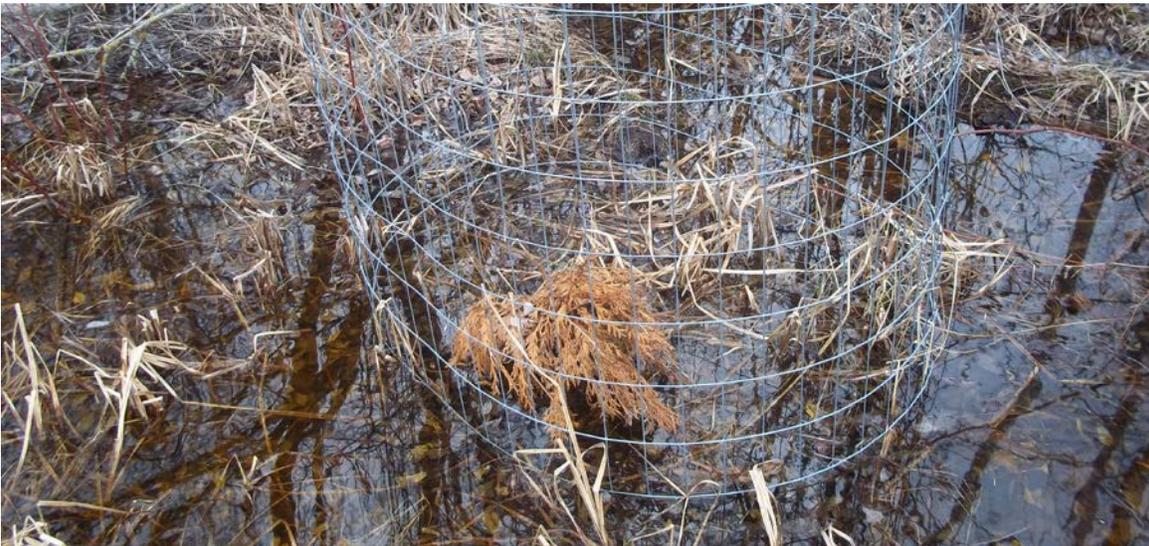
Figure 18. Photo showing a dead cedar planted in wet conditions.

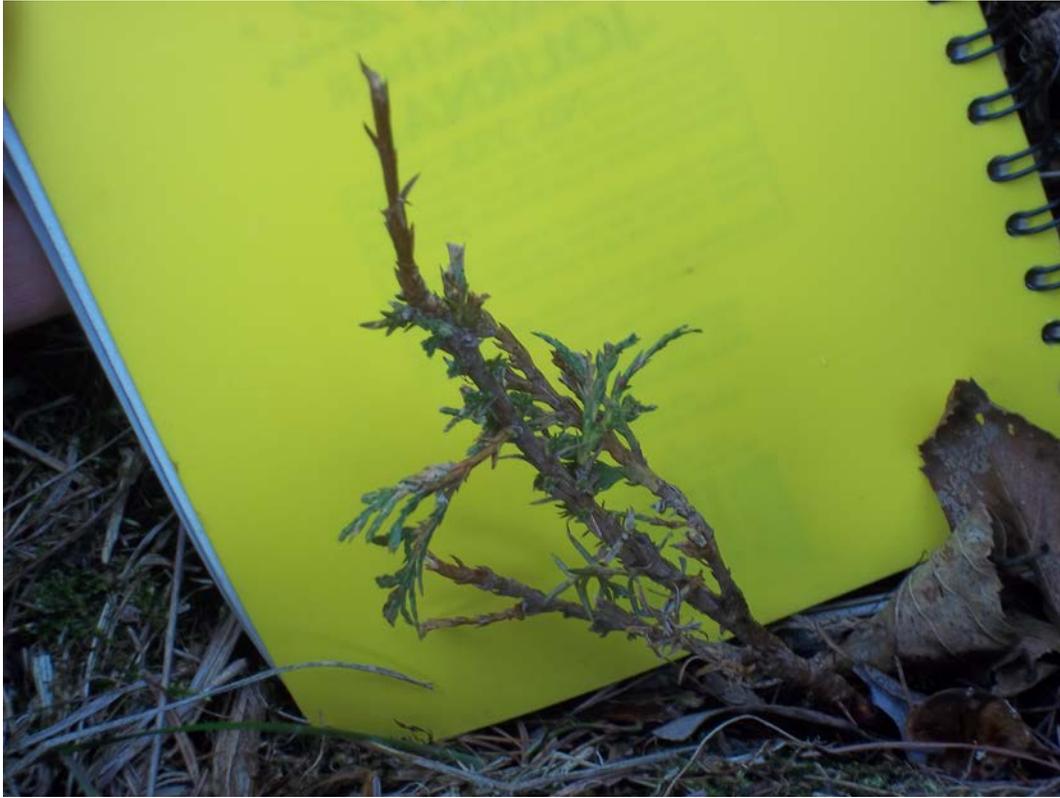
Figure 29. Photo showing a heavily browsed cedar.

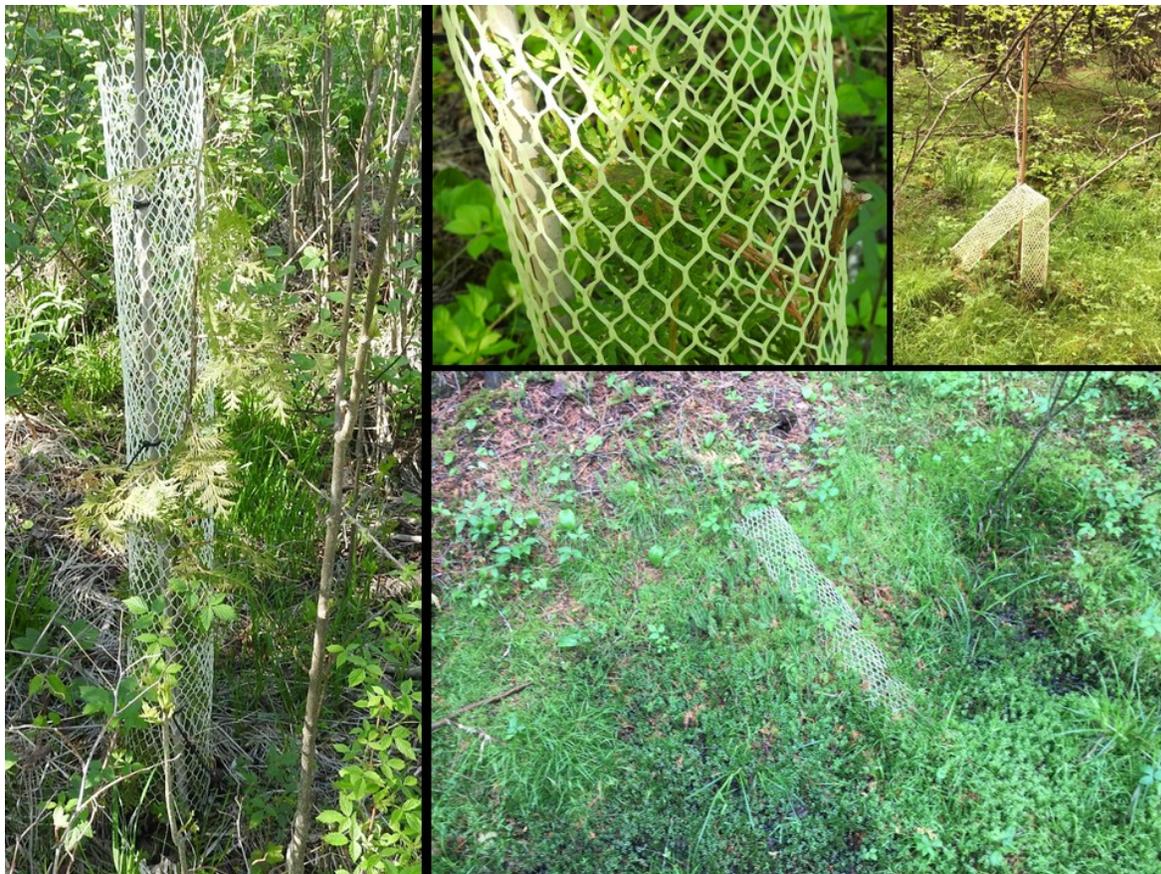
Figure 33. Some examples of issues with plastic protectors.

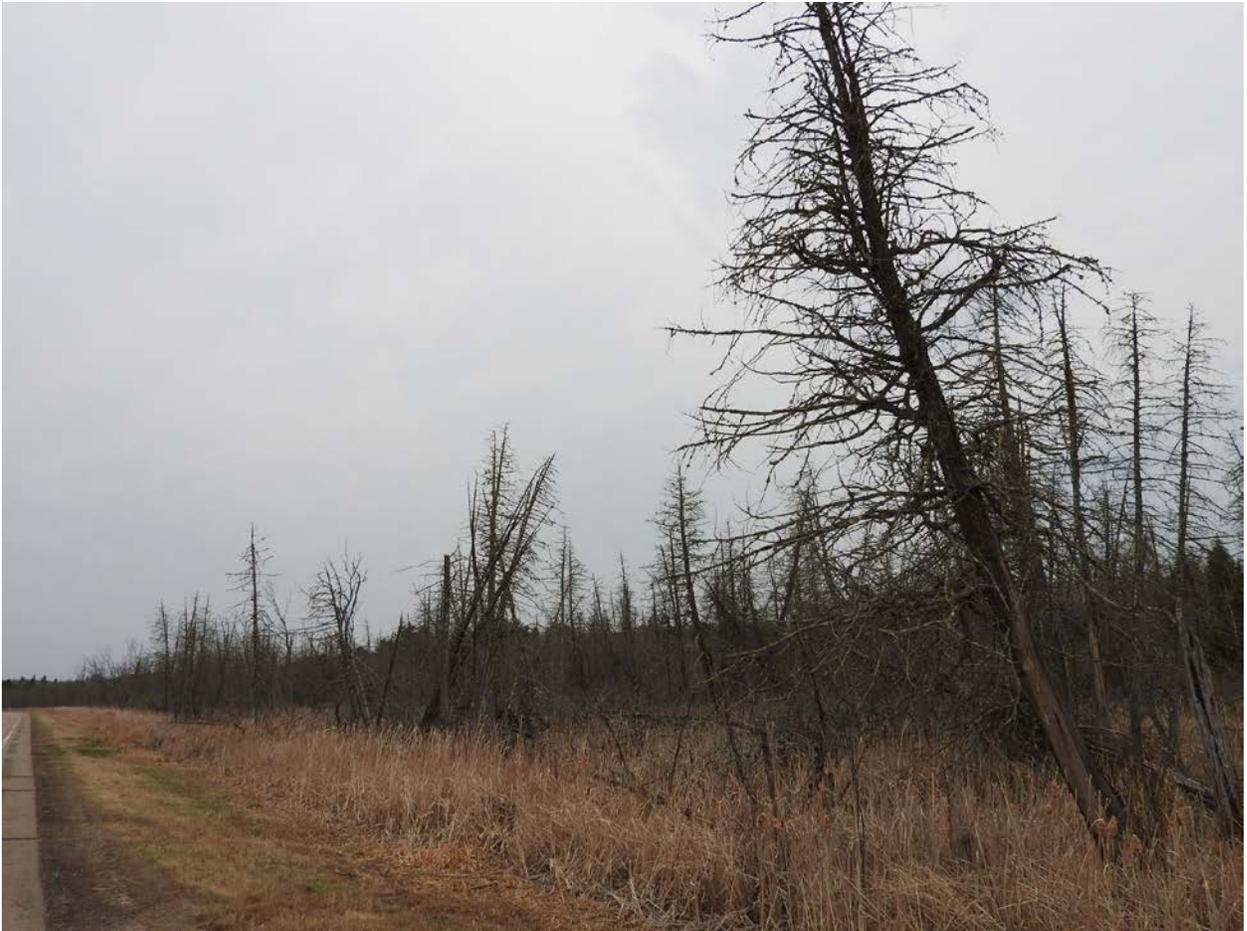
Figure 36. Dead cedar killed by inundation from poorly design road in N. Minnesota.

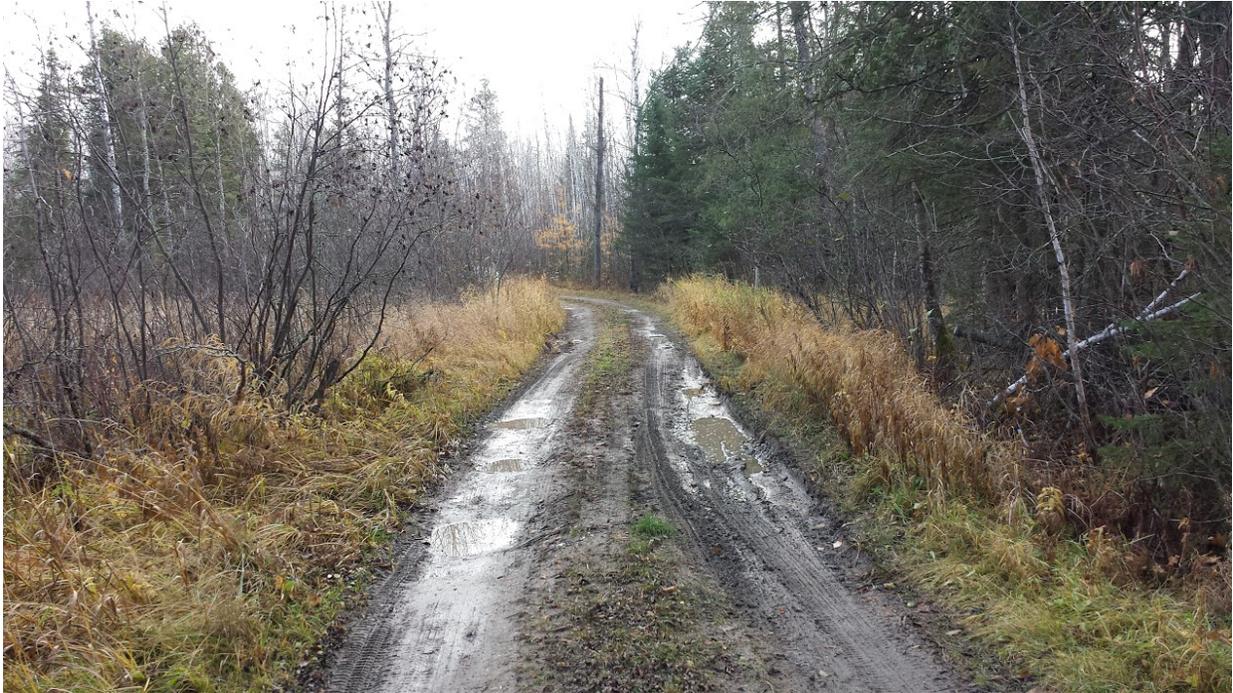
Figure 37. Ranch Road in Wirt, MN before restoration.

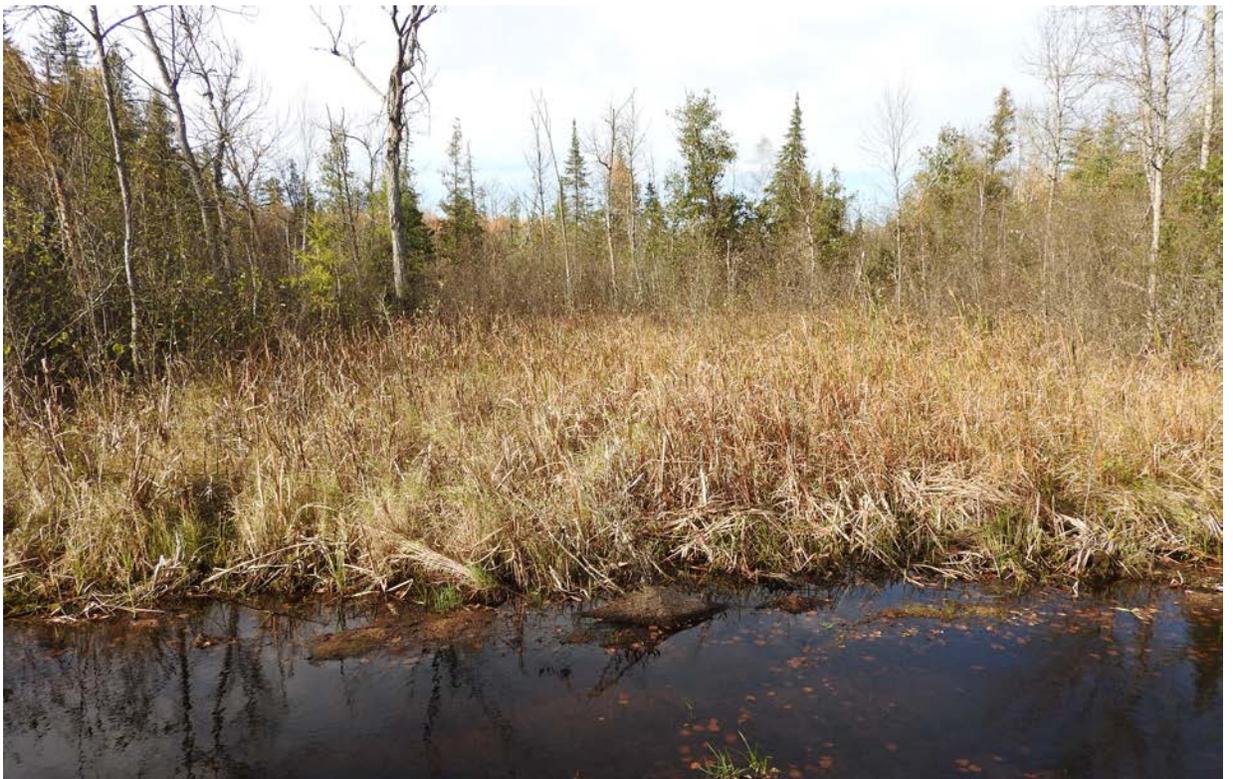
Figure 38. Ponded water upgradient that caused NW cedar tree mortality.

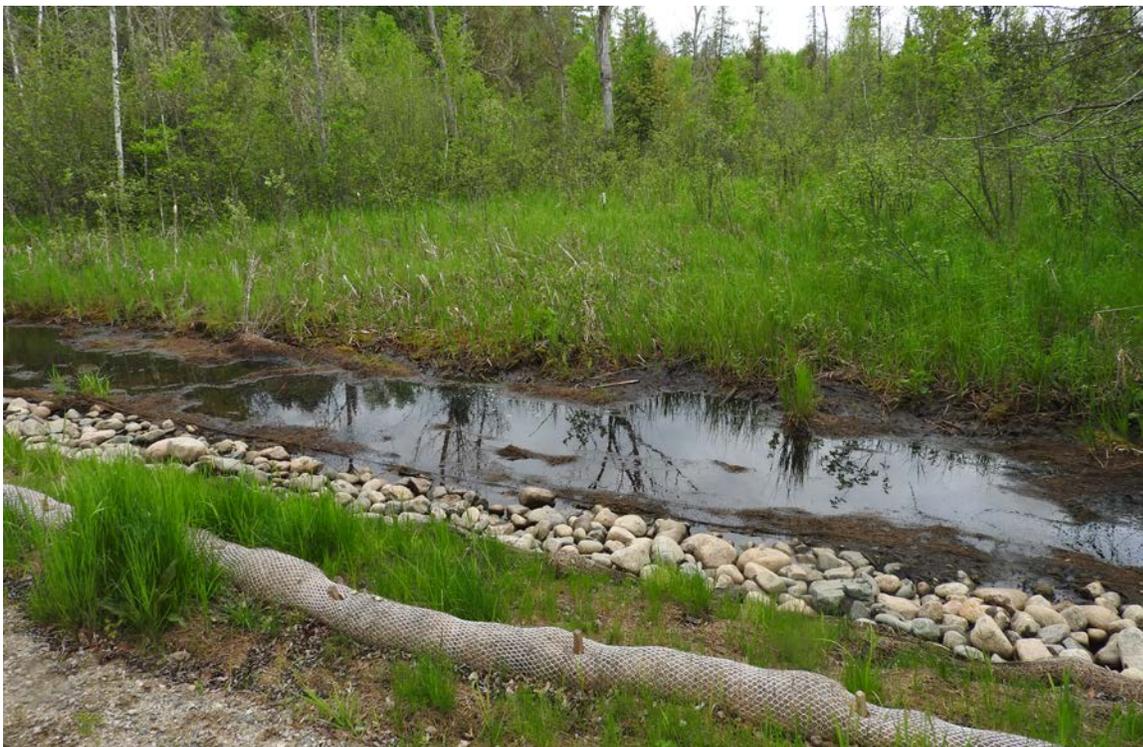
Figure 47. Upgradient of Wirt road after restoration showing lower ponding of water.

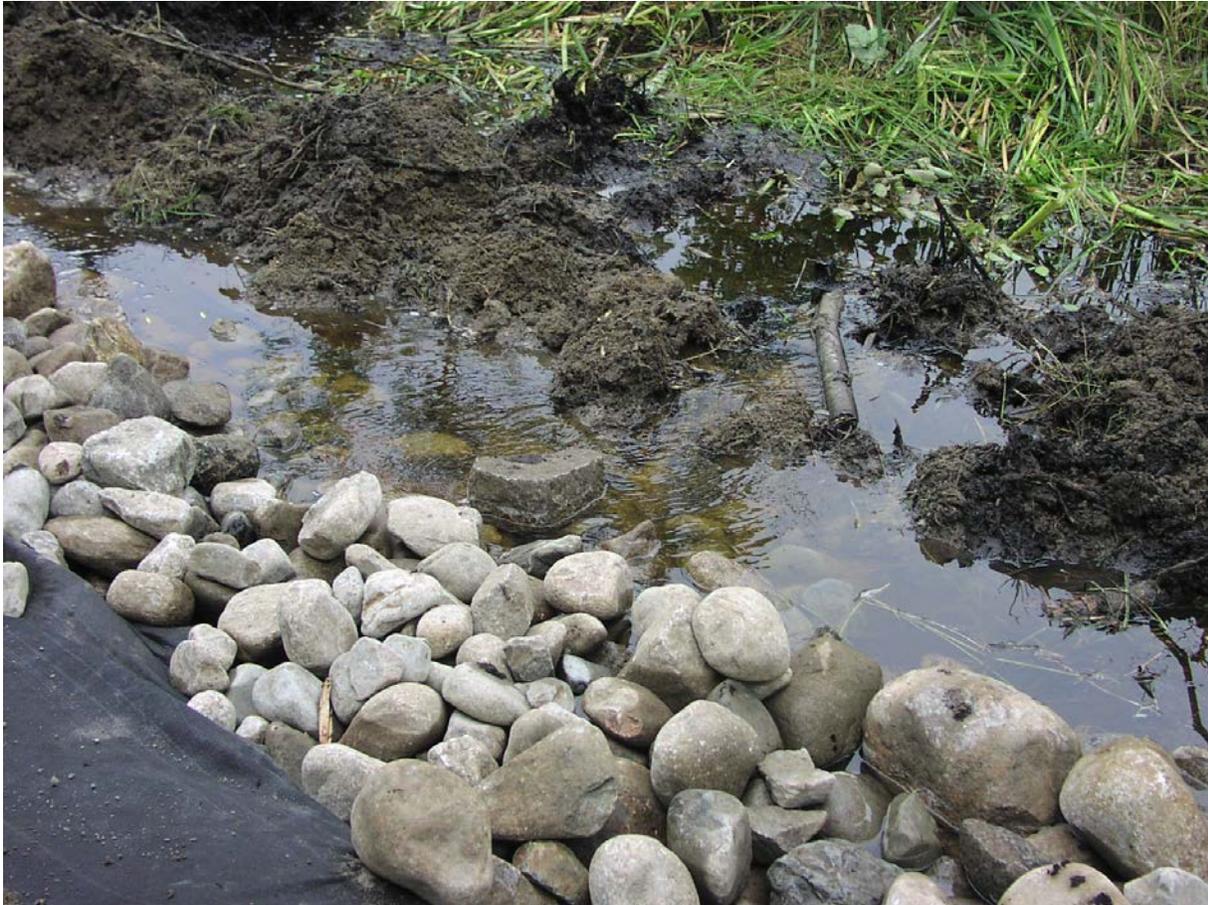
Figure 48. Downgradient of Wirt Road showing water flowing out of the porous roadbed.

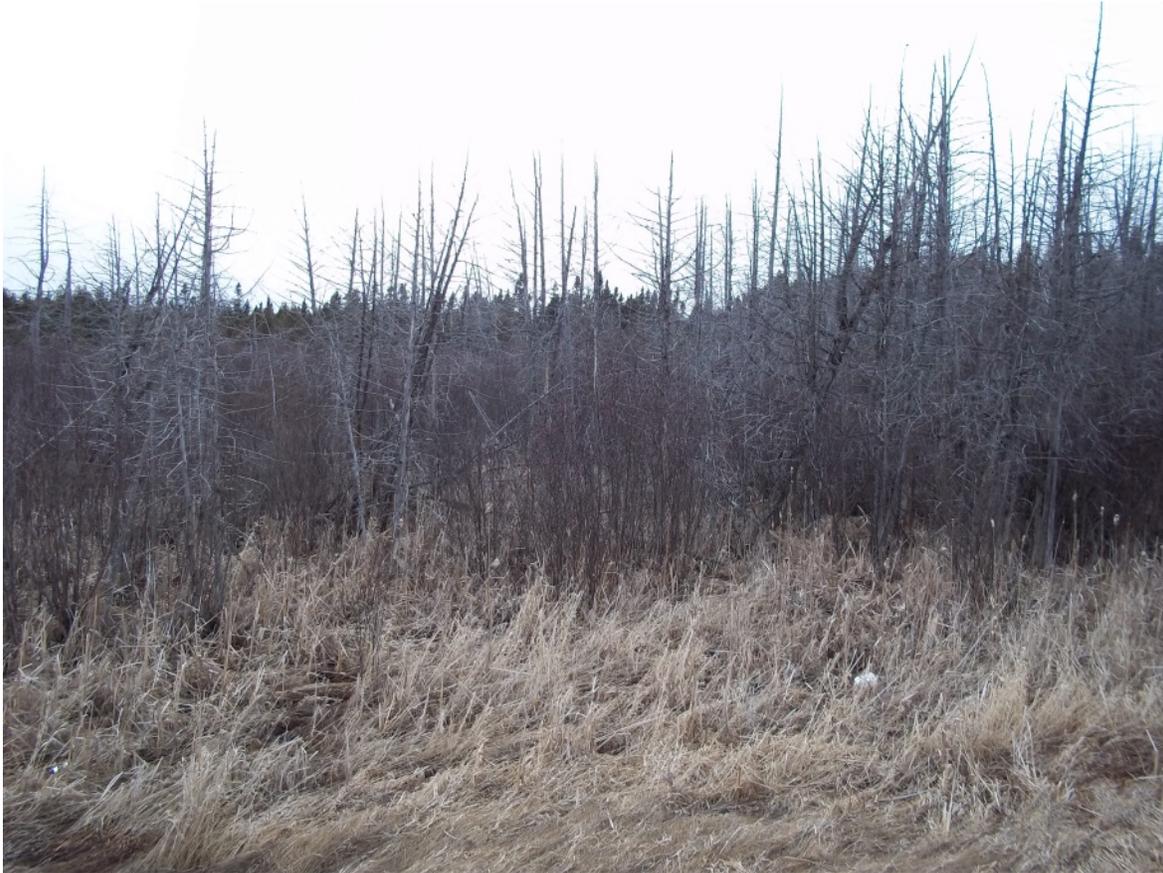
11. Are there lots of dead cedar trees? Usually from blocked drainage. See photo below for “road kill” cedar from blocked drainage.
