State Office Building and Parking Deck Preservation, Restoration and Repairs Predesign **FINAL DRAFT**

21 Dec 2012

Updated 19 April 2013 - Predesign Addendum 1

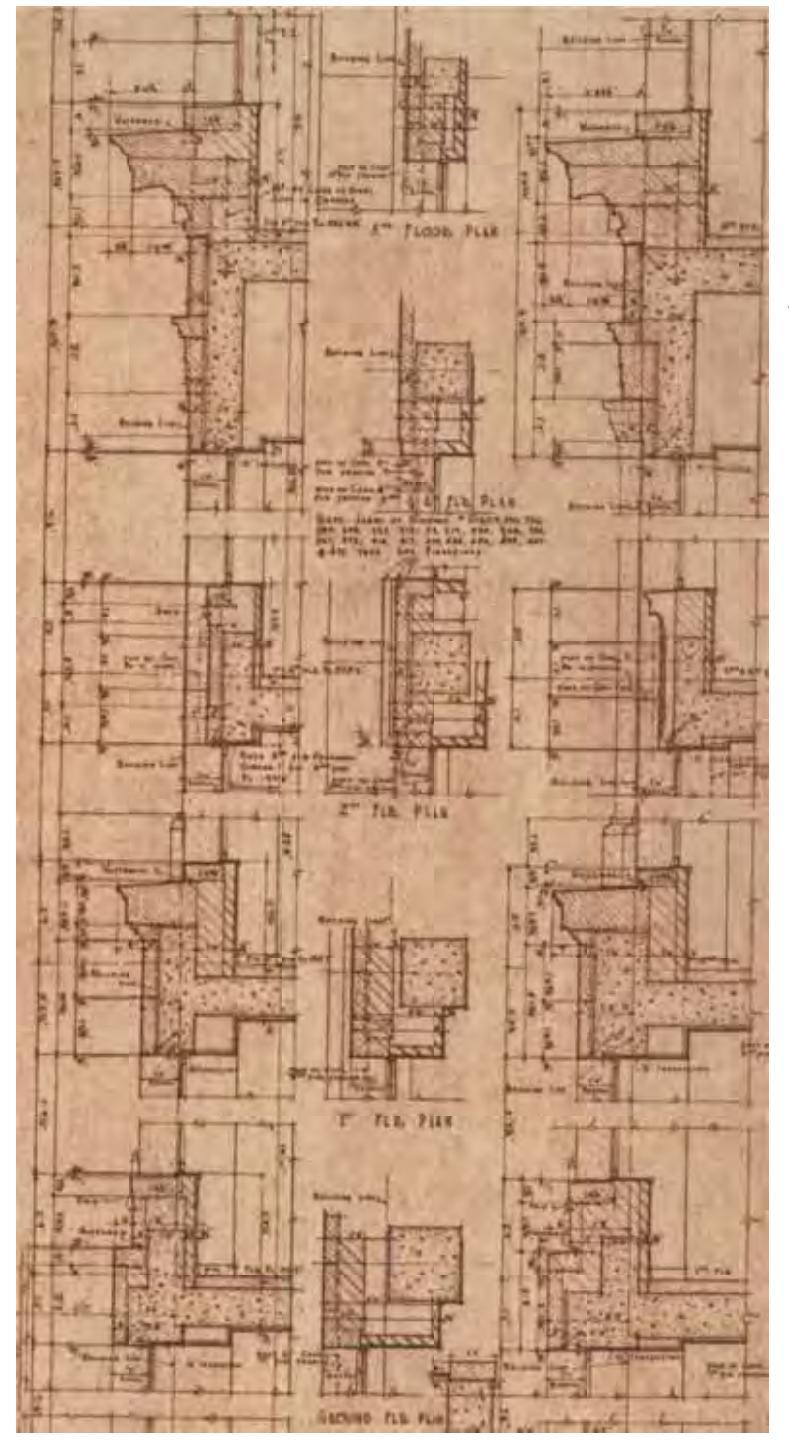
#### Exterior Wall Review

The State Office Building per the original 1932 Clarence Johnston Drawings is solid concrete framing with stone veneer. The entire building was re-pointed in 2002. Spot pointing will be required at some stone displacement and failed joints that has occurred since the 2002 project.

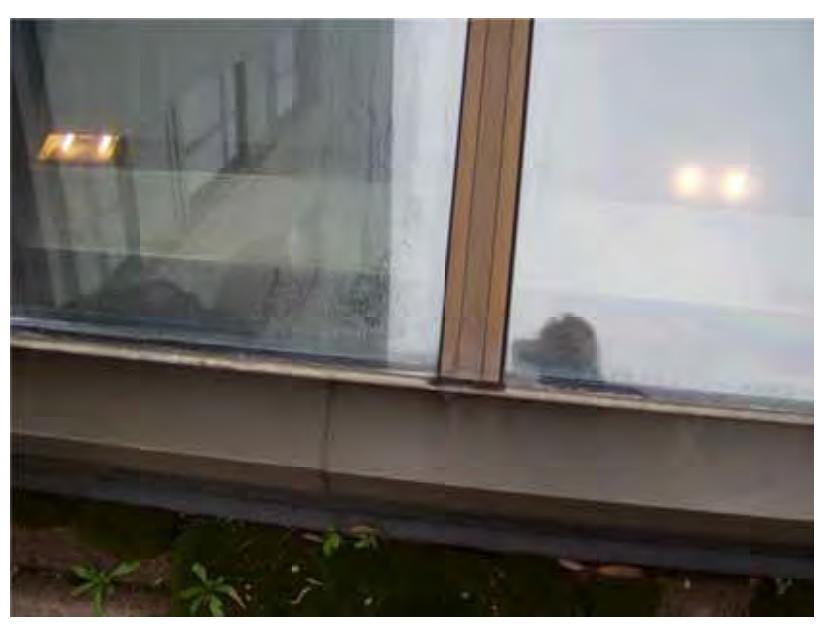
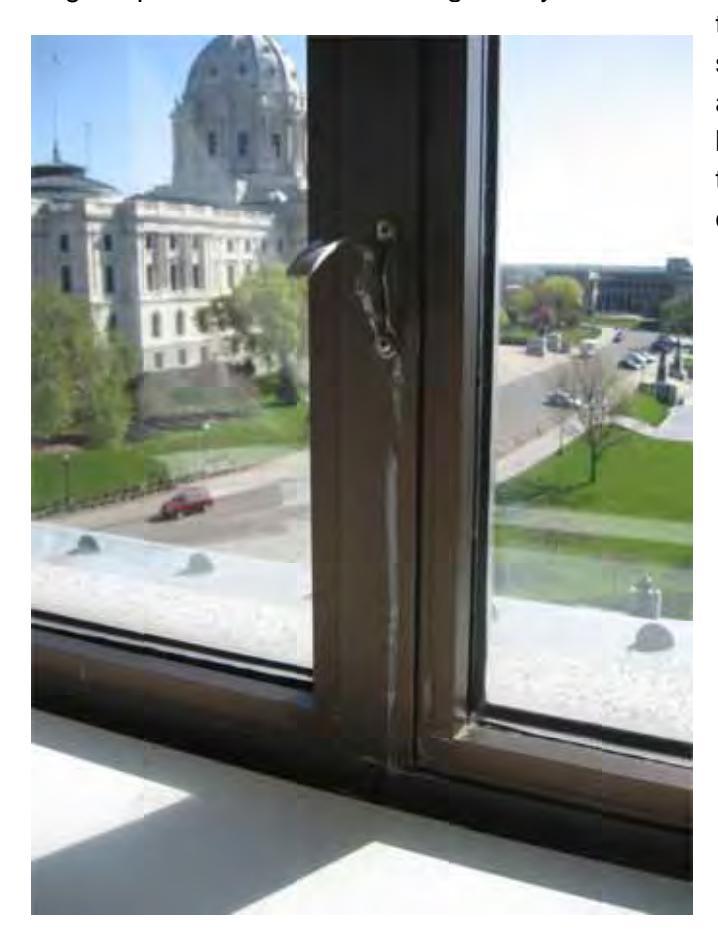
#### Window Review

original profiles. The insulated glass systems are in fair condition with some present hazing of

the glass. The frames however are showing signs of internal deterioration and are contributing to interior damage of the building as condensation moisture within the frames is trapped within the frames and draining to the interior of the building.

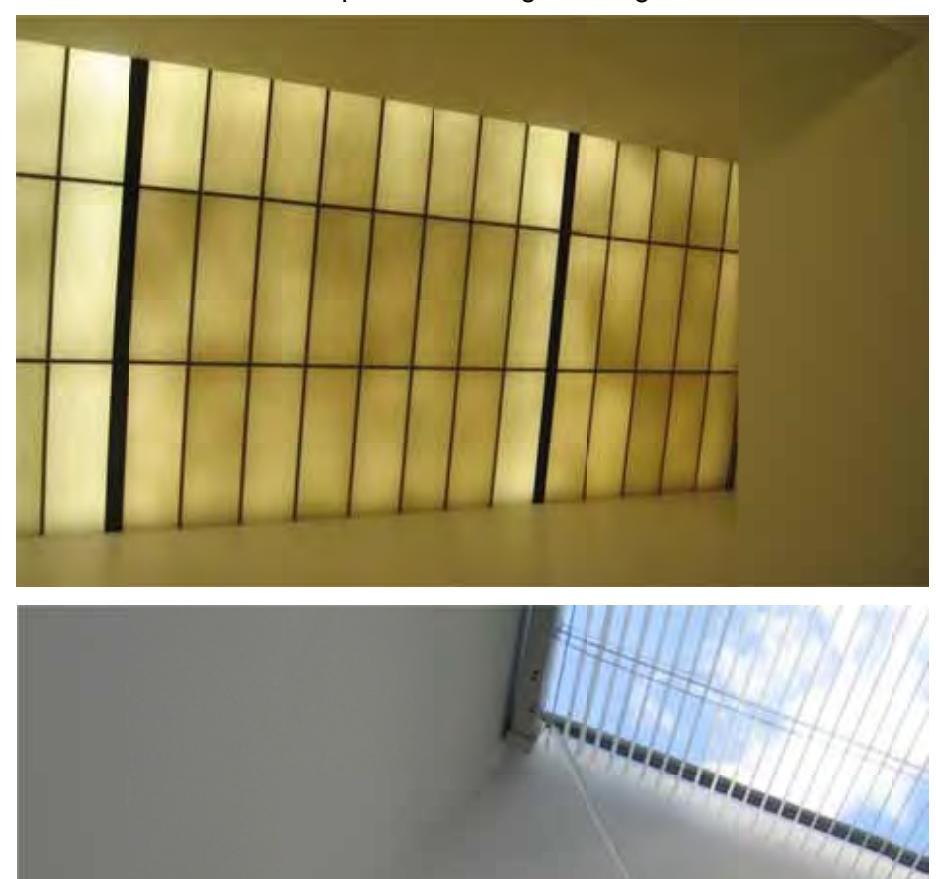
The skylights are also metal frame and were all added in the 1985 addition. The majority are double pane insulated glass but there a few 'kalwall' assemblies. The metal frames are not thermally broken or properly detailed for exterior drainage. The insulated glass systems are in fair condition with some present hazing of the glass. The 'kalwall' assemblies have 'yellowed'

substantially which is typical for this product but impact the quality of light filtered through the assembly. The frames however similar to the windows are showing signs of internal deterioration and are contributing to interior damage of the building condensation as moisture within the frames is trapped within the frames and draining to the interior of the building. The difficulty is that the detailing of the interior wall finishes relation to these in frames will require mean replacement will require removal and replacement the of interior finishes. This is required in some areas to correct damage but others in is only required for access the skylight assembly.

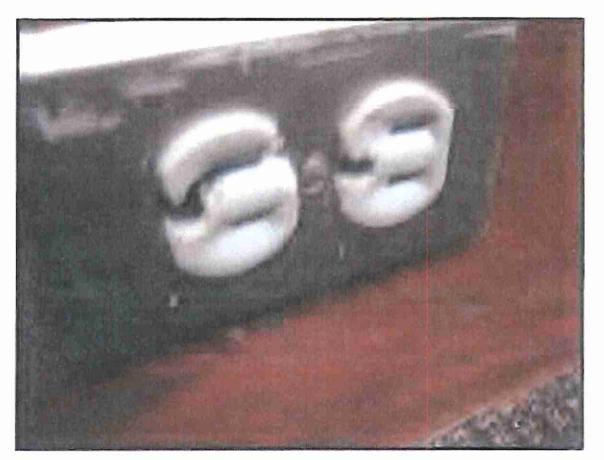
Branch Wiring - Receptacle in Disrepair - Room G10

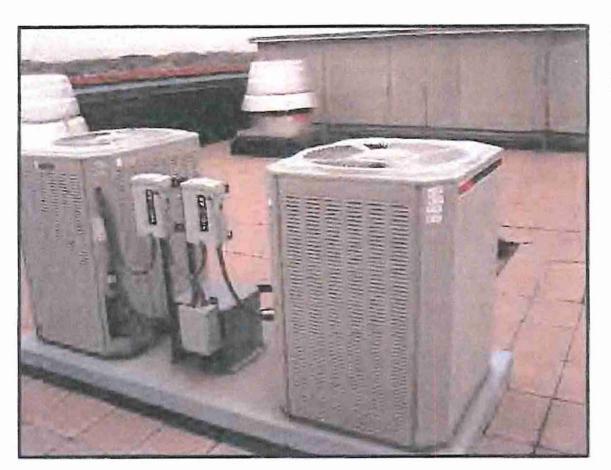
Branch Wiring - Outlets Not Installed at HVAC Units

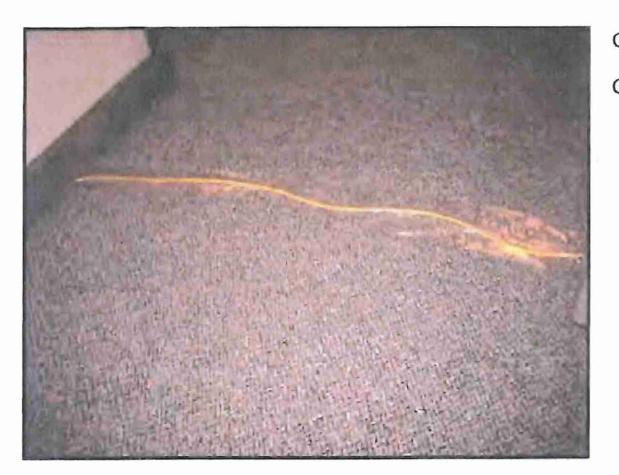
Communication Wiring - Improperly Installed - Corridor 180B Communication Wiring - Improperly Installed - Corridor 180B

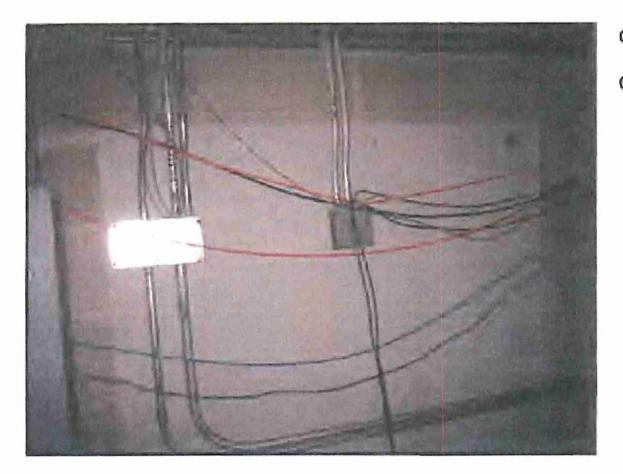
Communication Wiring - Improperly Installed - Room 142F Communication Wiring - Improperly Installed - Room 142F

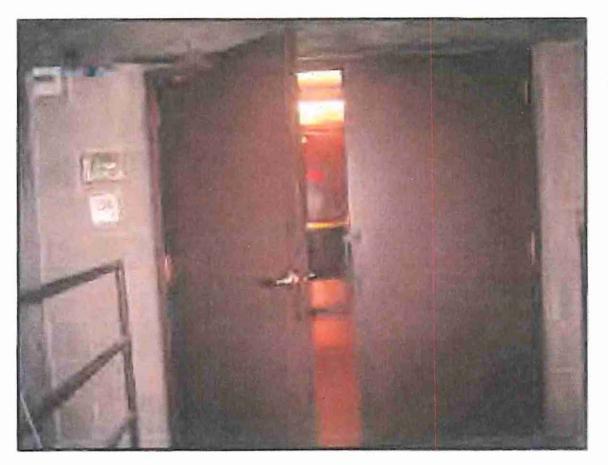
Electrical Service – Inadequate Means of Egress from Electrical Room Electrical Service – Inadequate Means of Egress from Electrical Room

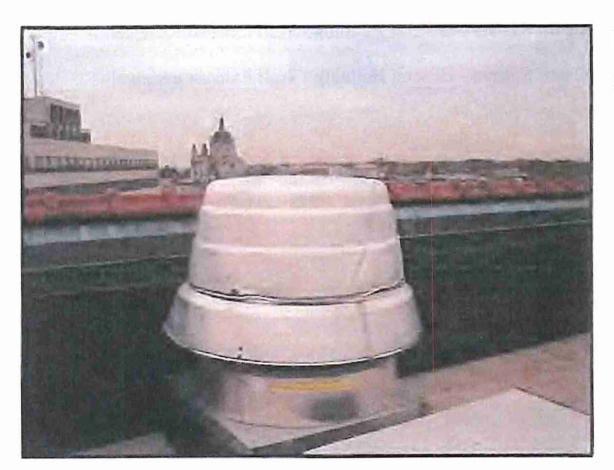
Exhaust System - General Building - Centrifugal Renewal

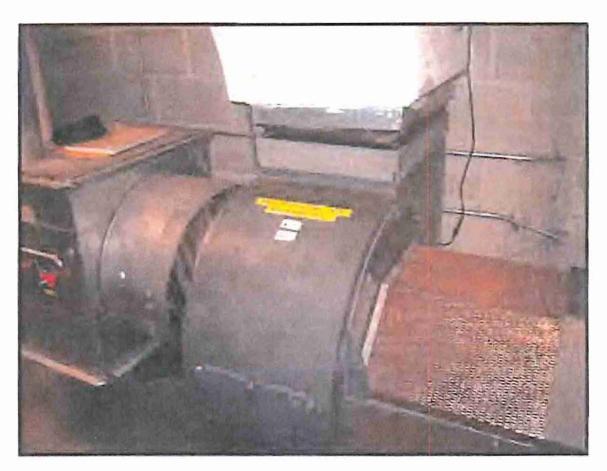
Exhaust System - Restroom w/Roof Fan Renewal

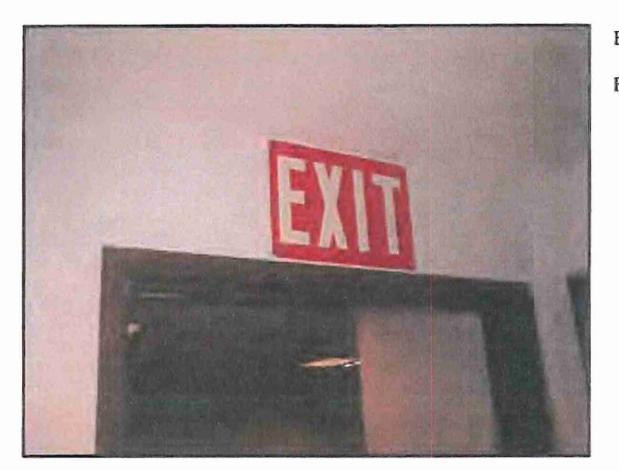
Exit Signs - Not Properly Illuminated

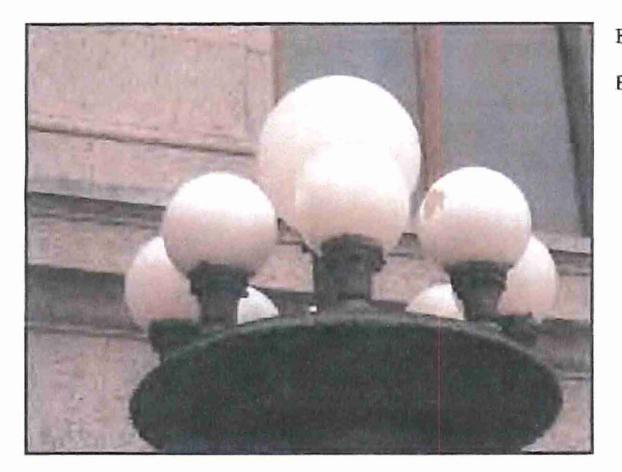
Exterior Lighting - Luminaires in Disrepair

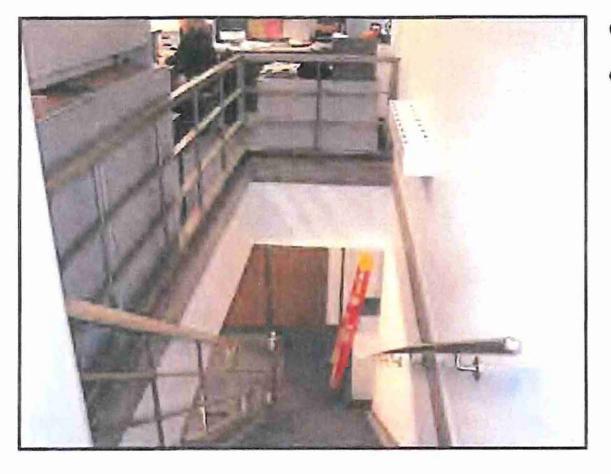
Guardrails - Non-Compliant Heights or Spacing - Unenclosed Access Stairs

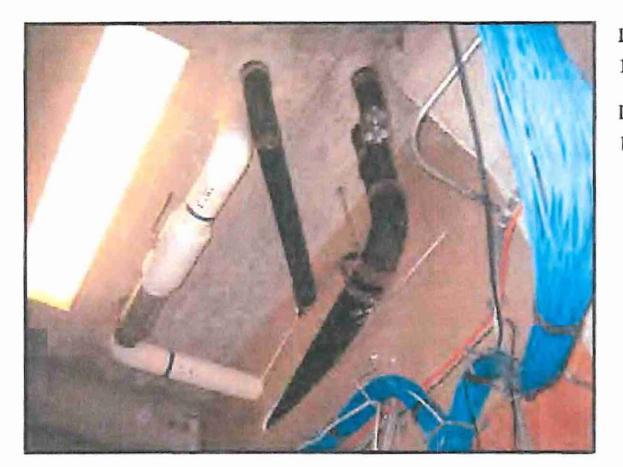
Local Area Networks – Unprotected Plumbing Pipes above Equipment – Room 132E

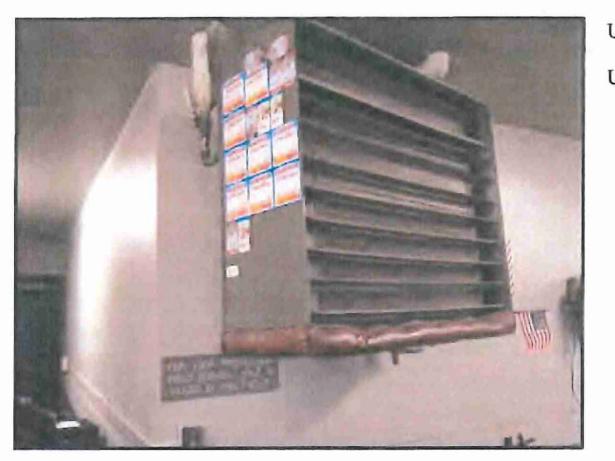
Unit Heaters - Hot Water Renewal

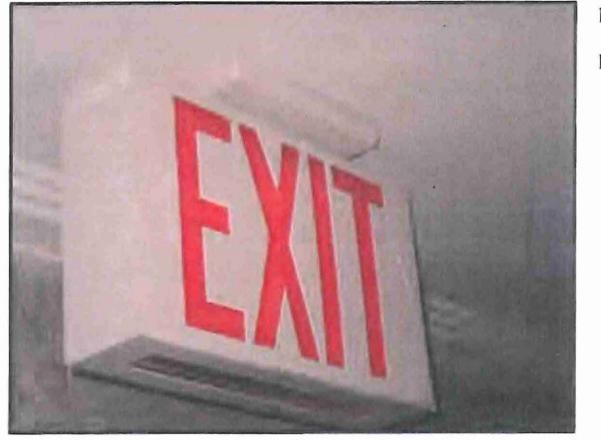
Exit Signs Renewal

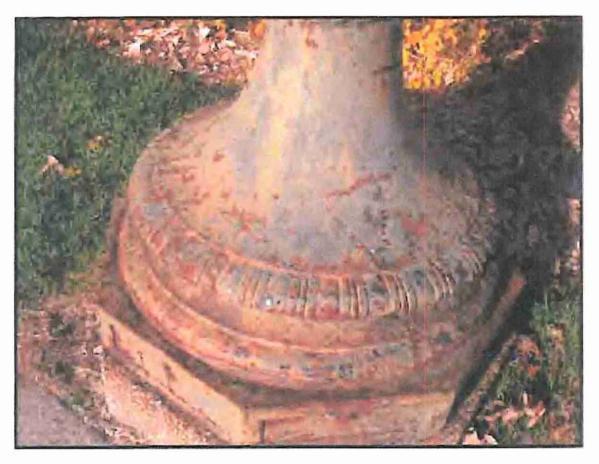
Site Lighting Renewal

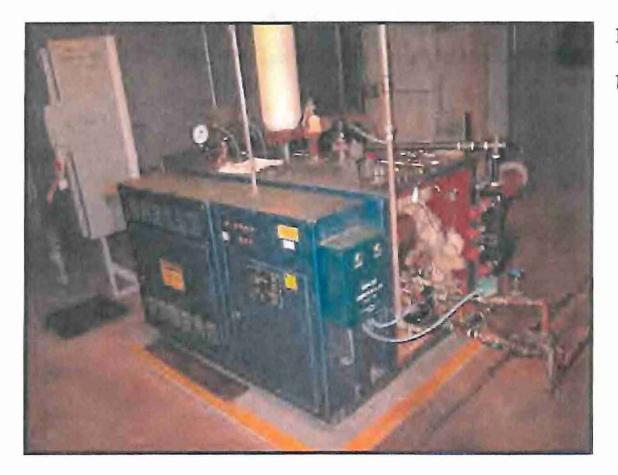
Boiler Steam - Humidification Renewal Boiler Steam - Humidification Renewal

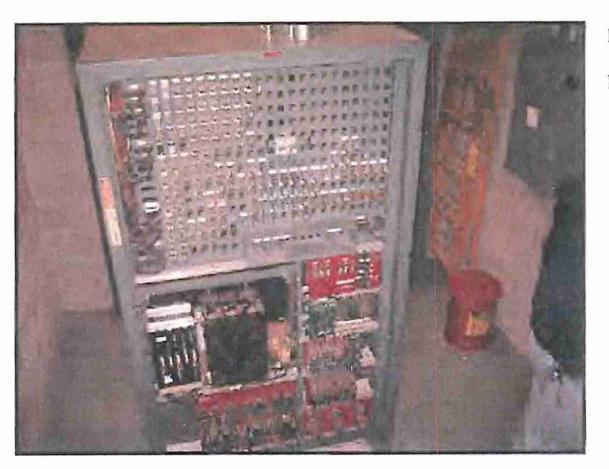
Elevator #5 Controller - Beyond Rated Life

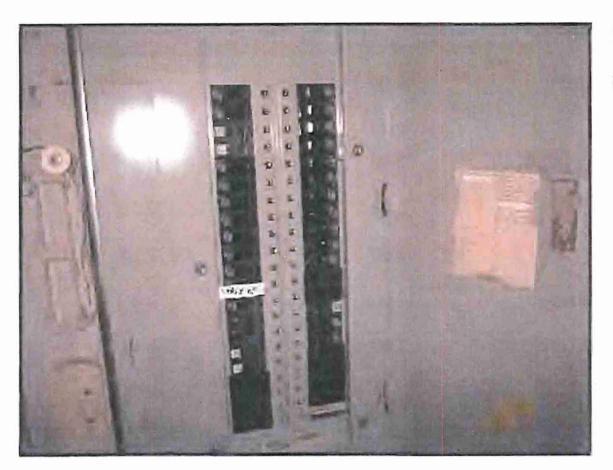
Emergency Panelboards - Approaching Rated Life

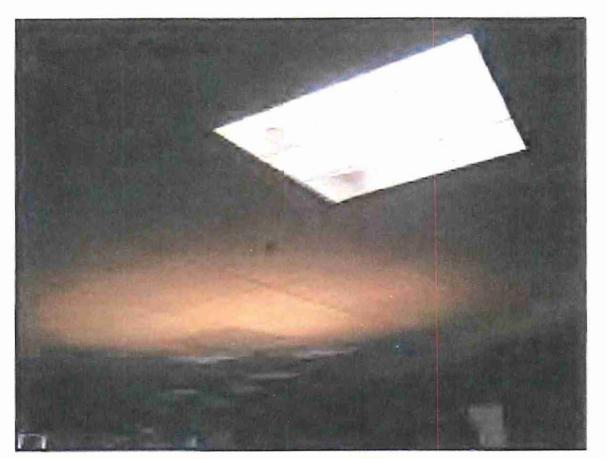
Fluorescent Lighting - Approaching Rated Life

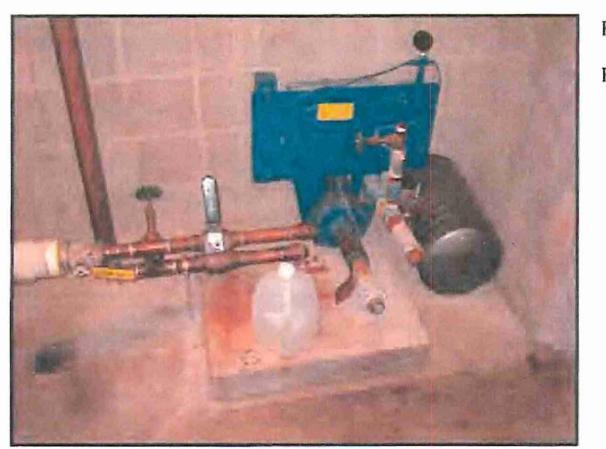
HVAC Equipment - Abandoned

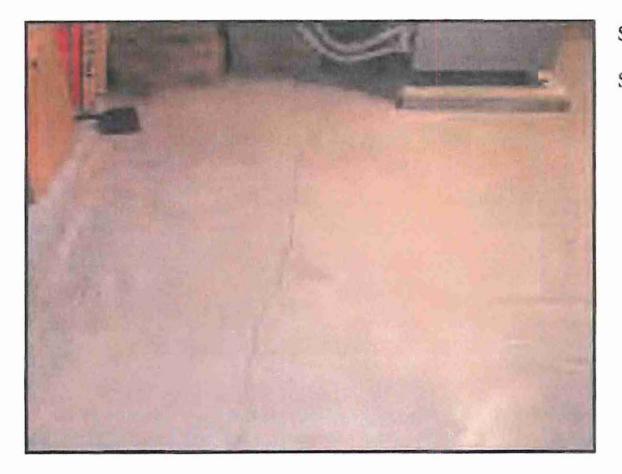
Substructure - Basement Slab Cracks Substructure - Basement Slab Cracks

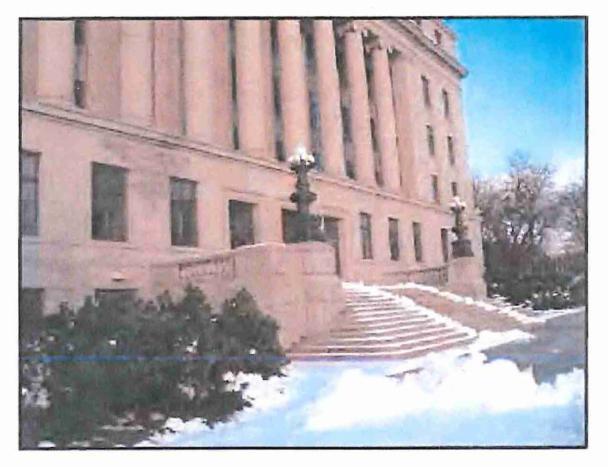
#### Exterior Stairs - Missing Handrails - Monumental Steps Exterior Stairs - Missing Handrails

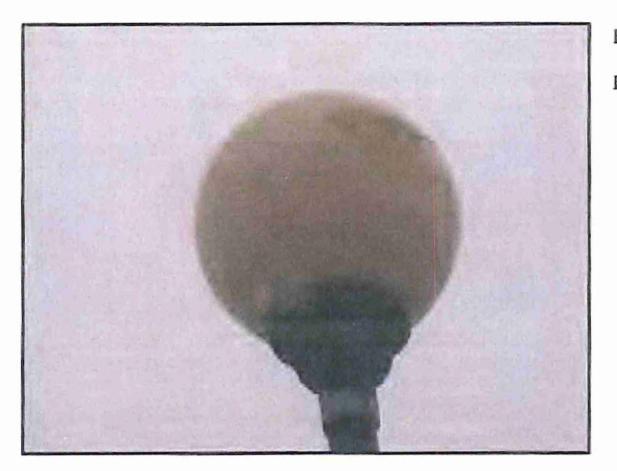
Exterior Pole Lighting - Luminaires in Disrepair

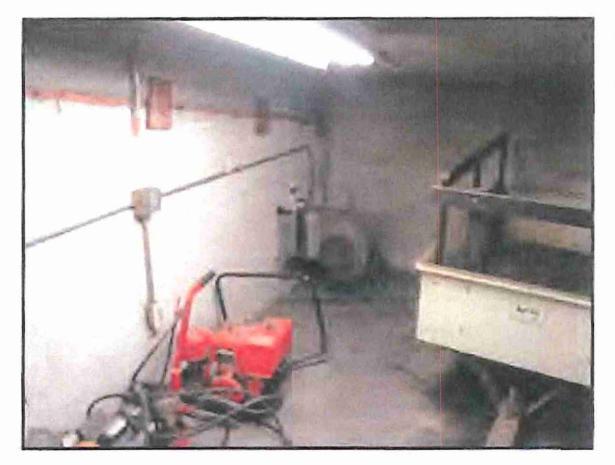
Exhaust System - Storage Room Renewal

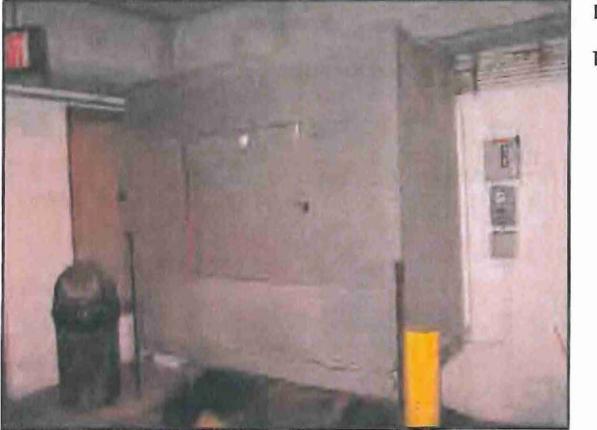
Exhaust System Renewal

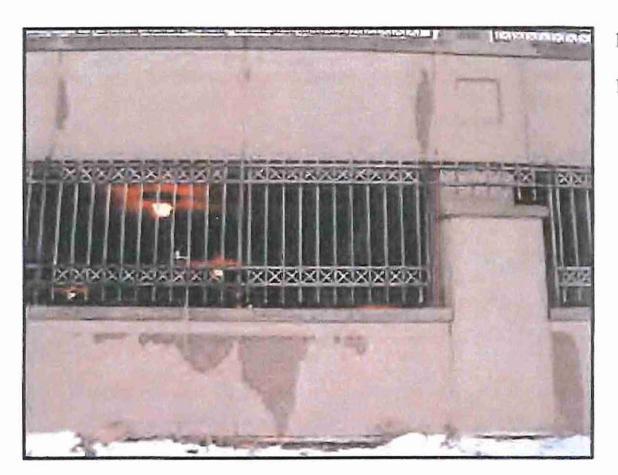
Exterior Guard Rails - Failing Paint Finishes

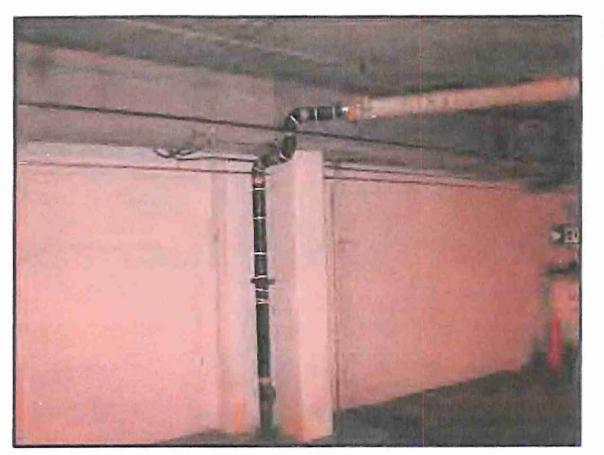
Pipe Insulation - Deteriorated
