Fatigue Evaluation of the  
Deck Truss of Bridge 9340

# **FATIGUE EVALUATION OF THE DECK TRUSS OF BRIDGE 9340**

## **Final Report**

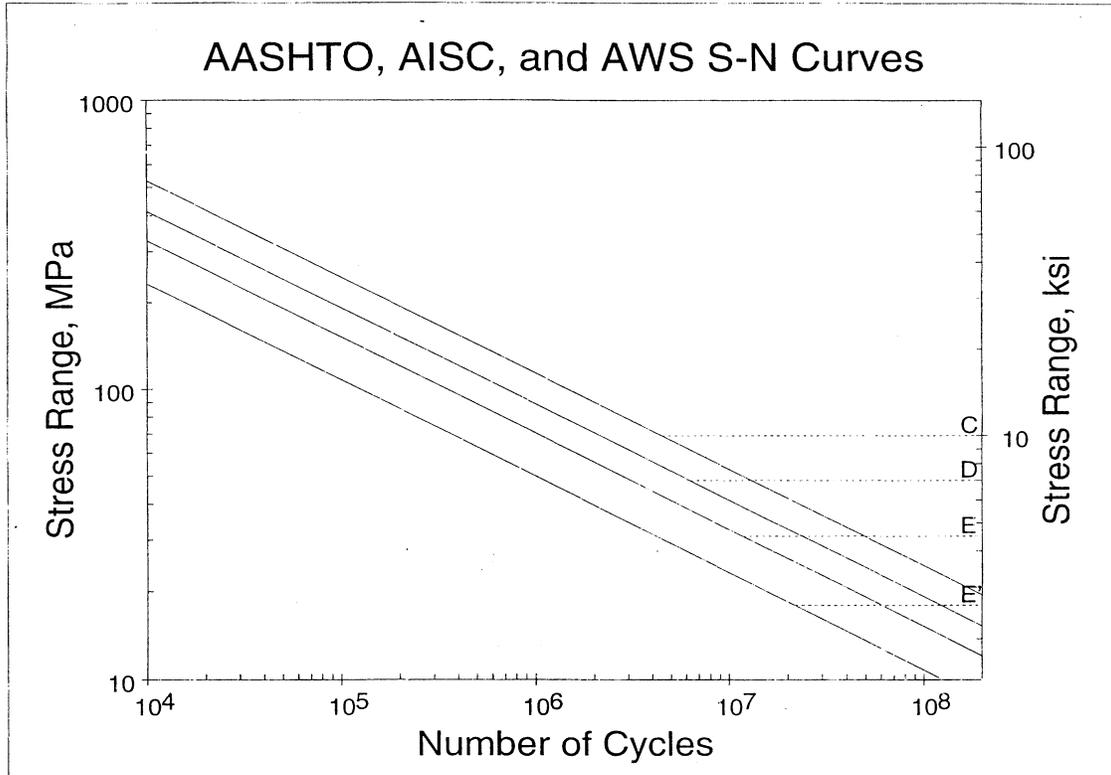
Figure 2 shows the fatigue threshold or constant amplitude fatigue limits (CAFL) for each category as horizontal dashed lines. When constant-amplitude tests are performed at stress ranges below the CAFL, noticeable cracking does not occur. For bridges in service, if almost all the stress ranges are below the CAFL, the fatigue life is considered essentially infinite. The CAFL for Category C, D and E is 69, 48, and 31 MPa, respectively.

Figure 2: AASHTO Fatigue Resistance Curves

An actual service load history is likely to consist of cycles with a variety of different load ranges, i.e., variable-amplitude loading [4]. However, the S-N curves shown in Figure 2 are based on constant-amplitude loading. There is an accepted procedure for converting variable stress ranges to an equivalent constant-amplitude stress range with the same number of cycles. This procedure is based on the damage summation rule jointly credited to Palmgren and Miner (referred to as Miner's rule) [18]. If the slope of the S-N curve is equal to three, then the relative damage of stress ranges is proportional to the cube of stress range. Therefore, the effective stress range is equal to the cube root of the mean cube of the stress ranges [19].

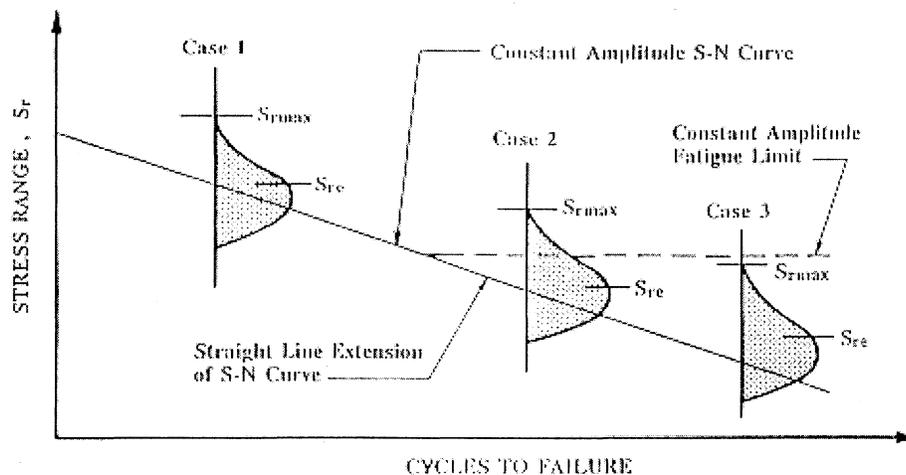
When the effective stress range is on the order of the fatigue threshold or less, dealing with variable stress ranges becomes more complicated. Figure 3 shows the lower part of an S-N curve with three possible variable stress-range distributions superposed [20]. The effective stress range is shown as  $S_{re}$  in this figure and is used the same way as a constant-amplitude stress range with the S-N curves in the finite-life regime (Case 1 and Case 2).

For Case 3 in Figure 3, essentially all the stress ranges are less than the CAFL. In this case, long-life variable-amplitude fatigue tests on full-scale girders with welded details show that if less than one in 10,000 cycles exceed the CAFL, then essentially infinite life is obtained [4]. This phenomenon is the basis of what is called the “infinite-life” approach, which is incorporated in the AASHTO LRFD specifications [5].

Figure 3: Possible Cases of  $S_{re}$  and  $S_{rmax}$  in Relation to the CAFL

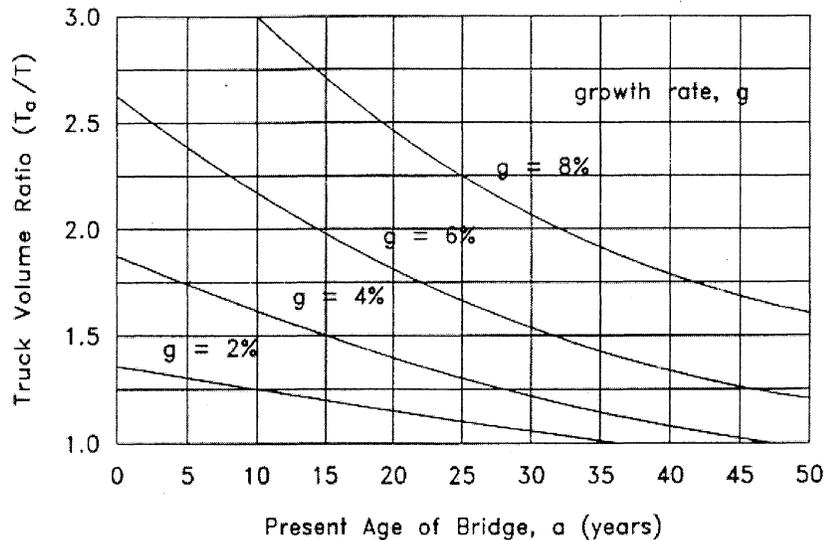
Figure 4: Truck Volume Ratio ( $T_a / T$ ) [10]

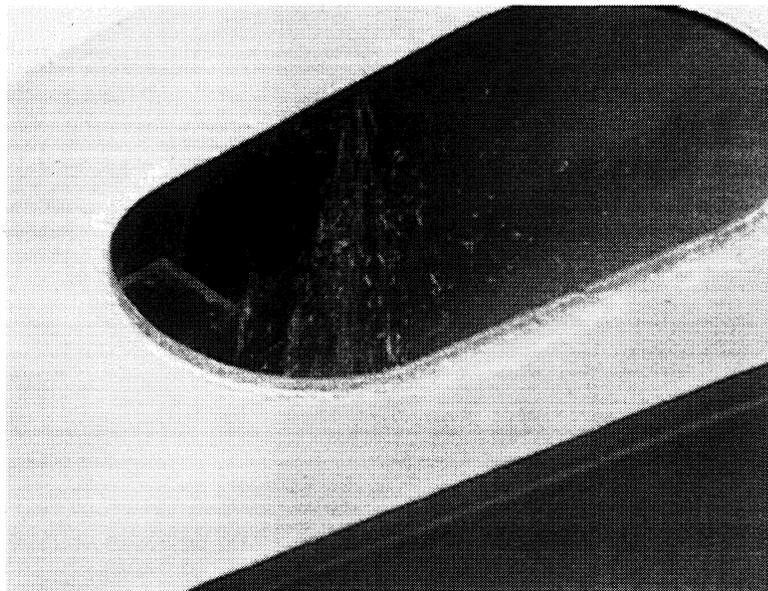
The built-up box sections have attachments measuring 8.9 cm square welded to diaphragms at the interior of all tension members (Figure 5). There are also intermittent fillet welds at the interior of all box sections. These are both Category D details. The floor truss members have longitudinal stiffeners measuring 30.5 cm, which would be considered a Category E detail (Figure 6).

Figure 5: Welded Attachment at Interior of Box Section of Main Truss

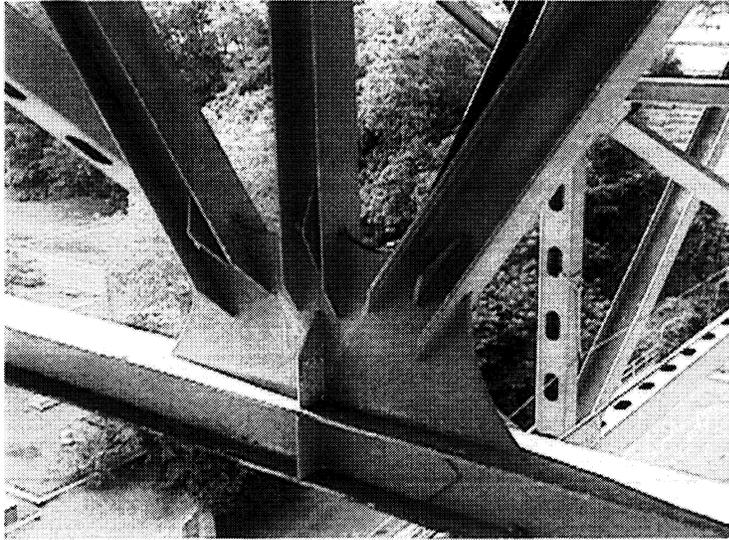
Figure 6: Longitudinal Stiffeners at Floor Truss Connections

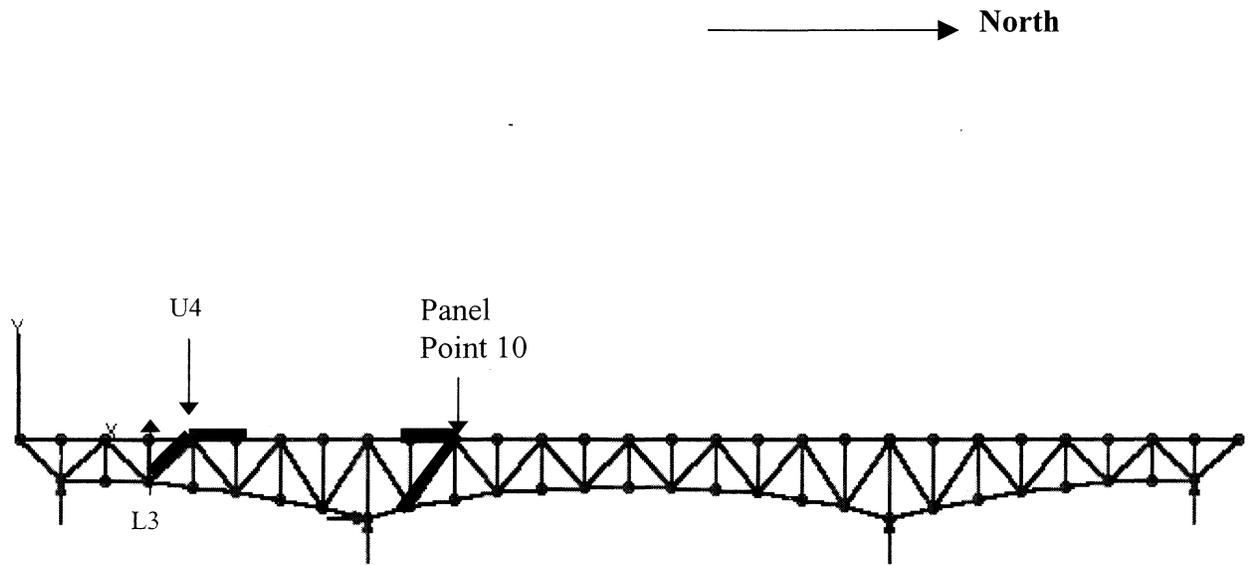
Six gages were put on each of the east and west main trusses and the floor truss. On the main trusses, a gage was placed on the interior and exterior of the members at mid-depth, to avoid any bending effects. An upper chord (U8-U10), a diagonal (L9-U10), and a lower chord (L9-L11) were instrumented. These members are identified in Figure 7 as the bold members next to panel point 10. The gages were placed at least one section depth away from the connection to avoid stress concentrations.

Figure 7: Gaged Locations on the Main Truss

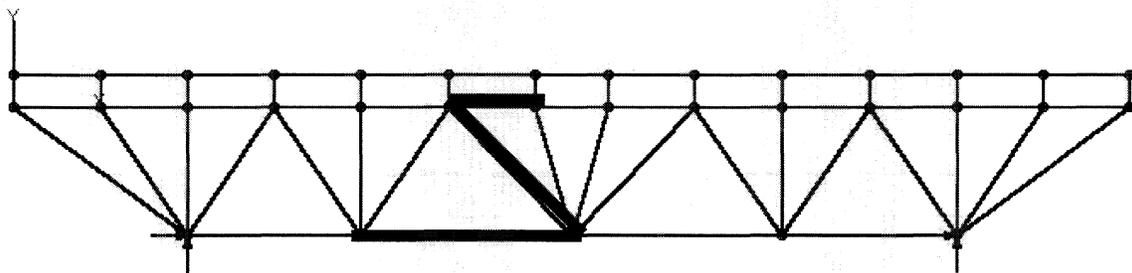
The floor truss has gages on the east side of the centerline. A gage was placed on the upper and lower flanges of an upper chord (U5-U6), a diagonal (U5-L7), and a lower chord (L4-L7) (Figure 8). These gages were also placed at least one section depth away from the connection to avoid stress concentrations. Figure 9 shows the gages in place on the exterior of the east truss on the upper chord and the diagonal.

Figure 8: Gaged Locations on the Floor Truss

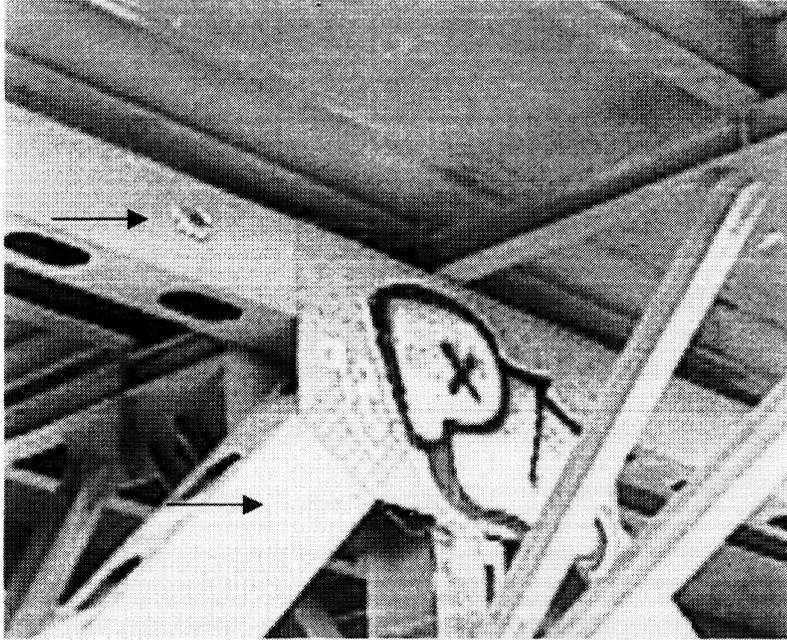
Figure 9: Gaged Upper Chord and Diagonal on Exterior of East Truss

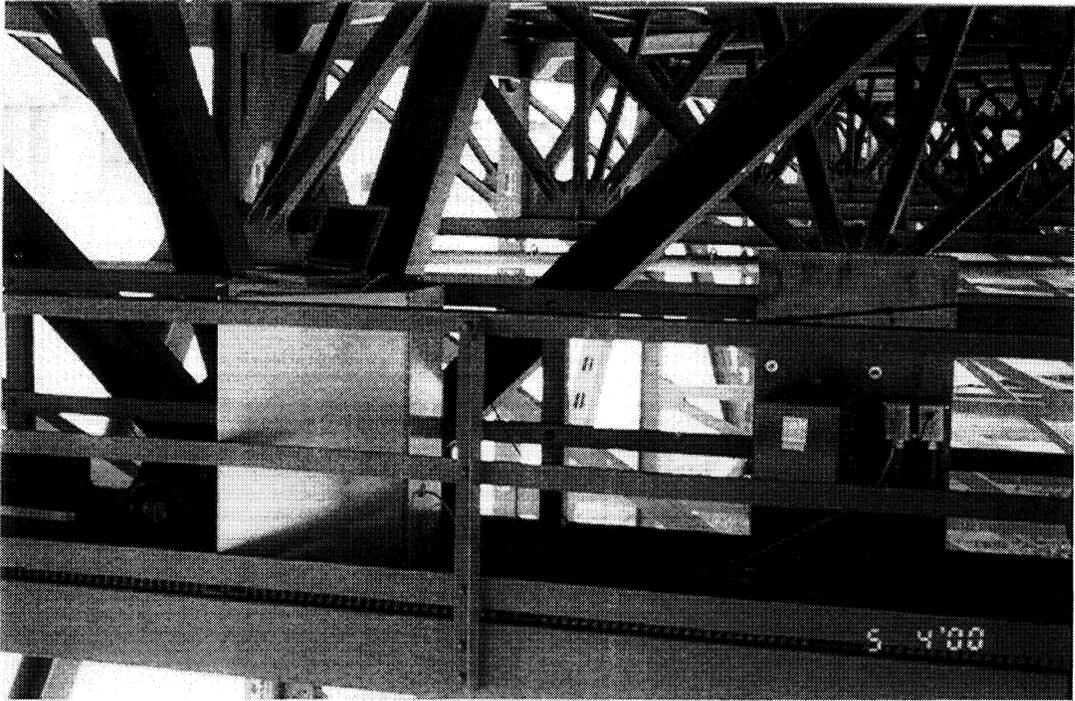
The wires leading from the gages ran to a central point on the transverse catwalk where they were wired into a data acquisition system housed in a locked electrical box. The box was attached to the catwalk railing using U-bolts. This set up is shown in Figure 10.

Figure 10: Data Recording Station on Catwalk of Bridge

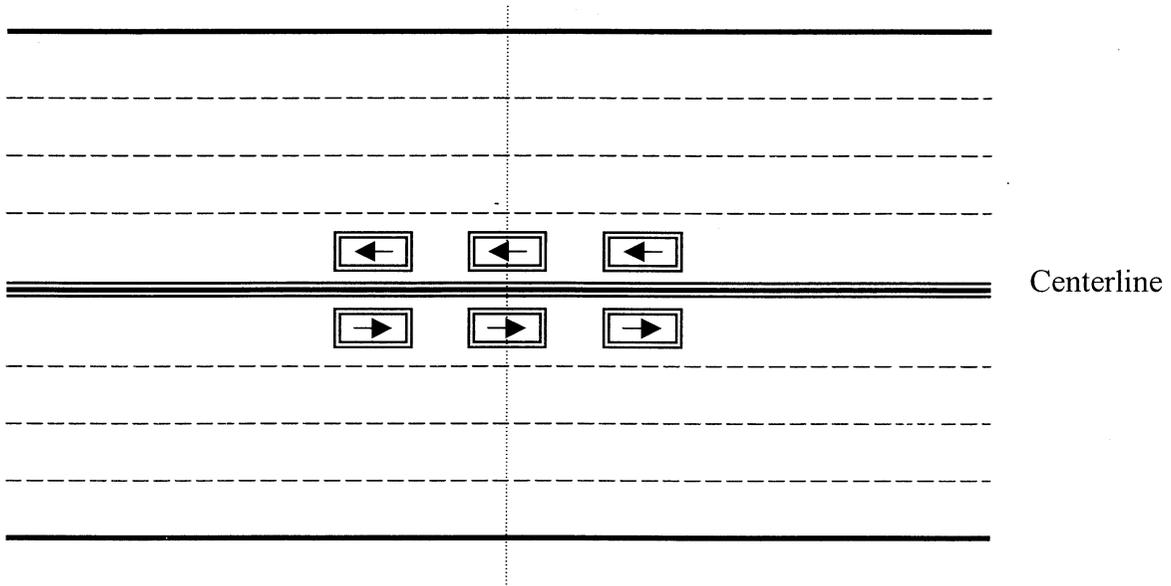
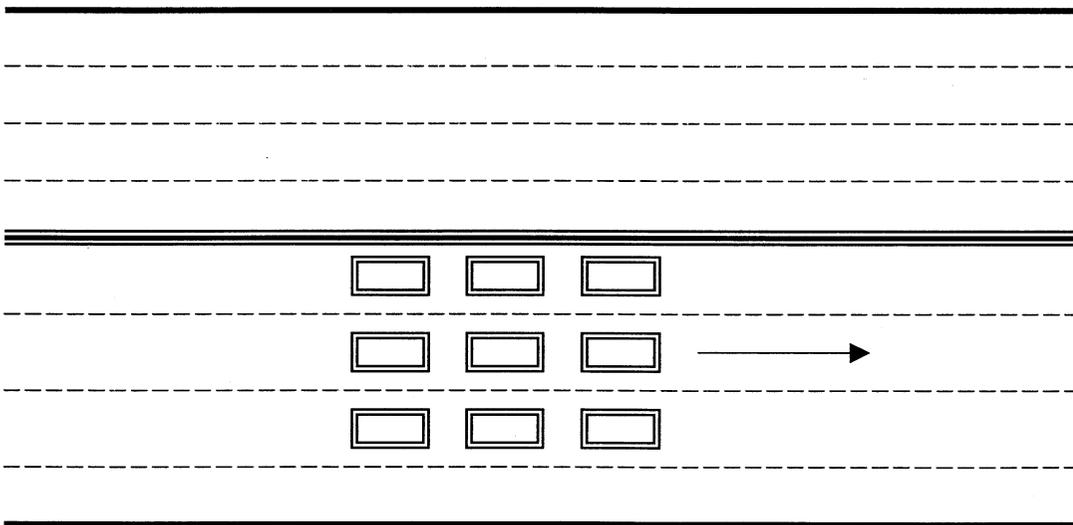
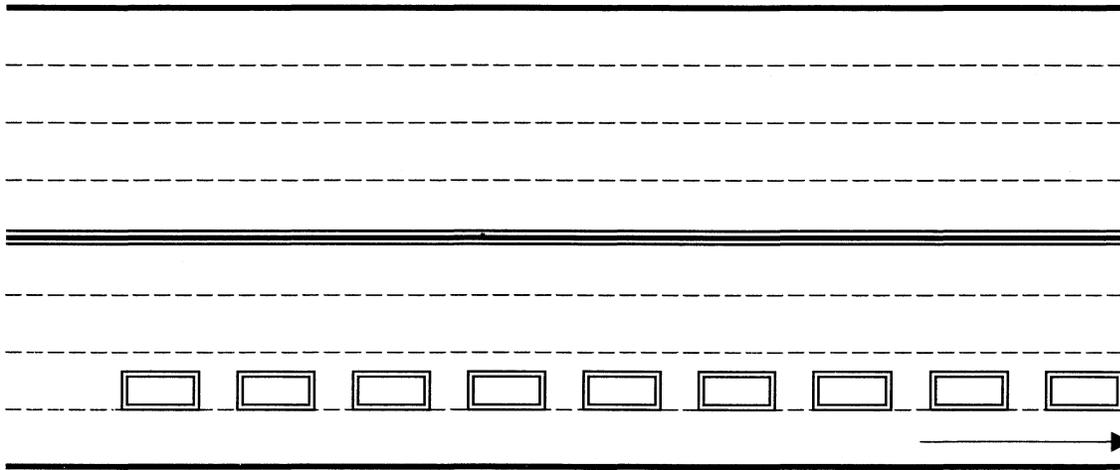
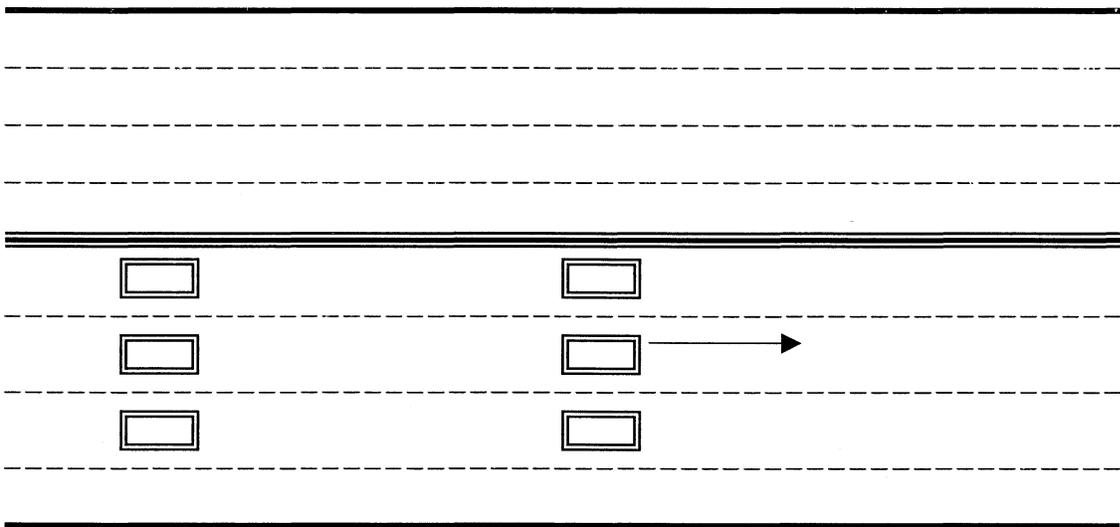
Test 1 consisted of two groups of three trucks, with each set driving in a single file line in the left lane in each direction of traffic. This test required that the left lanes were closed. This was done with signing and traffic control provided by Mn/DOT. To represent static conditions each line of trucks were traveling at a crawling speed. The trucks were to follow each other as closely as possible. Optimally, the middle trucks in each group were to meet simultaneously at panel point 10, directly above the instrumented floor truss (Figure 11a).

Test 3 consisted of using all nine trucks and running them in a single file line as close as possible to each other (Figure 11c). This was done in the third lane from the centerline as it was the lane most directly over the main truss. The test was run at highway speeds with no lane closures.

In Test 4, the trucks ran side-by-side in groups of three. All nine trucks were used with each group of three following the preceding group by no less than one-half mile. This was done to ensure that only one group of three would be on the bridge at a time. This test was also run at highway speeds. No lane closures were required for this test. The set-up is shown in Figure 11d.

Figure 11: Test Set-ups

To analyze the results of Test 2, trucks were centered in their lanes as shown in Figure 11b. By measuring the time between peaks in the stress history and estimating the trucks travel speed at 88 kph, it was determined that the following distances for the three rows of trucks was 30.5 and 39.6 meters. Loads were applied to the model with appropriate distances between them and were moved across the length of the bridge.

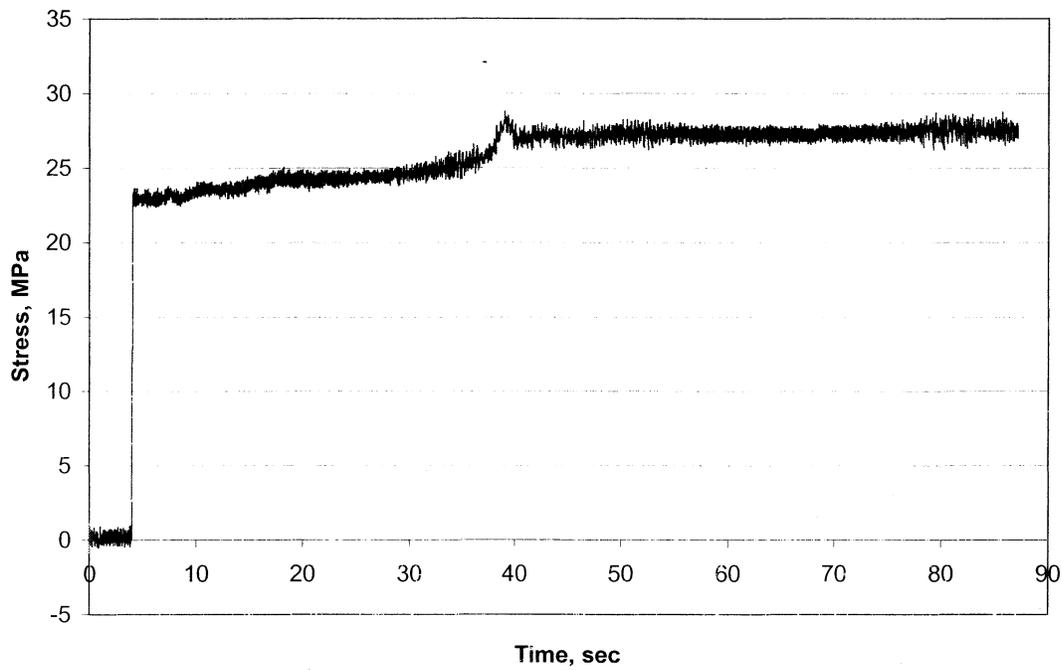
The goal of the first test was to get the greatest response possible under static conditions in the floor truss. Figure 12 shows a time history of the lower chord in the floor truss during this test. There was a discontinuity in the recording before and after the trucks were in position, making it appear as though the load is applied instantly instead of slowly increasing as the trucks neared the gages. The measured strains show that the lower chord goes into tension as expected. The peak stress range is 28 MPa, which is actually the largest stress range recorded in any member in any test.

### Test 1; Lower Chord of Floor Truss

Figure 12: Time History of the Response During Test 1

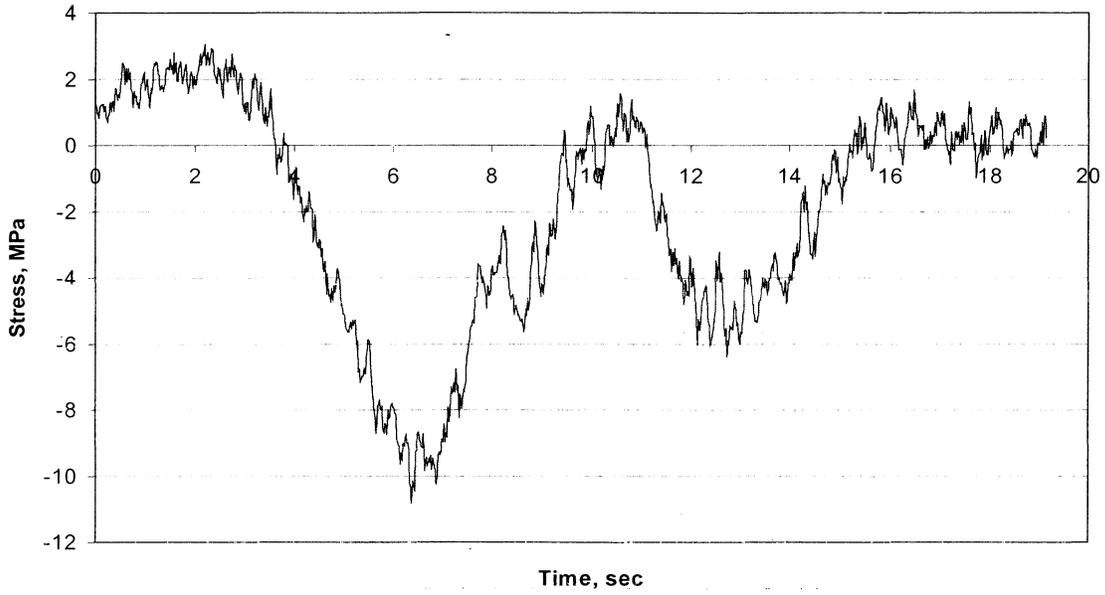
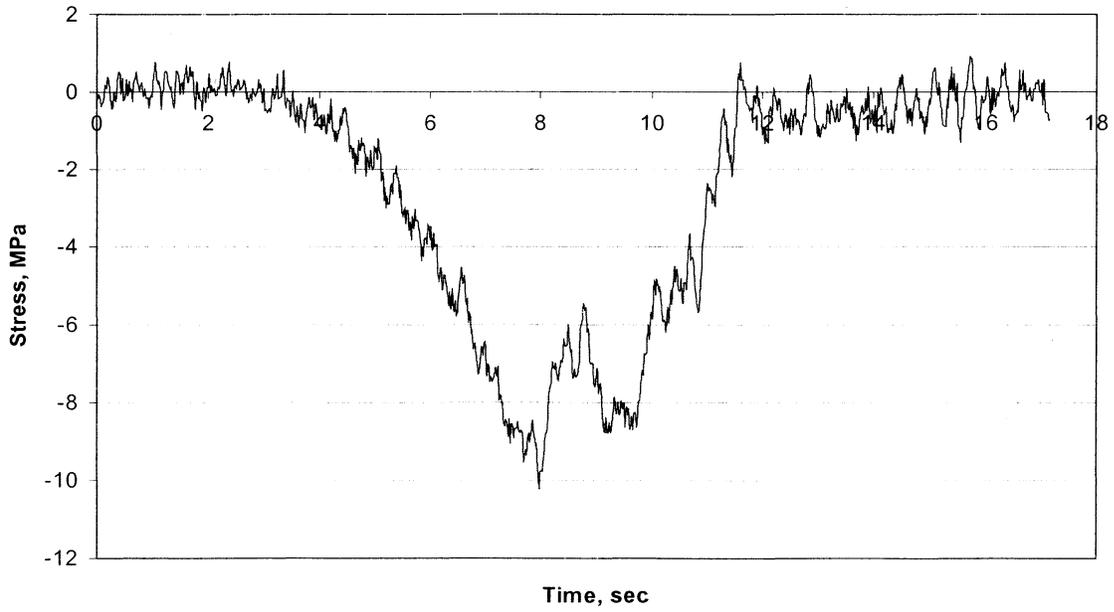
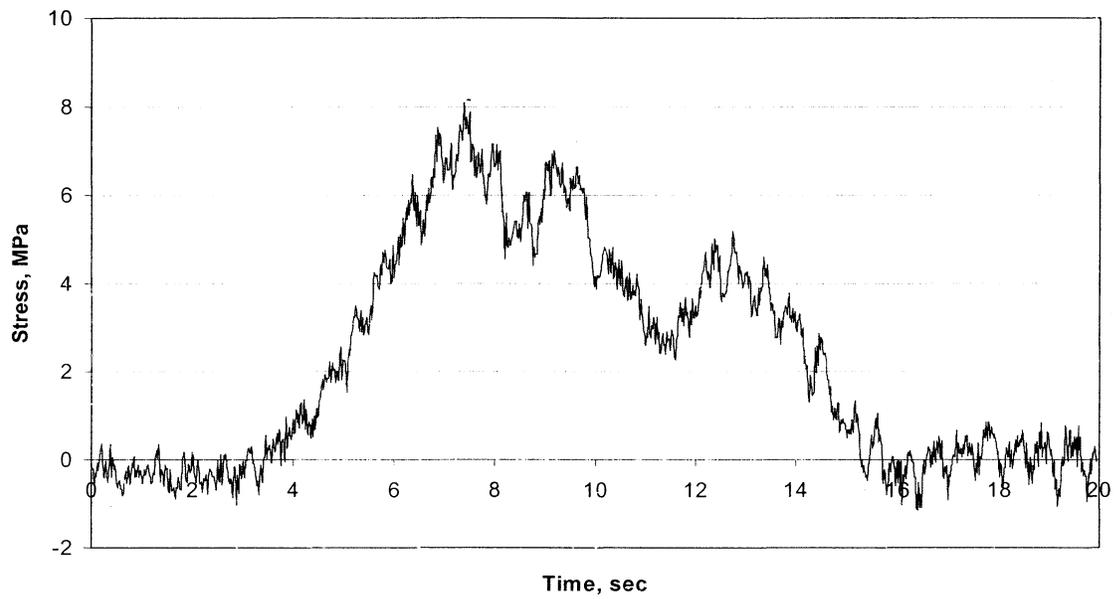
Figures 13b and 13c show the stress ranges in the diagonal and upper chord from the truss during the same event. The stress ranges in the diagonal and upper chord during this test were 10 and 8 MPa, respectively.

Figure 13: Time Histories of the Response During Test 2

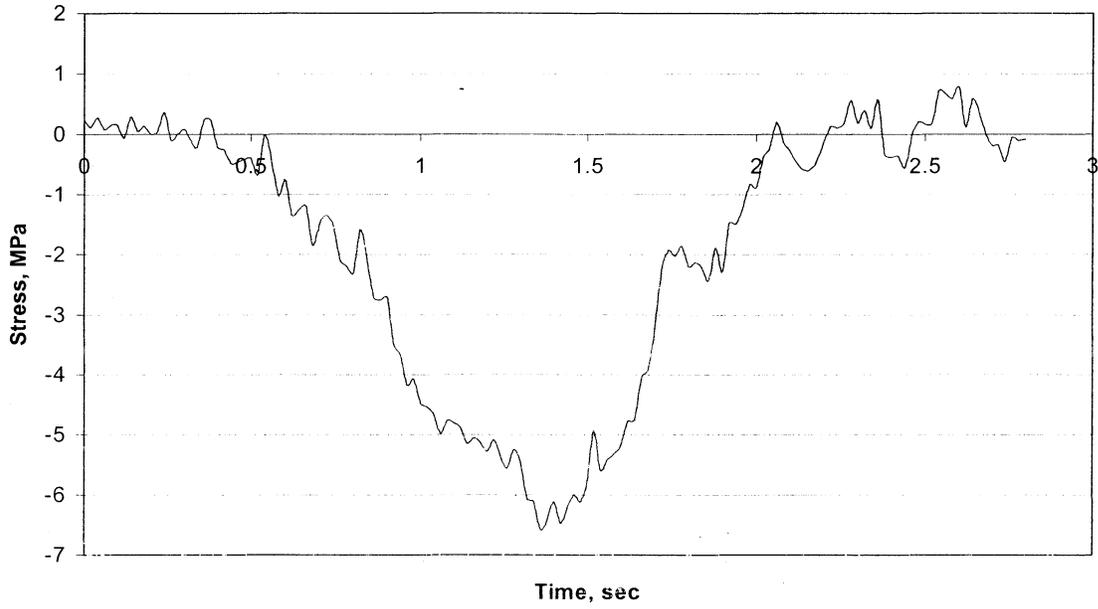
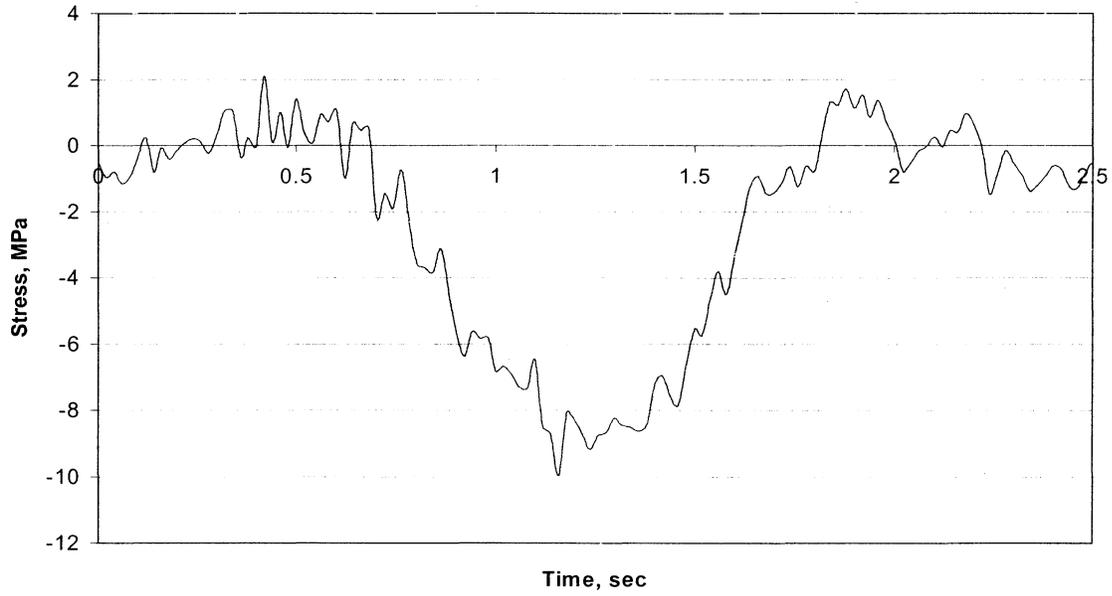
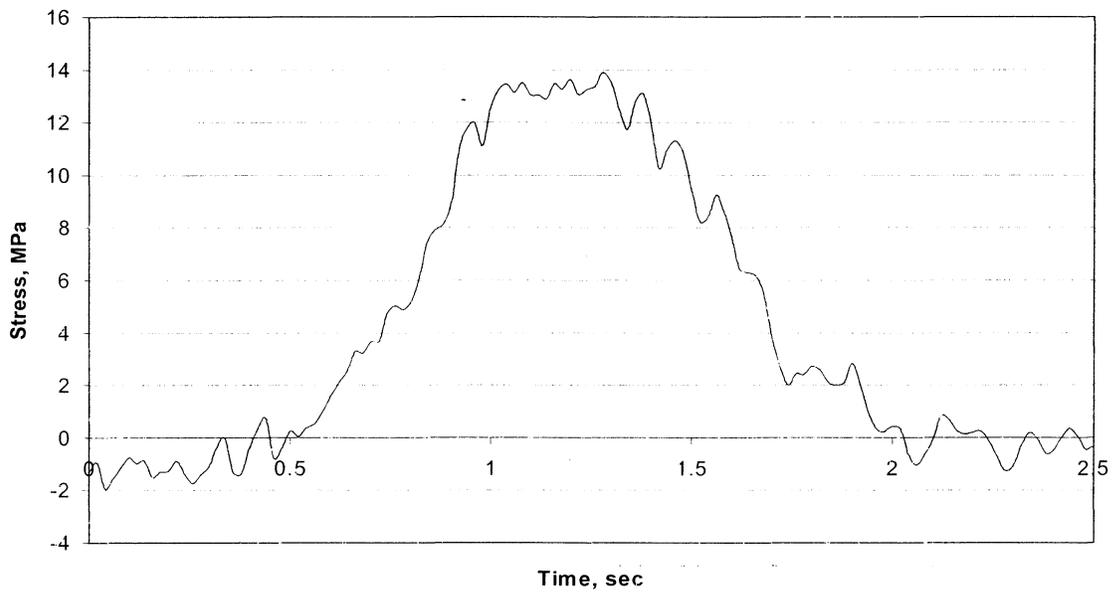
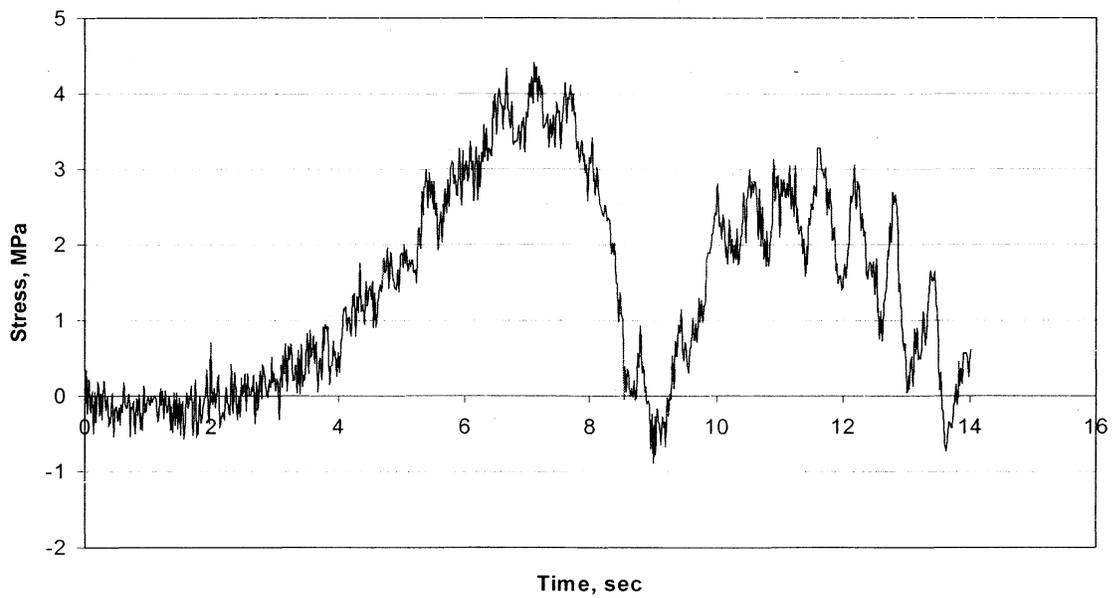
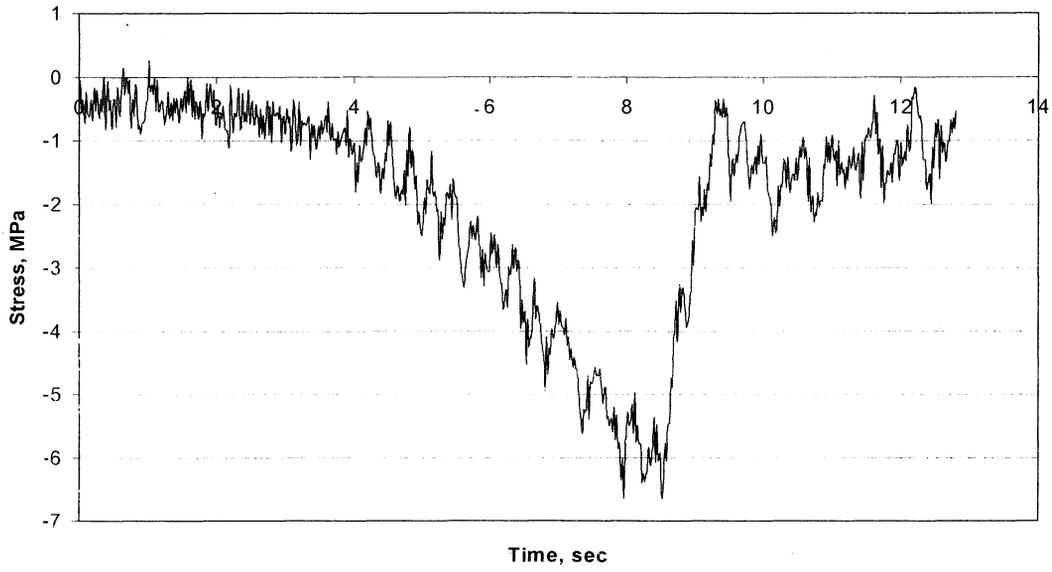
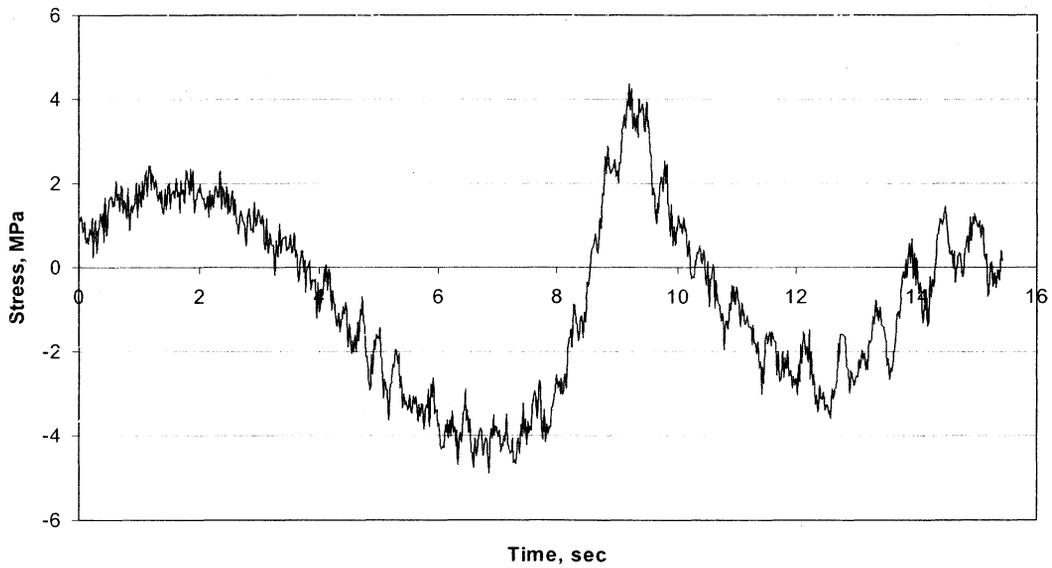
Figure 14: Time Histories of the Response During Test 4

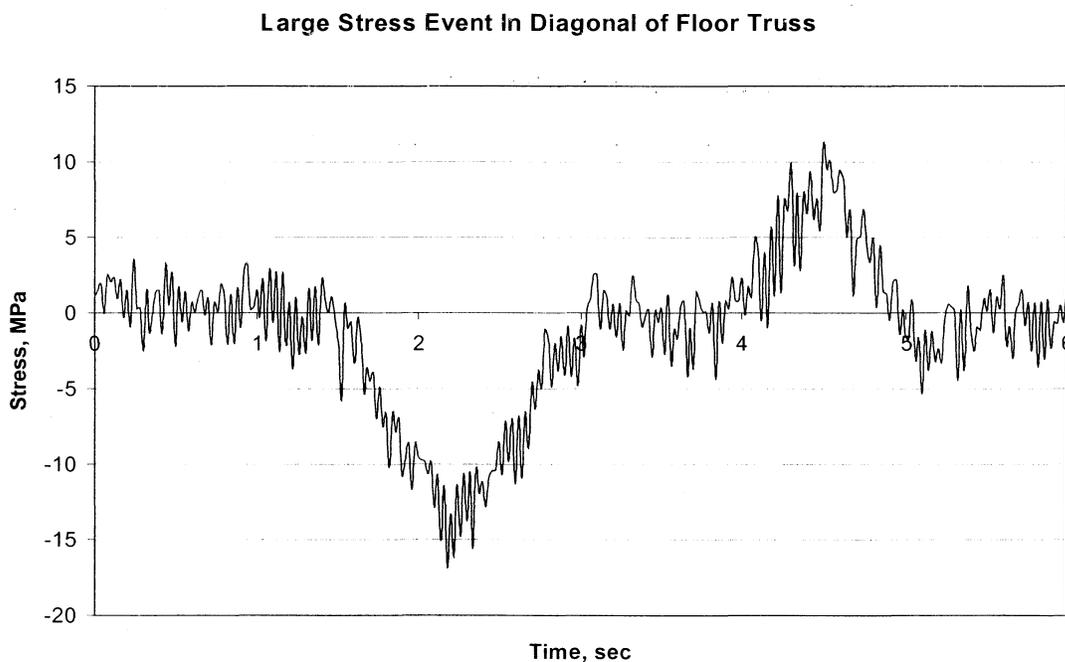
The largest floor truss stress history is presented in Figure 15. The diagonal member is in compression when a load is traveling in the northbound direction, directly over the gaged members, and is in tension when a load is traveling in the southbound direction. Therefore it can be assumed that this large event occurred when two large trucks, each traveling in opposite directions, passed the gaged location within seconds of each other.

Figure 15: Largest Stress Event Recorded in Open Traffic Conditions

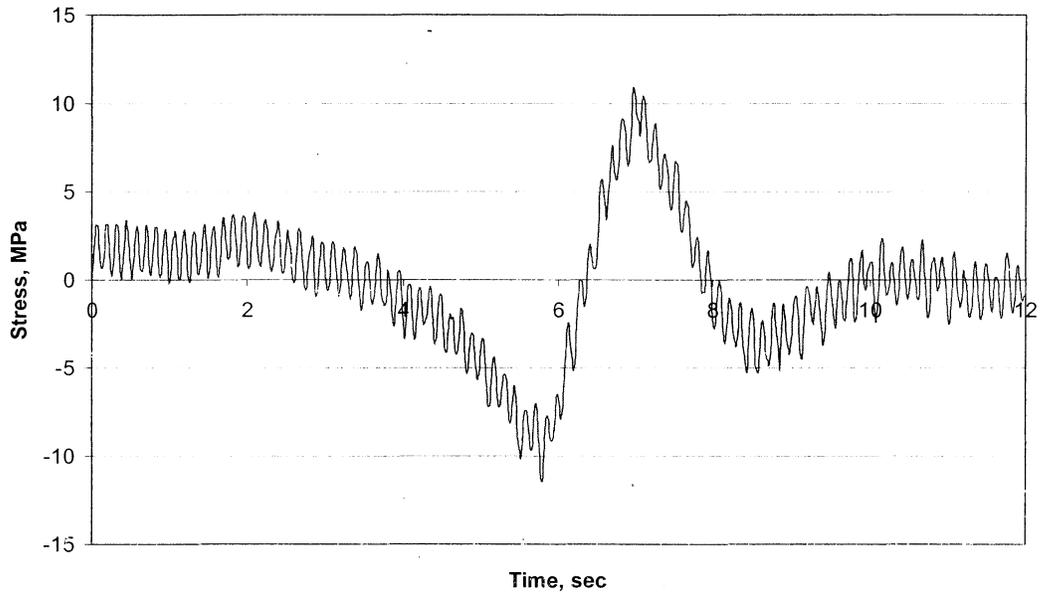
### Largest Stress Event in High Tension Member L3U4

Figure 16: Largest Stress Event in High-Tension-Stress Member L3U4

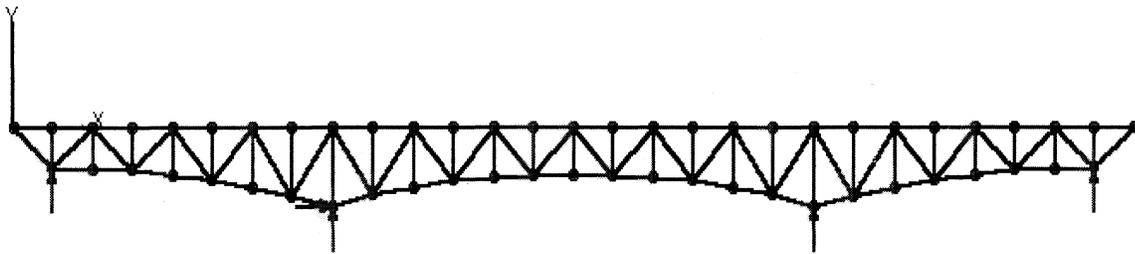
The computer program Visual Analysis was used to model the main truss and analyze the loads applied during Tests 2 and 4. First, a two-dimensional model of the main truss was created based on the plan dimensions (Figure 17). Influence lines were then calculated for the trusses across the width of the bridge and between panel points along the length of the bridge to determine how the loads would be distributed.

Figure 17: 2-D Visual Analysis Model of Main Truss

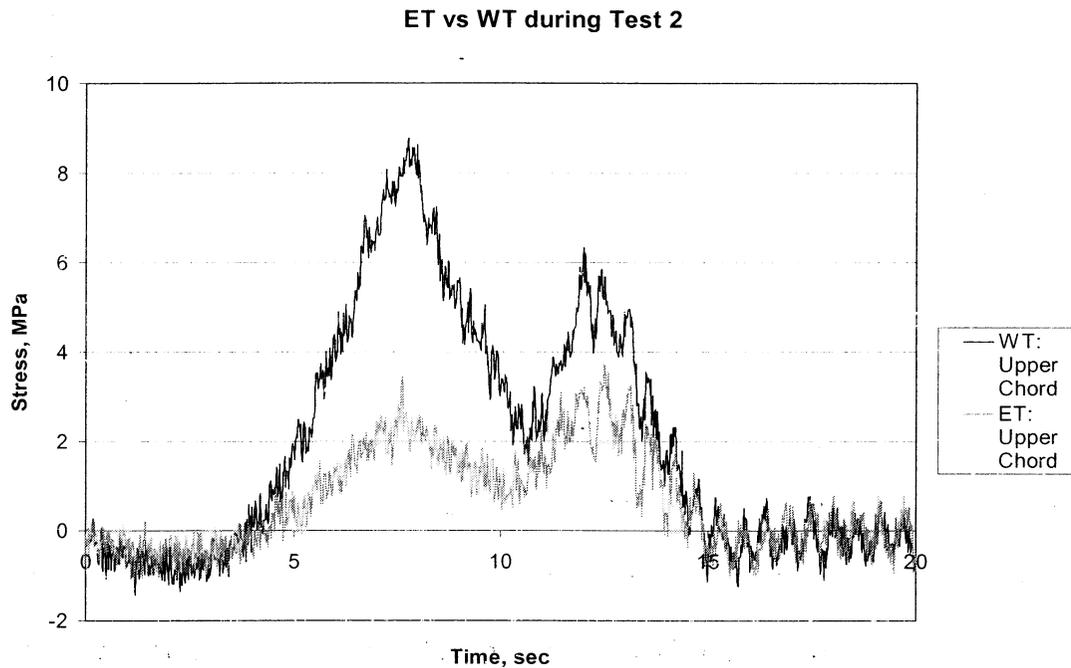
The load distribution across the bridge deck was first checked by plotting the time histories for an east truss and west truss member during Test 2. The percentage of the west truss member stress felt by the east truss was then compared to the percentage predicted by an influence line. The data presented in Figure 18 shows that the east truss recorded 30 percent of the stress recorded in the west truss during Test 2. Calculations from a simple influence line yield a percentage of 28, suggesting good agreement between theoretical and actual distribution.

Figure 18: Distribution of Load Across the Bridge Deck

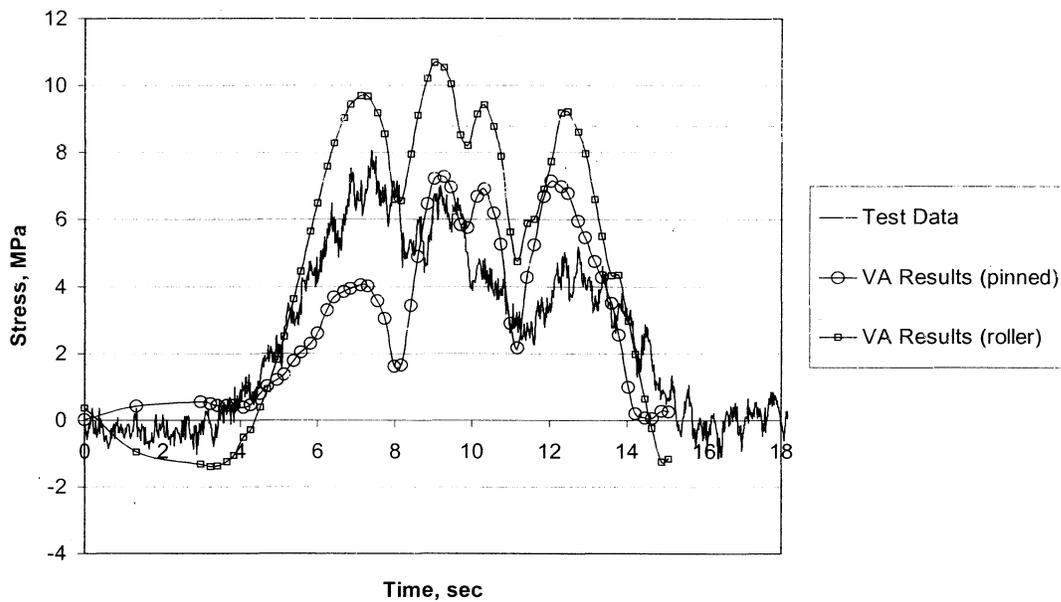
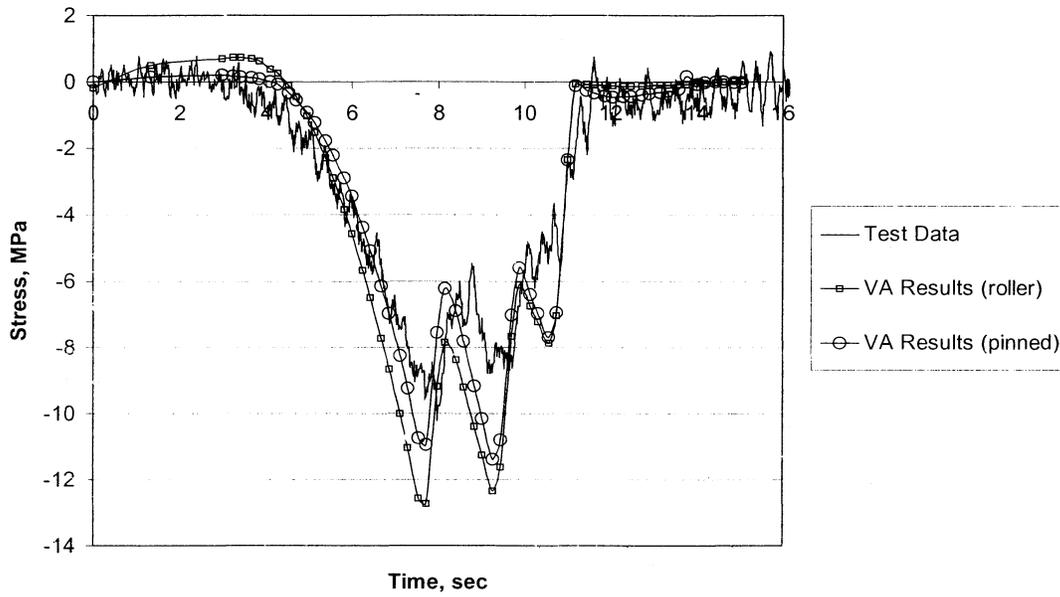
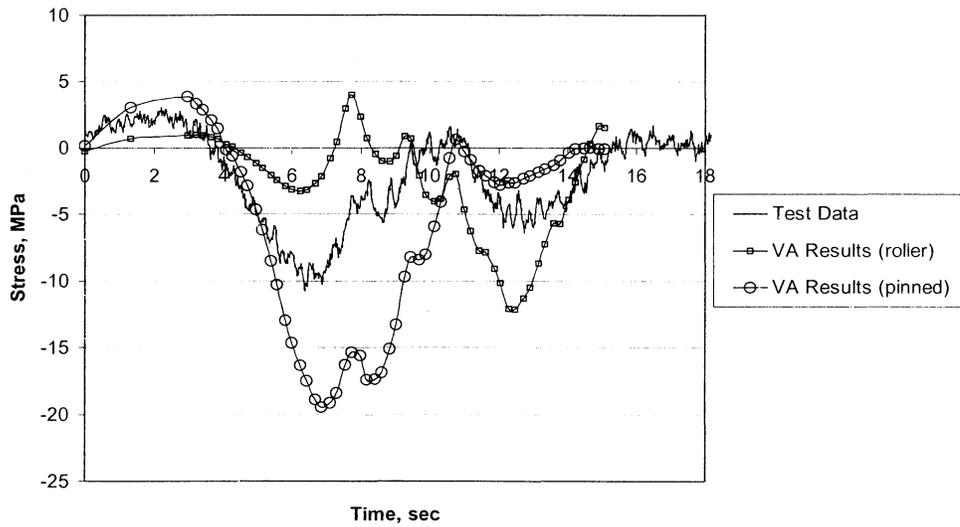
From the plots of the analytical results versus the actual time histories for Test 2 in Figure 19a-c, one can see that for the upper and lower chord, the actual stress lies somewhere in between the roller support and pinned support analyses. This is to be expected, as it is unlikely that the support neither totally restrains movement nor is completely free.

Figure 19: Comparison of 2-D Analysis and Test Data for Main Truss in Test 2

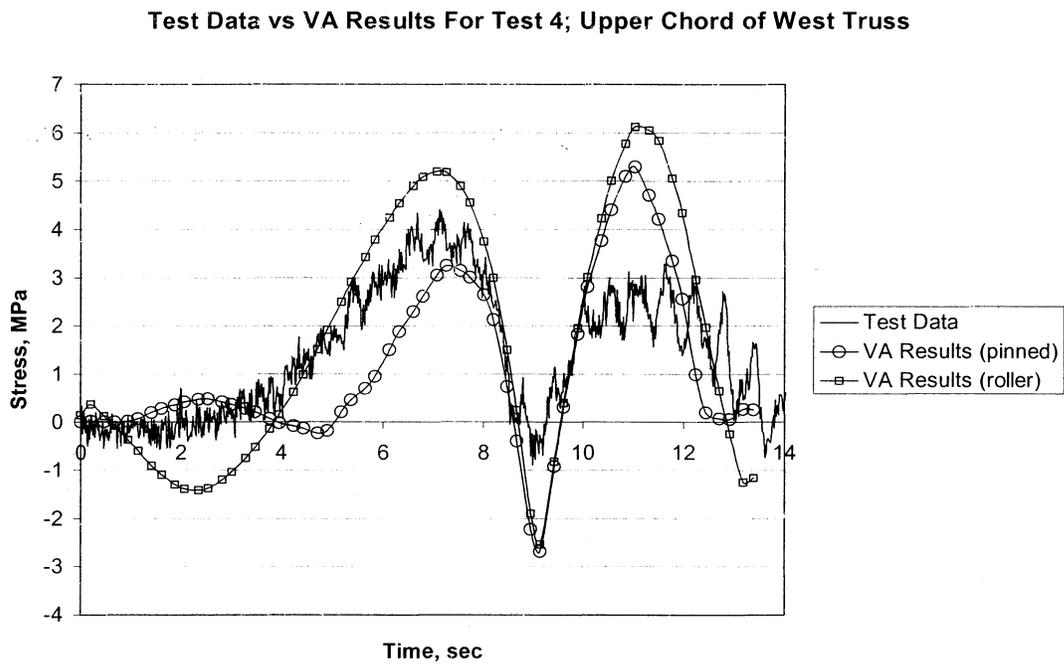
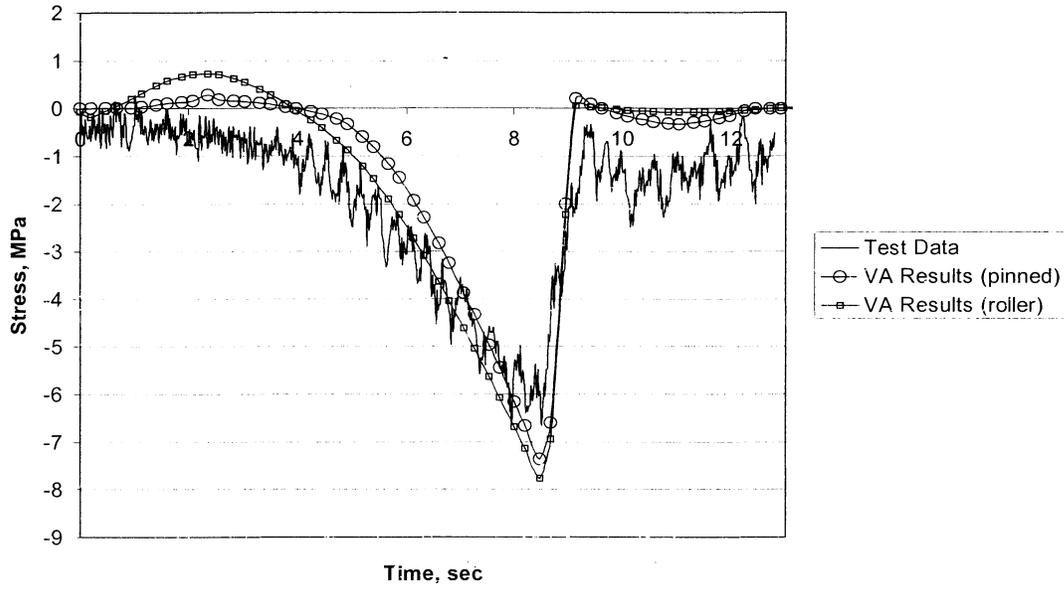
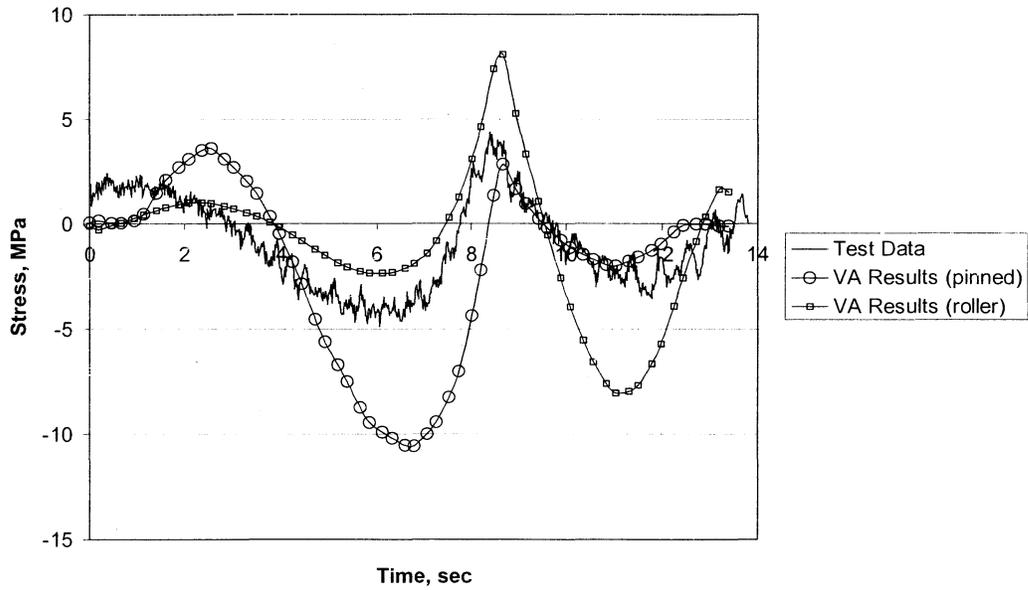
Test 4 was analyzed with the same model used to analyze Test 2. The bridge pier supports were also again modeled using roller bearings and pinned bearings. Influence lines were used to determine how loads were to be applied to the model. It was assumed that the trucks were centered in each lane and aligned as shown in Figure 11d. The results of the analyses are shown in Figures 20a-c.

Figure 20: Comparison of 2-D Analysis and Test Data for Main Truss in Test 4
