Fatigue Evaluation of the  
Deck Truss of Bridge 9340

# **FATIGUE EVALUATION OF THE DECK TRUSS OF BRIDGE 9340**

## **Final Report**

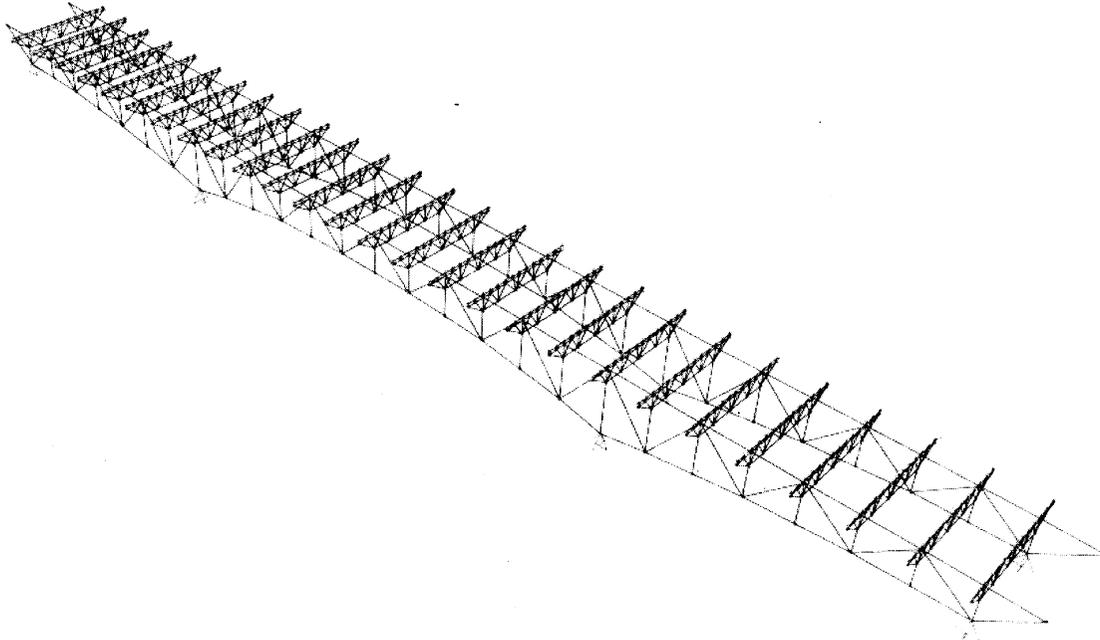
Since the 3-D analysis is meant to refine the current analyses, it was only applied to Test 4 as it was the most accurate and consistent under 2-D analysis. The bearings were again modeled as both roller and pinned supports. The results of the analyses are presented in Figure 22a-c.

Figure 21: 3-D SAP2000 Model

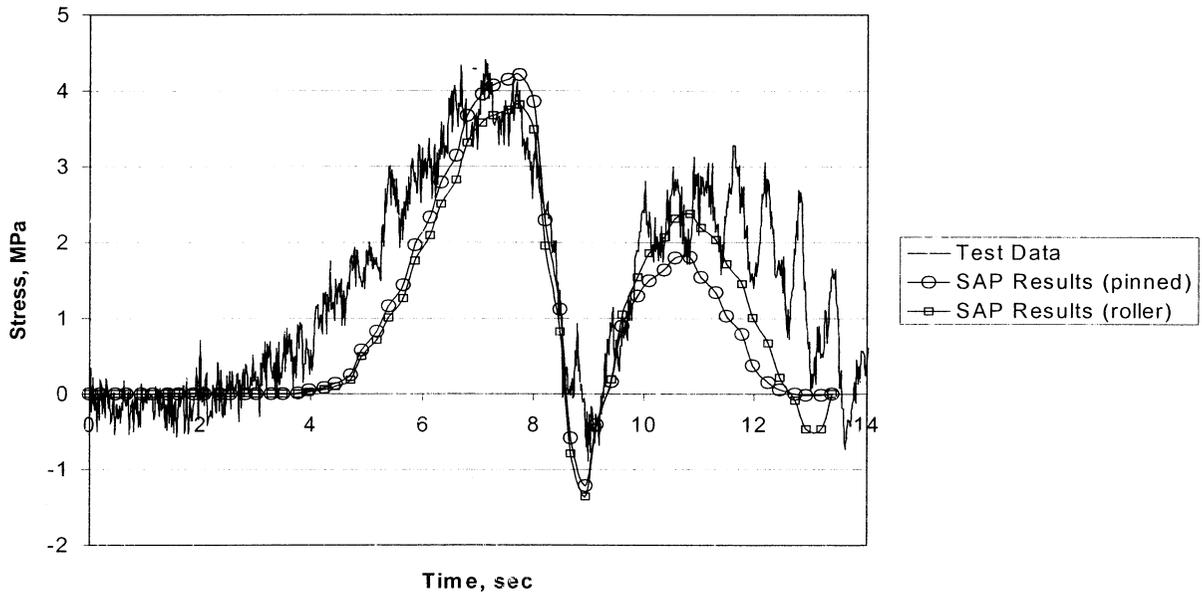
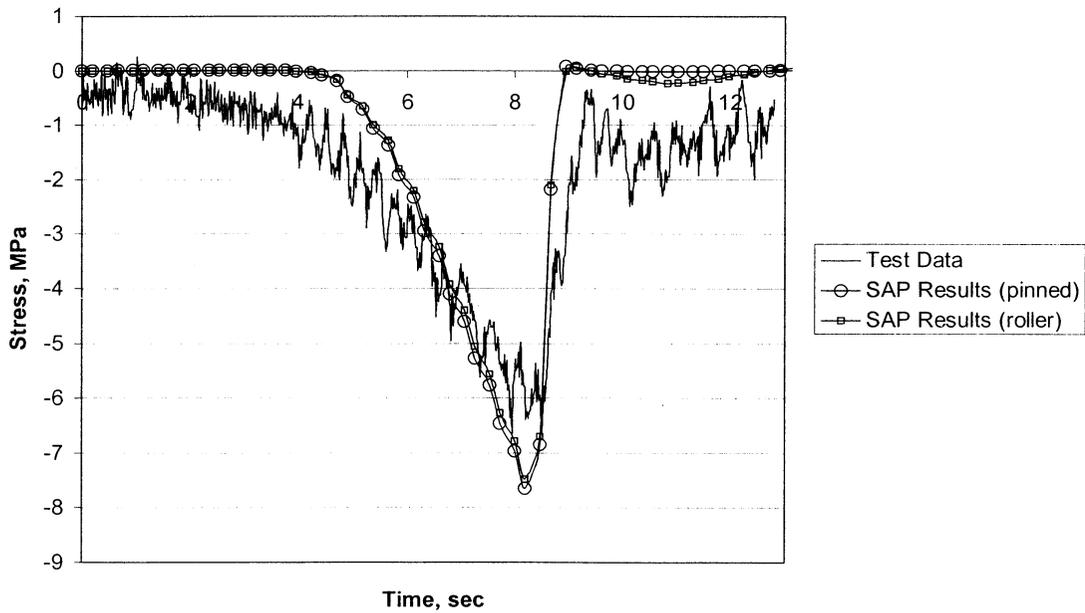
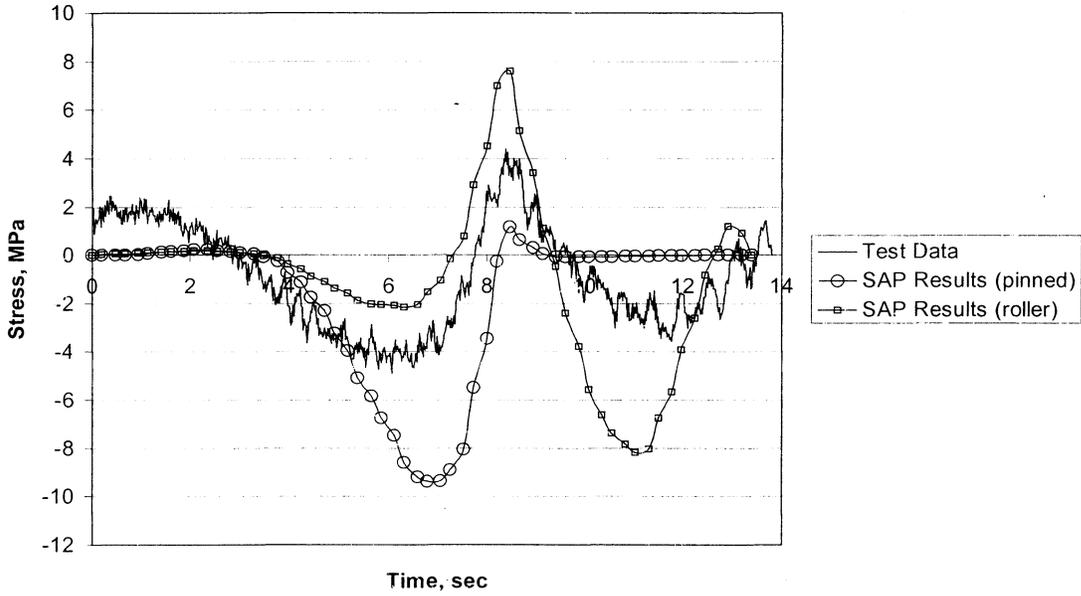
The stress ranges were more accurate for the upper chord and diagonal, but the stress ranges in the lower chord ranged from worse when the bearings were modeled as rollers to only slightly better with pinned bearings. In the upper chord, the predicted stresses for roller and pinned bearings were 5.2 and 5.4 MPa, respectively, compared to an actual stress range of 5 MPa. The diagonal recorded a stress range of 6 MPa while the analyses predicted 11.4 and 11.7 MPa for the roller and pinned bearings. Lastly, the lower chord recorded a stress range of 8 MPa and analyses predicted 16 and 11.7 MPa for the roller and pinned bearings. The ratio of actual to predicted stress ranges is presented in Table 13.

Figure 22: Comparison of 3-D Analysis and Test Data for Main Truss in Test 4

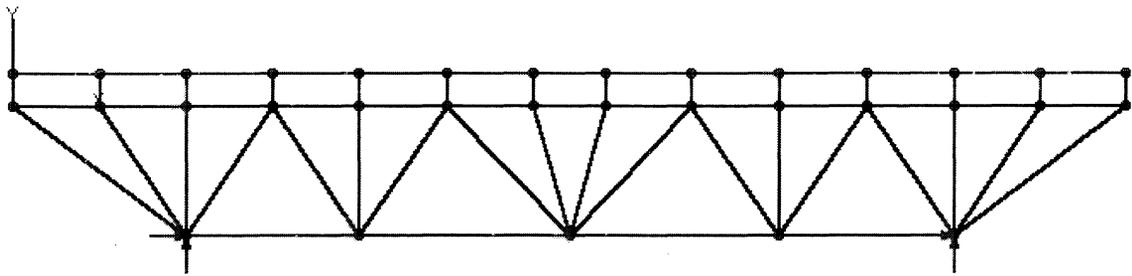
To get analytical results for the first test, the front axle of a truck was assumed to be 4.57 meters away from the rear axle of the truck directly in front of it. An influence line for the floor truss showed that the load on the truss would be largest when the rear axle of the center truck was directly on the truss. For simplicity, a single load for each axle was applied at the center of each interior lane. The maximum stress range during this test occurred in the lower chord and measured 28 MPa. The analysis yielded a maximum stress for the same member of 36.7 MPa, yielding an actual to predicted stress range ratio of 76 percent. If the distance between the front and rear axles was reduced to 3.05 meters, the analysis yielded a maximum stress in the lower chord of 42.8 MPa, a ratio of 65 percent.

Figure 23: 2-D Visual Analysis Model of Floor Truss with Concrete Deck

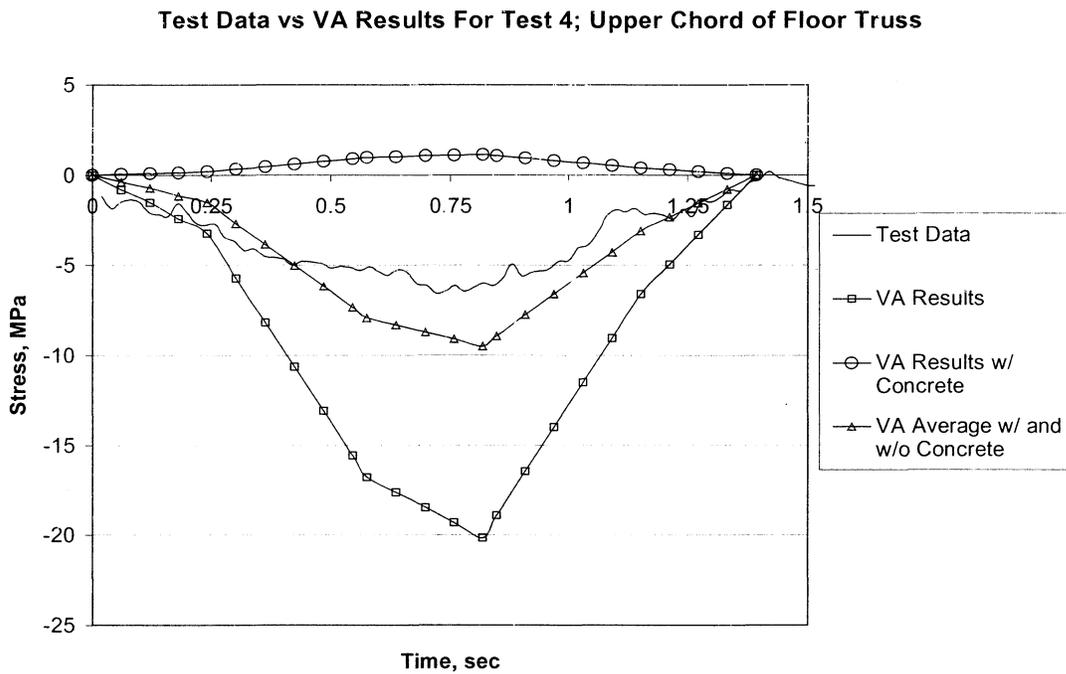
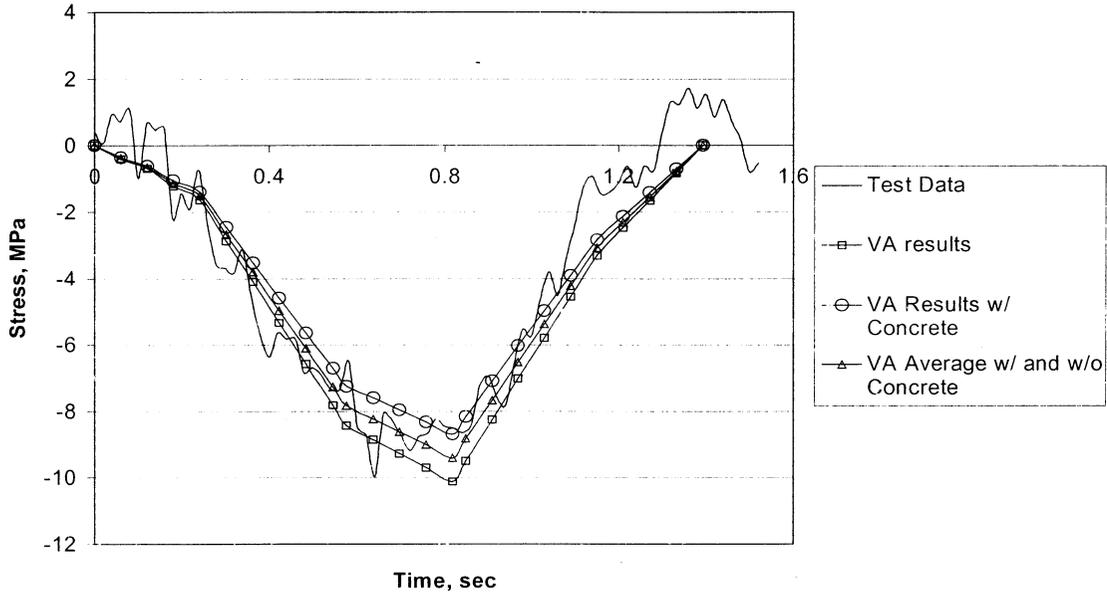
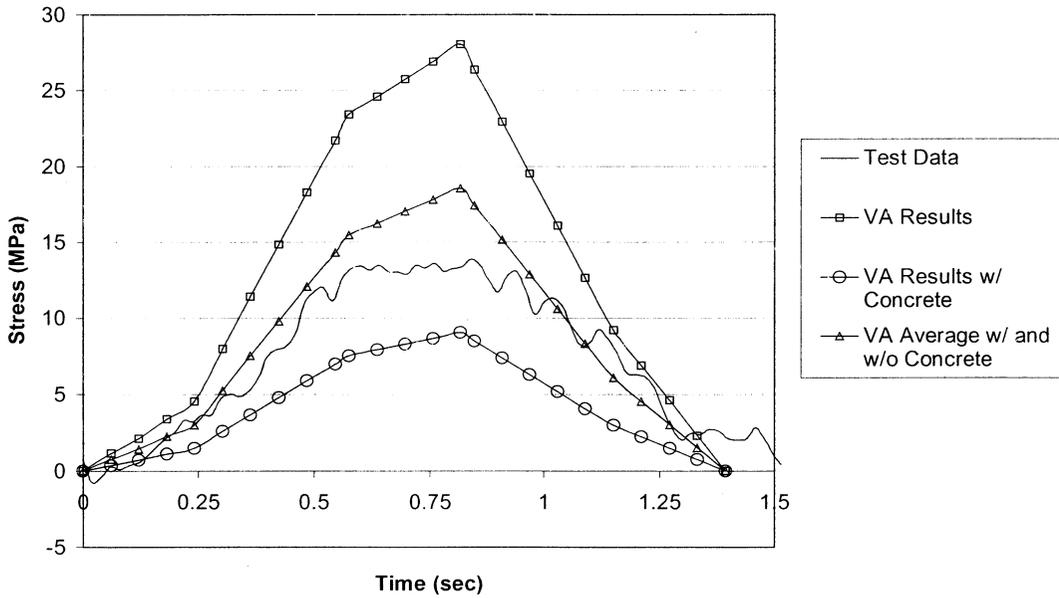
Analyses of the floor truss results for the fourth test were done in much the same way. Truck loads were applied to an influence line, which was used to determine the load distribution between neighboring floor trusses as the line of trucks moved across the bridge. Analysis was done with and without the concrete deck in place. Later, these results were averaged. The time histories for each member of the floor truss versus the analysis results are shown in Figures 24a-c.

Figure 24: Comparison of 2-D Analysis and Test Data for Floor Truss in Test 4
