# Rapidan Dam Investigations Blue Earth River Feasibility Study Ecosystem Restoration

**Rapidan Dam Investigations  
Blue Earth River Feasibility Study  
Ecosystem Restoration**

## GEOTECHNICAL INVESTIGATION OF THE RAPIDAN DAM

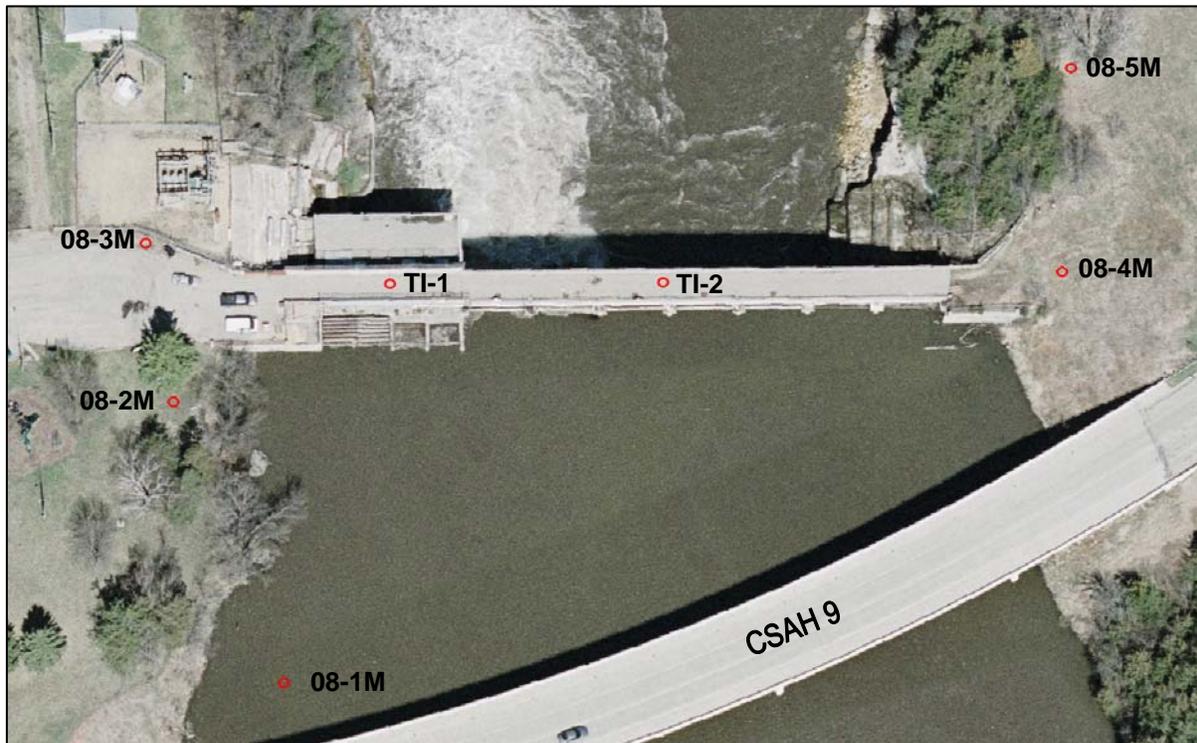
Figure 3.1 A site map showing locations of the borings in the abutments and pre-existing piezometers inside the dam (NAD – 83'/UTM).

**3.3 Instrumentation plan.** A total of six grout-in-place piezometers were installed in the abutments of Rapidan Dam. Locations of the boreholes in which the piezometers were installed are shown in Fig. 3.1. Table 3.1 lists the sensors with their corresponding installation elevation. Boreholes 08-2M and 08-4M each contain two piezometers installed at different depths in order to allow for the calculation of vertical hydraulic gradients. Holes 08-3M and 08-5M each contained a single piezometer at elevations corresponding with the “deep” sensors in the other holes.

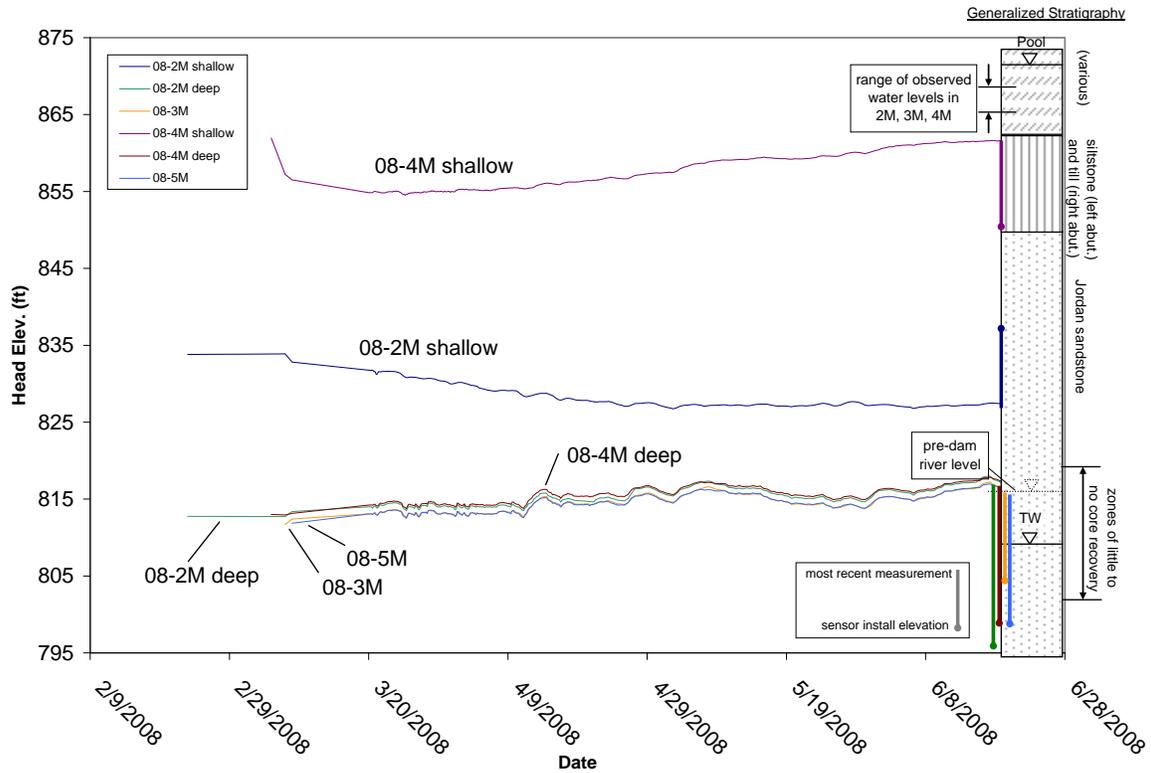
Figure 3.2 Piezometer readings at Rapidan Dam between February and June 2008.

3.6 The remaining sensors were installed at deeper locations, between El. 798 and El. 805. All show very similar readings, with head levels several feet above tailwater (approx. El. 815). Figure 3.3 shows the readings from the deep piezometers in detail.

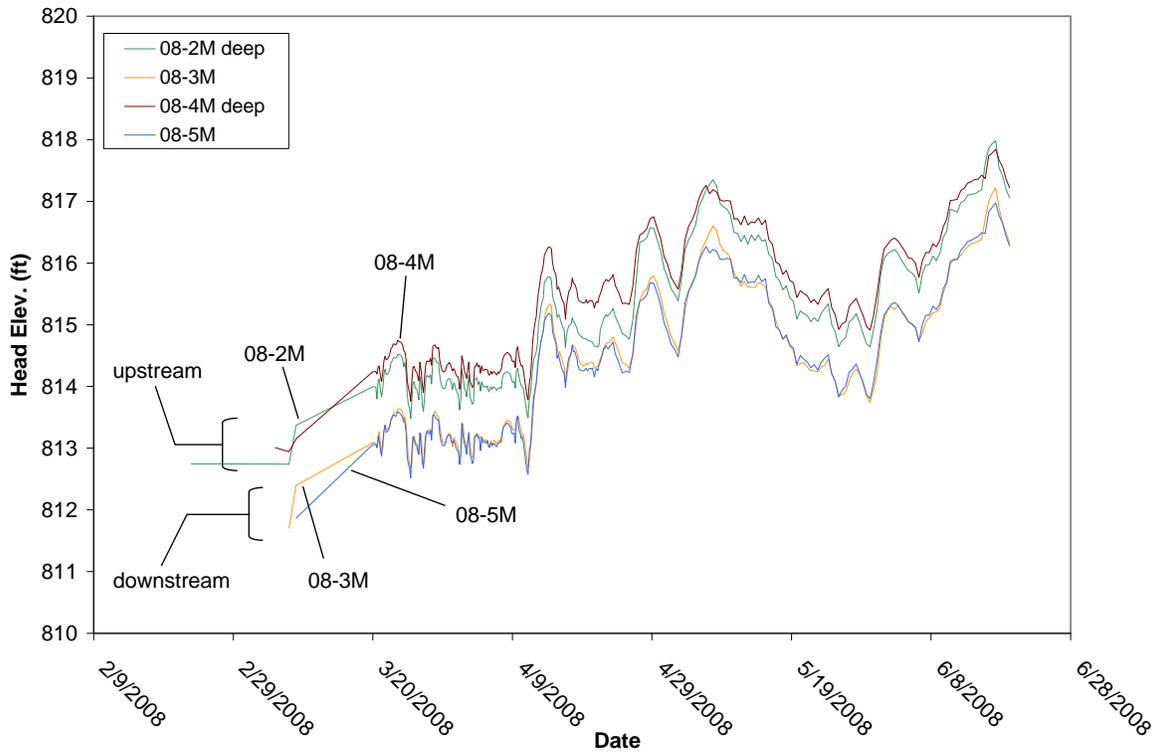
Figure 3.3 Detail of readings from piezometers installed at "deep" locations.

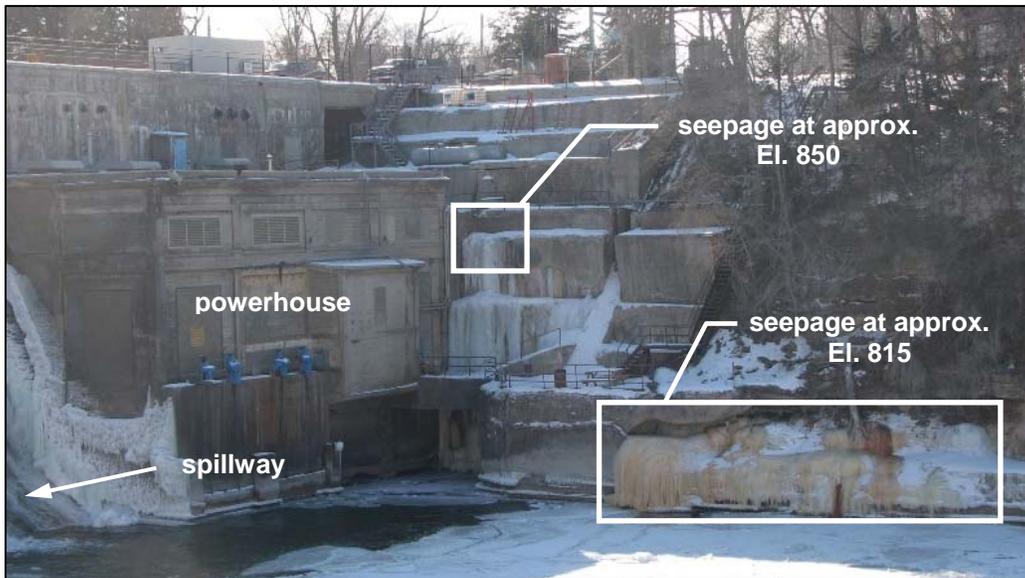
Figure 3.4 Photograph of downstream left abutment showing frozen seepage at two locations (February 2008).

3.8 First, there is an upper, perched water table slightly lower than the pool elevation. This interpretation is based on piezometer 08-4M (shallow) and water level observations made during drilling in boreholes 08-2M, 08-3M, and 08-4M. In each of these borings, water was observed several feet below the pool elevation (Table 3.3). In boring 08-5M, no water was observed in the borehole, perhaps an indication of the perched nature of the water table. Finally, seepage has been consistently observed at about El. 850 on the downstream left abutment, slightly above the first appearance of the Jordan Sandstone. (Fig. 3.4).

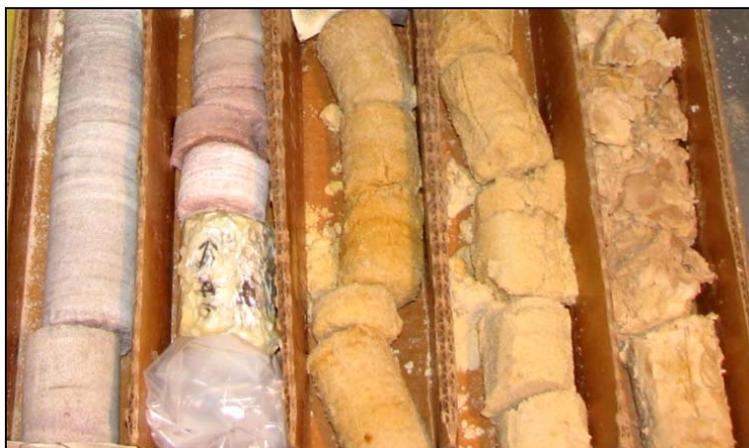
Figure 4.1 A box of rock cores from hole 08-2M showing typical variation of the Jordan Sandstone at the Rapidan Dam. Core samples ranged from hard, well-cemented, purple (left) to medium-hard with medium to poor cementation (middle) to crushed and uncemented (right).

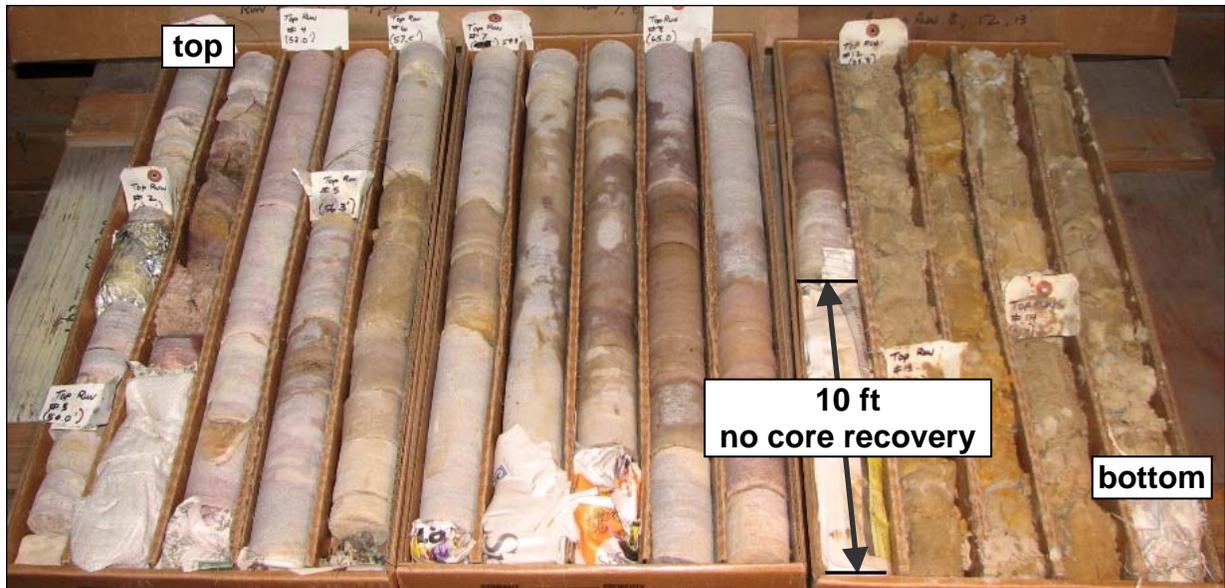
Figure 4.2 Core samples from 08-4M show a stark change in texture. Hard, well-cemented purple sandstone (left, middle) dominated at the top of the formation and transitioned to crushed, uncemented sandstone (right) below about El. 820. The transition is marked by roughly 10 ft of unrecovered core.

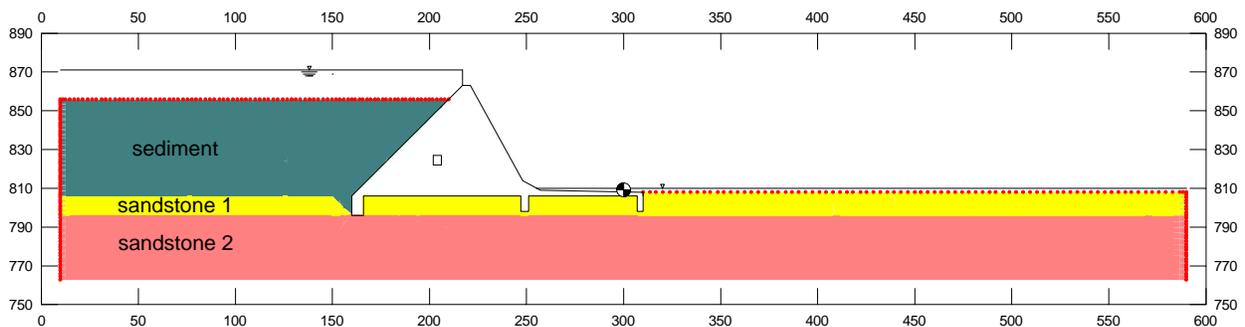
Figure 5.1 Seep/W model of the Rapidan Dam.

5.2 **Seep/W model.** A cross-section model of the dam (Fig. 5.1) was created using the geometry specified in the original plans. Important features of the dam geometry included the lengths of the base slab and the downstream apron, the keys on the upstream and downstream edges of the dam, and the end sill of the concrete apron. Although there have been extensions and modifications of the apron, they are not well documented. It was judged that modeling the original apron would yield conservative results.

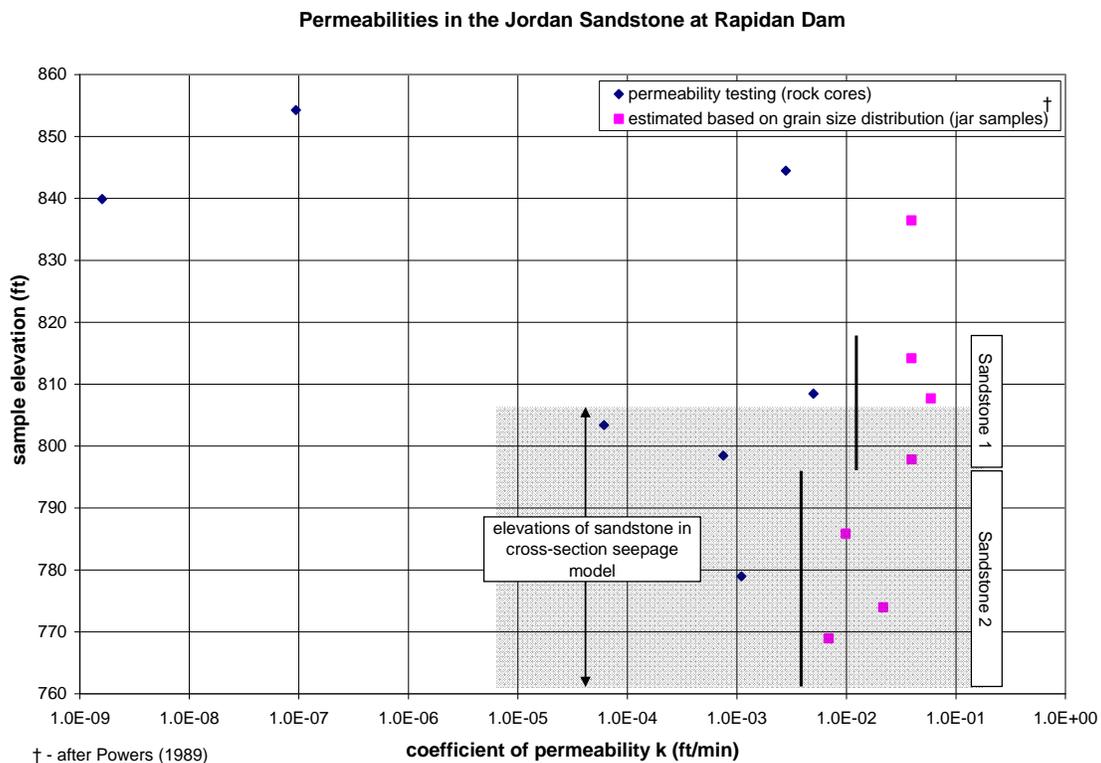
Figure 5.2 Permeability data for the Jordan Sandstone at Rapidan Dam.

5.4 Permeabilities chosen for the materials are shown in Table 5.1. The sediment was assigned a permeability based on the average of the two tests from 08-1MU described in paragraph 4.8. For the sandstone, results of permeability testing were used in conjunction with correlations based on grain size in order to estimate permeabilities (see Fig. 5.2). Values determined from direct testing of the rock cores are likely lower than average since core samples selected for testing were generally better cemented, and therefore less permeable, than the surrounding material. On the other hand, mechanical analyses of jar samples favored uncemented material, likely yielded permeability values greater than the average. Therefore, intermediate values were ultimately chosen for the model.

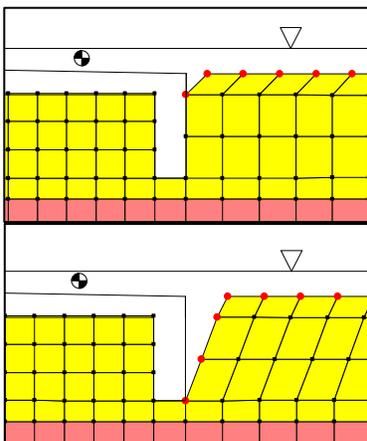
**Figure 5.2** Scenarios considering a gap due to erosion downstream of the apron sill.

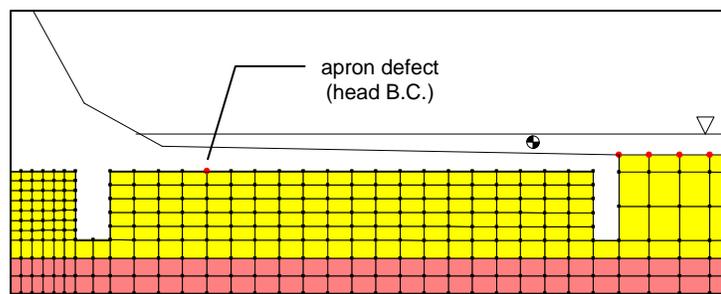
**Figure 5.3** Scenario considering a defect such as a gap in the downstream apron.

5.9 The next case considered some defect in the apron further upstream near the spillway that would expose the sandstone to the tailwater head level (Fig. 5.3). The defect could be a crack or gap in the concrete due to scour.

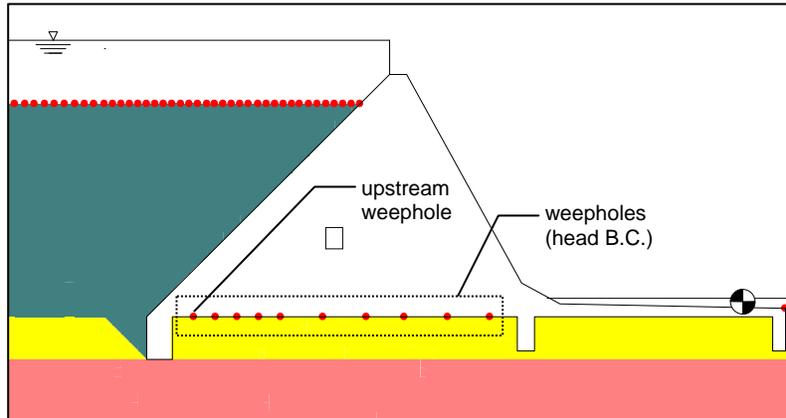
**Figure 5.4 Weepholes were modeled by applying a head boundary condition (tailwater) at the weephole location.**

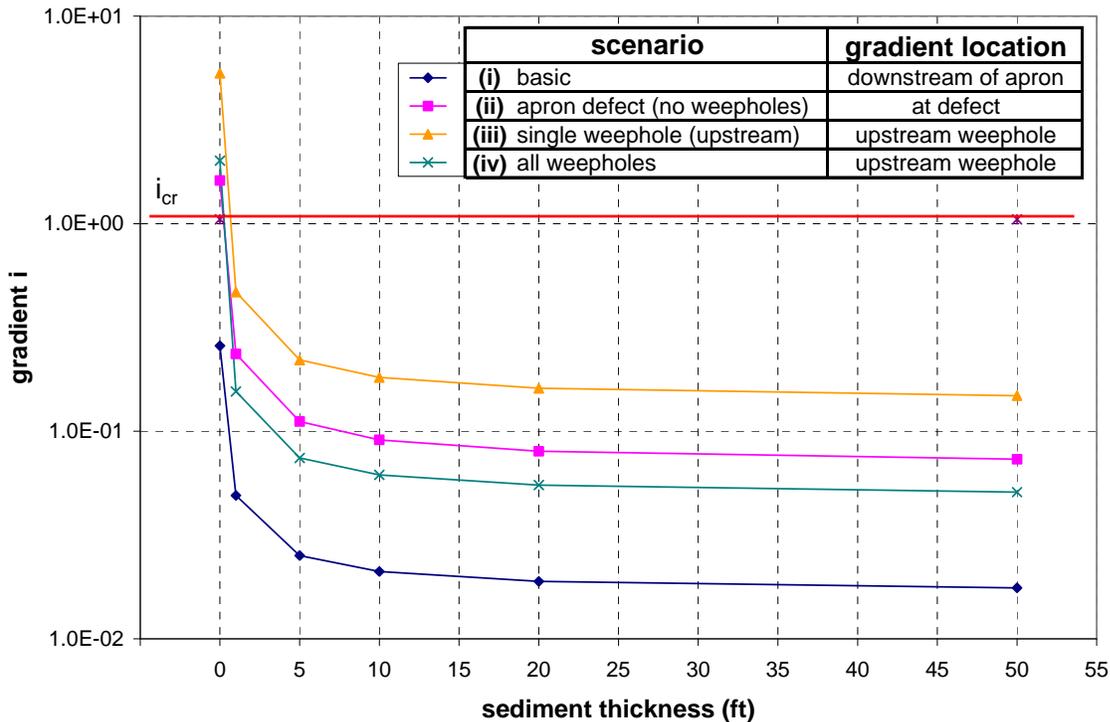
Figure 5.5 Computed vertical hydraulic gradients for several scenarios with varying sediment thickness.

sediment thickness (ft)	scenario			
	(i)	(ii)	(iii)	(iv)
0	0.258	1.61	5.30	2.01
1	0.0491	0.236	0.468	0.155
5	0.0252	0.112	0.221	0.07438
10	0.0211	0.0909	0.182	0.06167
20	0.0189	0.0801	0.161	0.05501
50	0.0176	0.0733	0.148	0.05091
scenario		gradient location		
(i) basic		downstream of apron		
(ii) apron defect (no weepholes)		at defect		
(iii) single weephole (upstream)		upstream weephole		
(iv) all weepholes		upstream weephole

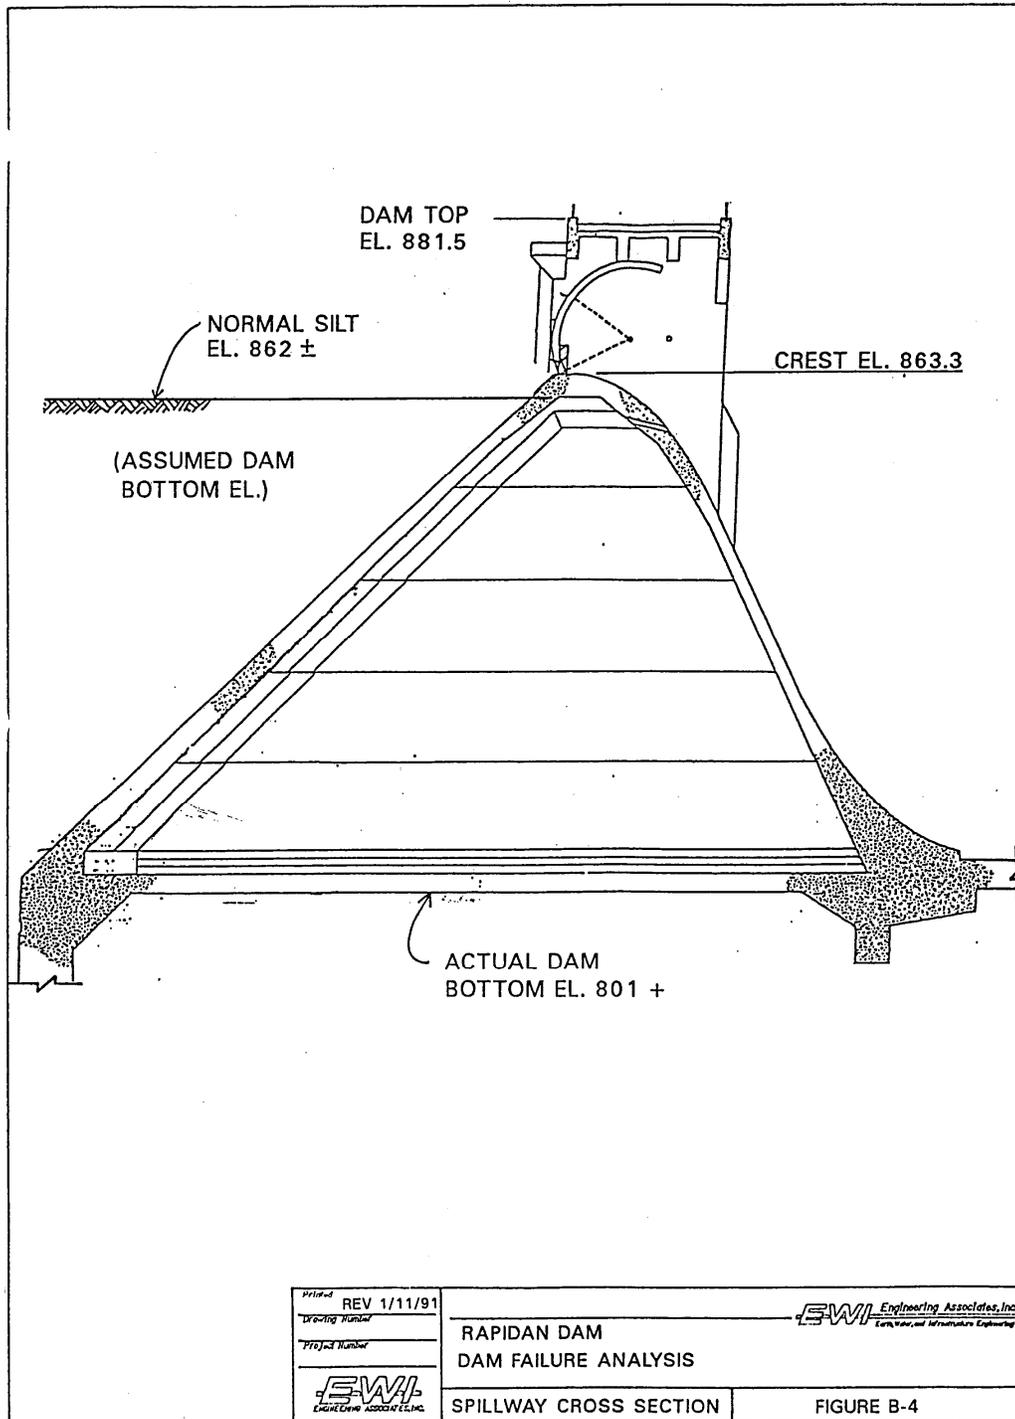
**Figure 1 Dam Cross Section**

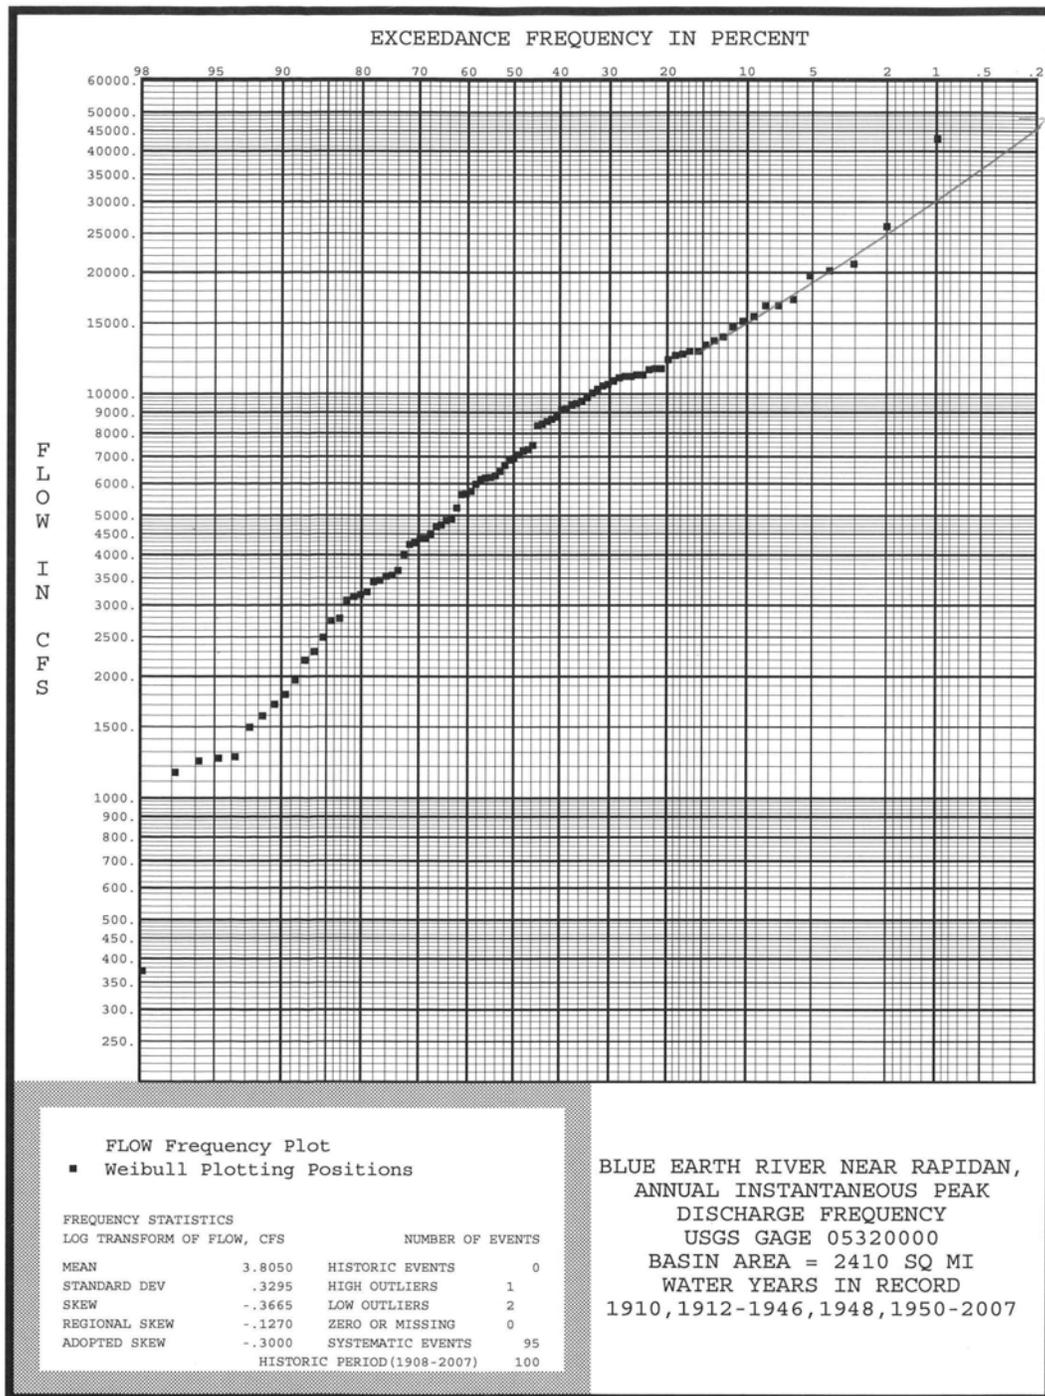
**Figure 4 Discharge-Frequency Curve, Blue Earth River near Rapidan, MN**

<i>Recurrence Interval</i>	<i>Discharge, cfs</i>
10-yr	15,000
50-yr	25,000
100-yr	30,000
500-yr	45,000

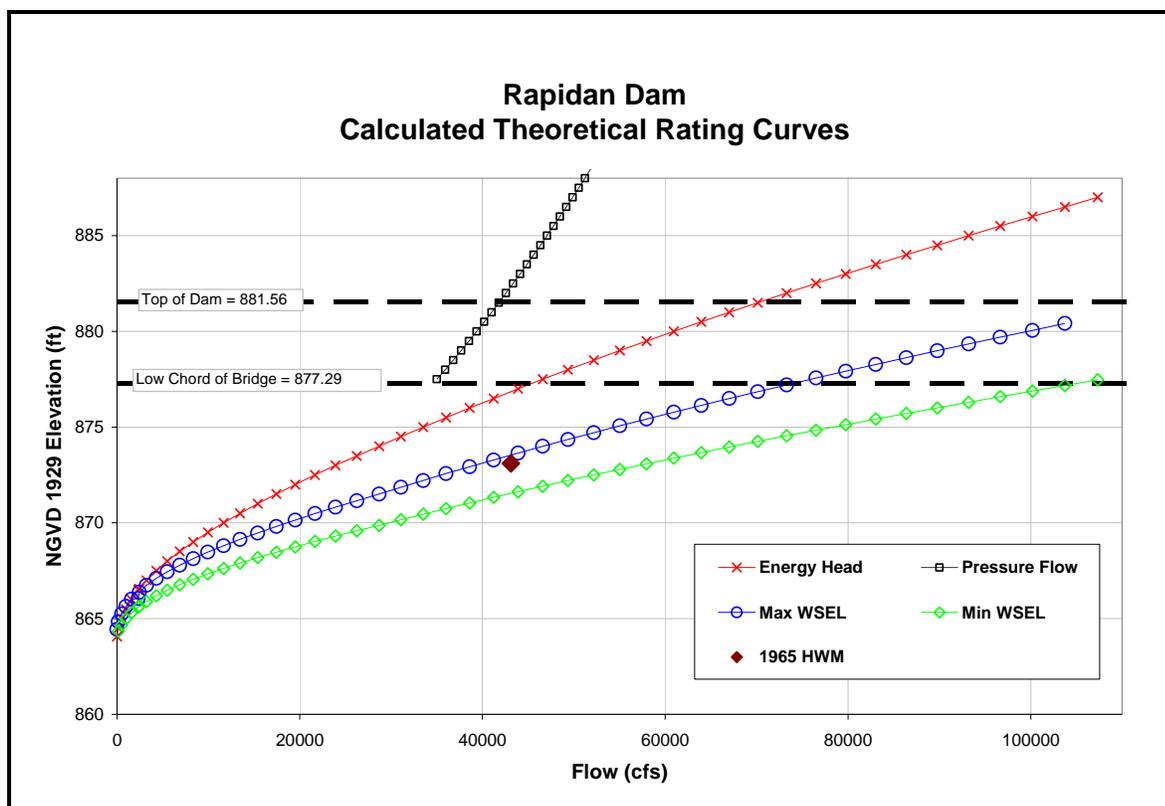
Figure 4: Theoretical rating curves for Rapidan Dam spillway.

The headwater rating curve was calculated for the Rapidan Dam by first estimating the design head based on the elliptical shape of the spillway crest. The design head was found to be approximately 5', which results in a downstream elliptical shape very close to the actual shape shown in the as-built drawings<sup>1</sup>. The approach height was estimated as 10', which is much smaller than the original design, to account for siltation that has taken place in the reservoir

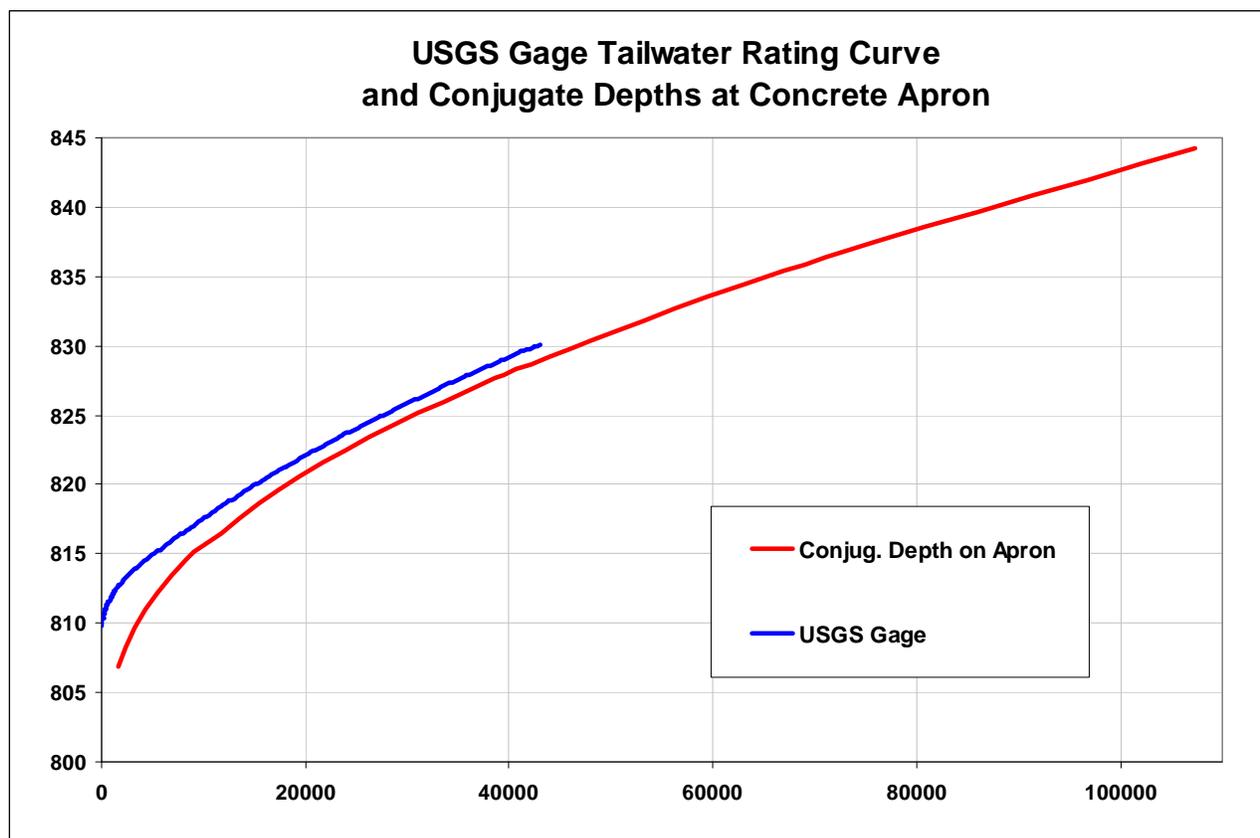
Figure 6. Conjugate depths for hydraulic jump and tailwater rating curve.

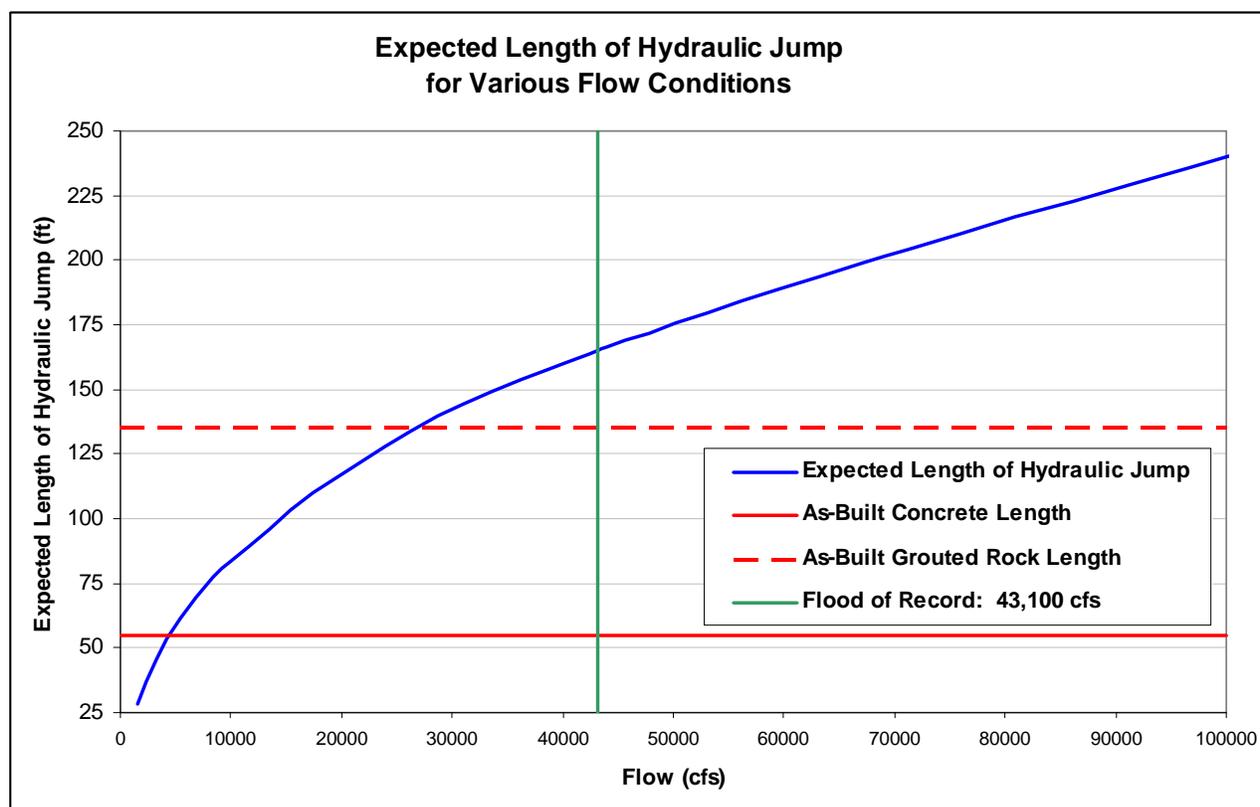
Figure 7. Expected length of hydraulic jump for a range of flows

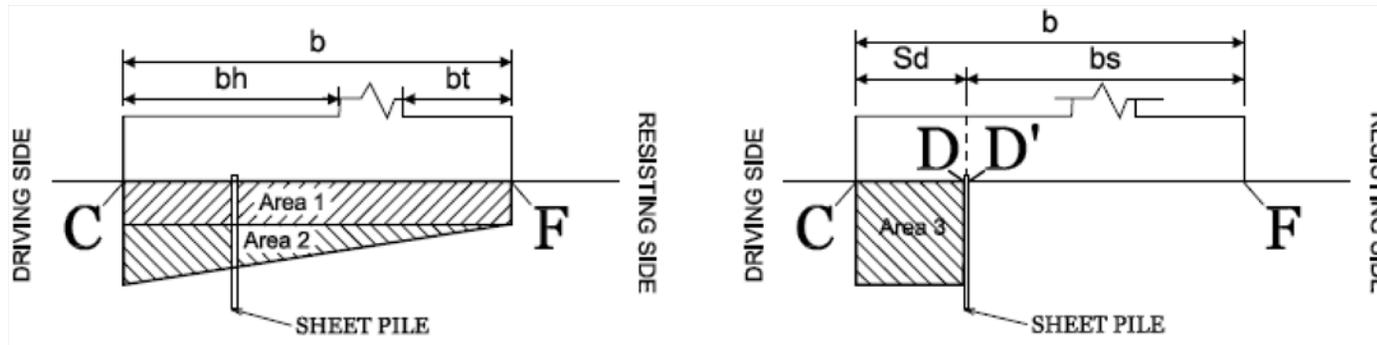
Assume axes runs along the heel at point c "into the board". The moment at the heel is positive using the right hand rule, therefore, how the picture is drawn, the moment is positive clockwise.
