Partridge River Watershed

Winter 2010-2011

Base Flow Analysis

Minnesota Department of Natural Resources

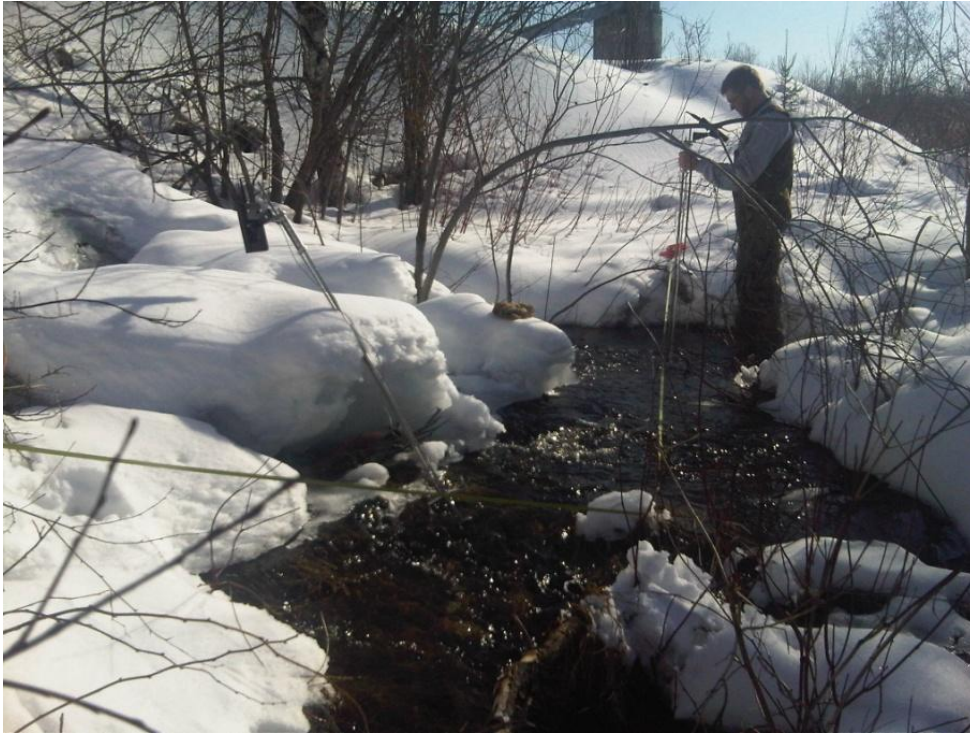
Cliffs Erie discharge point to the upper Partridge River, February 15, 2011 (MDNR gage # H03155004)

- Cliffs Erie pumping throughout the winter was inconsistent making it difficult to establish steady state conditions for the contributing watershed in the upstream section.

- Wetlands at the upstream end likely slowed and stored large proportions the mine discharged waters (*gage #H03155004*) when compared to the measured flows at the 0.9 mile location (*gage #H03155003*).

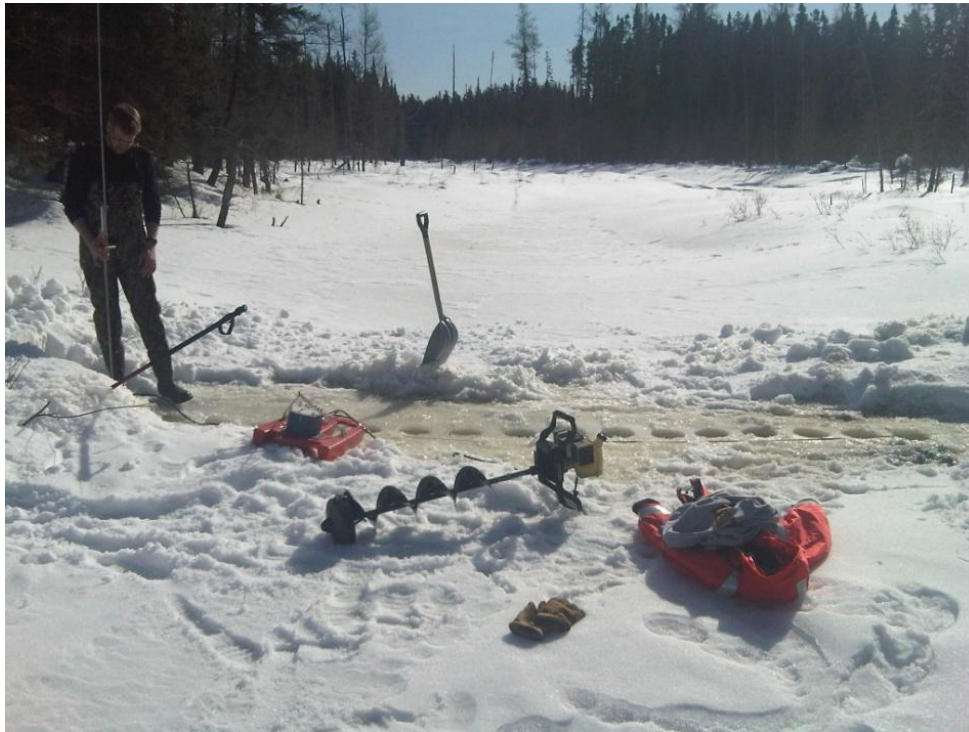
Partridge River nr Babbitt, 0.9mi upstream of Dunka Rd., looking downstream. February 15, 2011 (MDNR gage # H03155003)

For example, the flow measurements for January and February showed a decline along the Partridge River between the 0.9 mile road crossing (*H03155003*) and the Dunka Road 4 mi (*H03155001*) crossing

downstream. Typically flow increases as the drainage increases. The decline in flows in this segment is likely due ice and wetland storage within the reach at the time of measurement. Later in March, the flow measurements indicated an increase in discharge in a downstream fashion between these two locations.

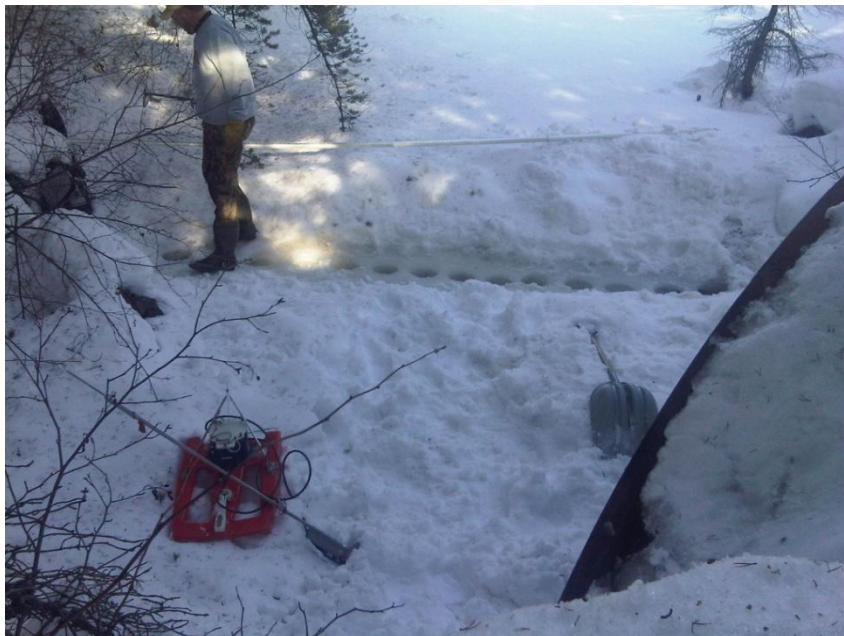
Partridge River nr Babbitt, Dunka Rd, looking upstream, February 15, 2011 (MDNR gage #H03155002)

A gradual decrease in discharge through time is shown in the flow measurements from January to March at the 0.9 road (H03155003) and CR666 (H03147001) locations. This is typical for winter base flow conditions. The Dunka Road gage site (H03155002) had an increase in flows from the February to the March discharge measurements. The increase in discharge between the two measurements at the Dunka Road site may be due to the brief melt that occurred in February or ice storage release between the measurement time periods.

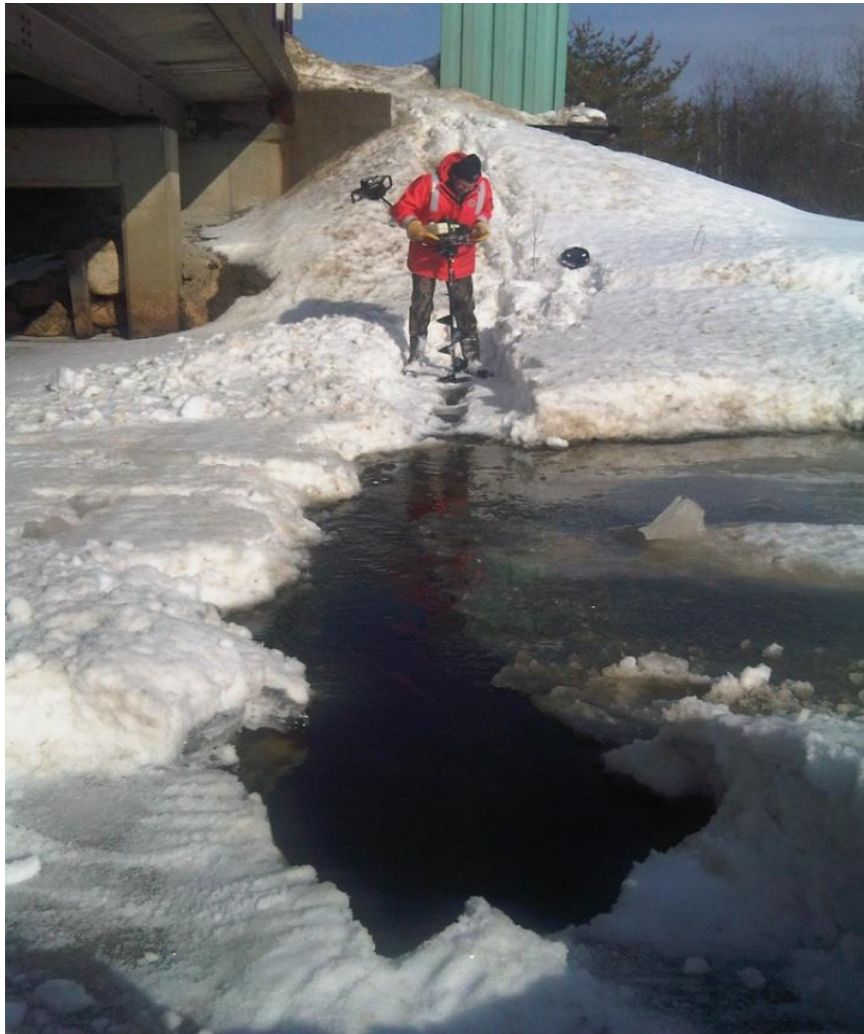
Partridge River at Hoyt Lakes, CR666, February 16, 2011 MDNR (gage # H03147001)

The Partridge River was completely ice covered throughout the observable reaches and measurement locations below the Cliffs Erie discharge point down to the C.R. 666 location. Ice depths at the measurement sites ranged from 0.5 ft. to 1.5 ft. throughout the study period. Open water on the Partridge River was only found at the C. R. 666 location directly under the bridge where a rock riffle caused sufficient turbulence. Thin ice 0.2 to 0.5ft was also observed at the measurement sites on the Longnose and Wyman Creek sites due to turbulence at riffle areas.

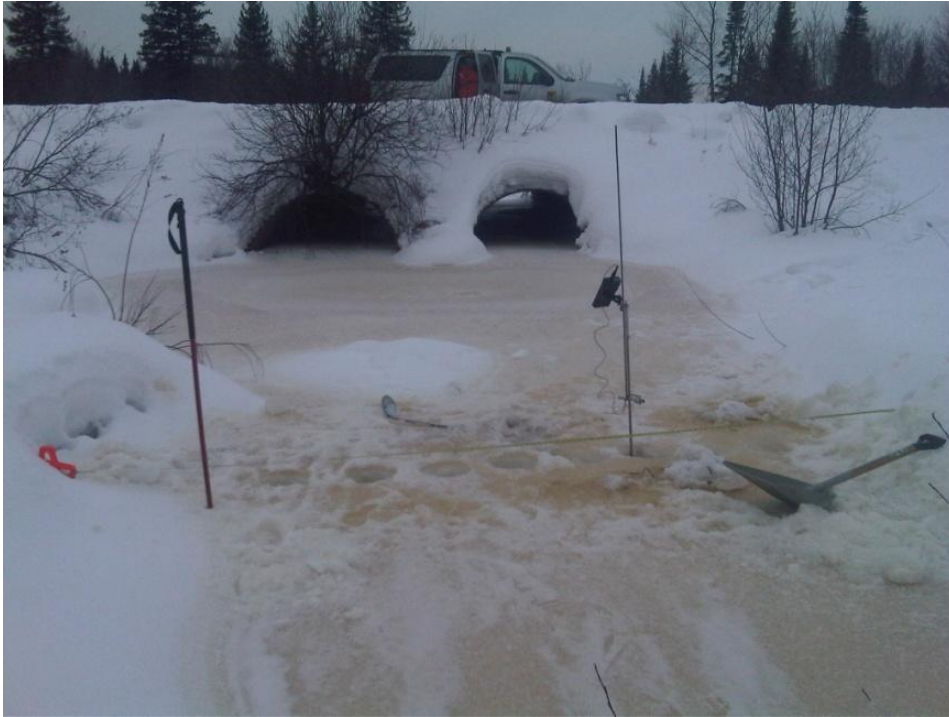
South Branch Partridge River nr Babbitt, CR680, looking downstream, February 16, 2011 (MDNR gage # H03145002)

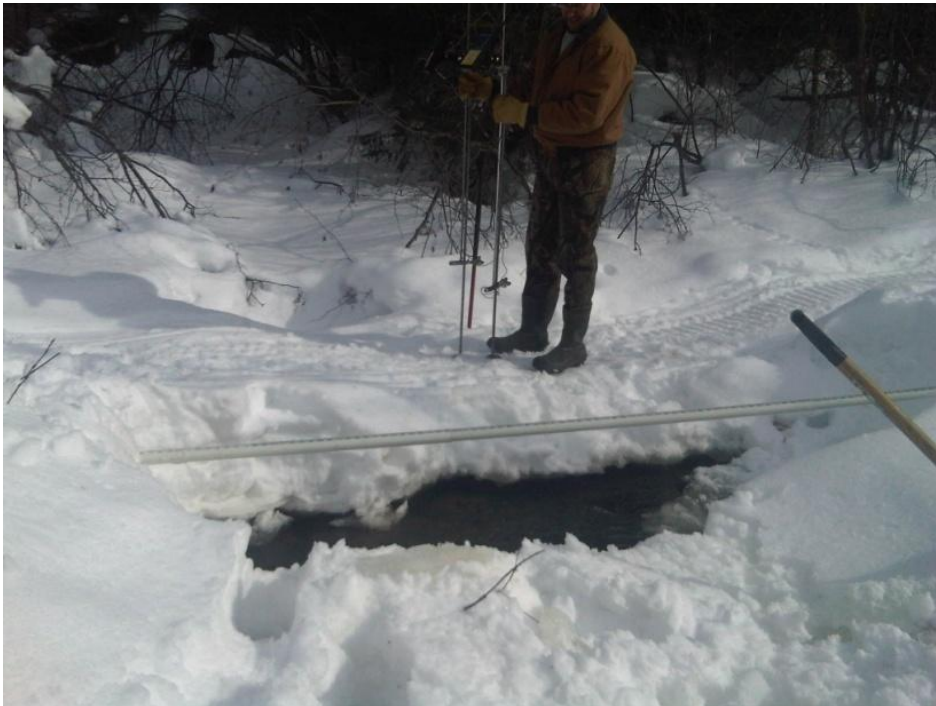
Wyman Creek at Hoyt Lakes, CR666, looking upstream, February 16, 2011 (MDNR gage# H03145002)

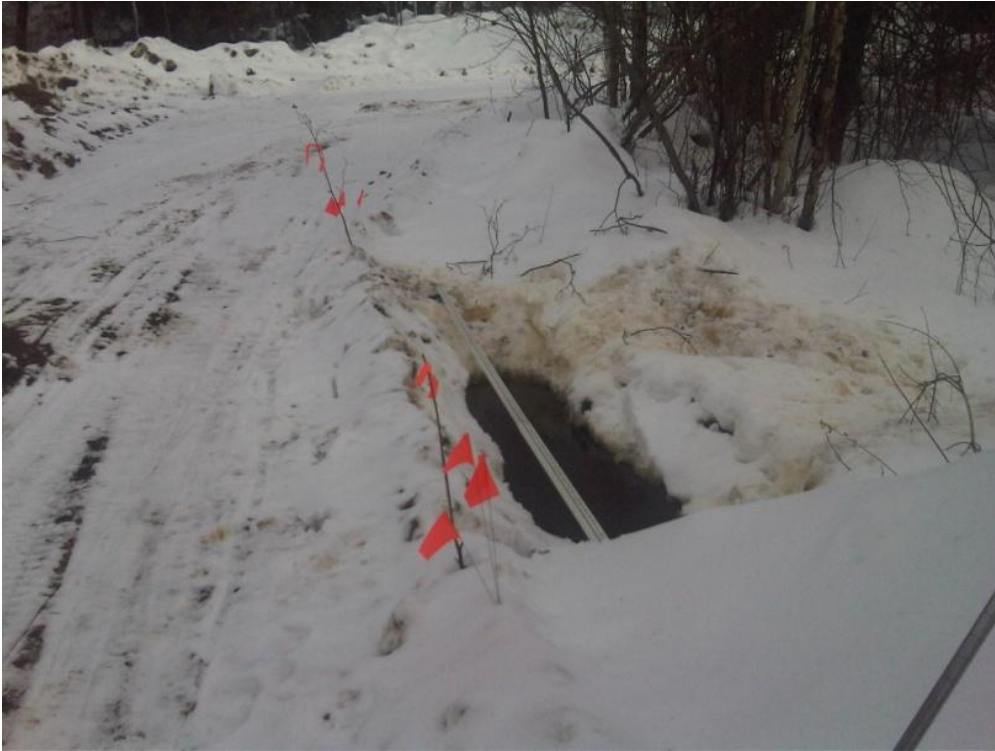
Longnose Creek nr Hoyt Lakes, FR117, February 16, 2011 (MDNR gage #H03146001)
