Field Assessment Manual

Zumbro River Watershed
Restoration Prioritization

Zumbro River Watershed Restoration Prioritization Project

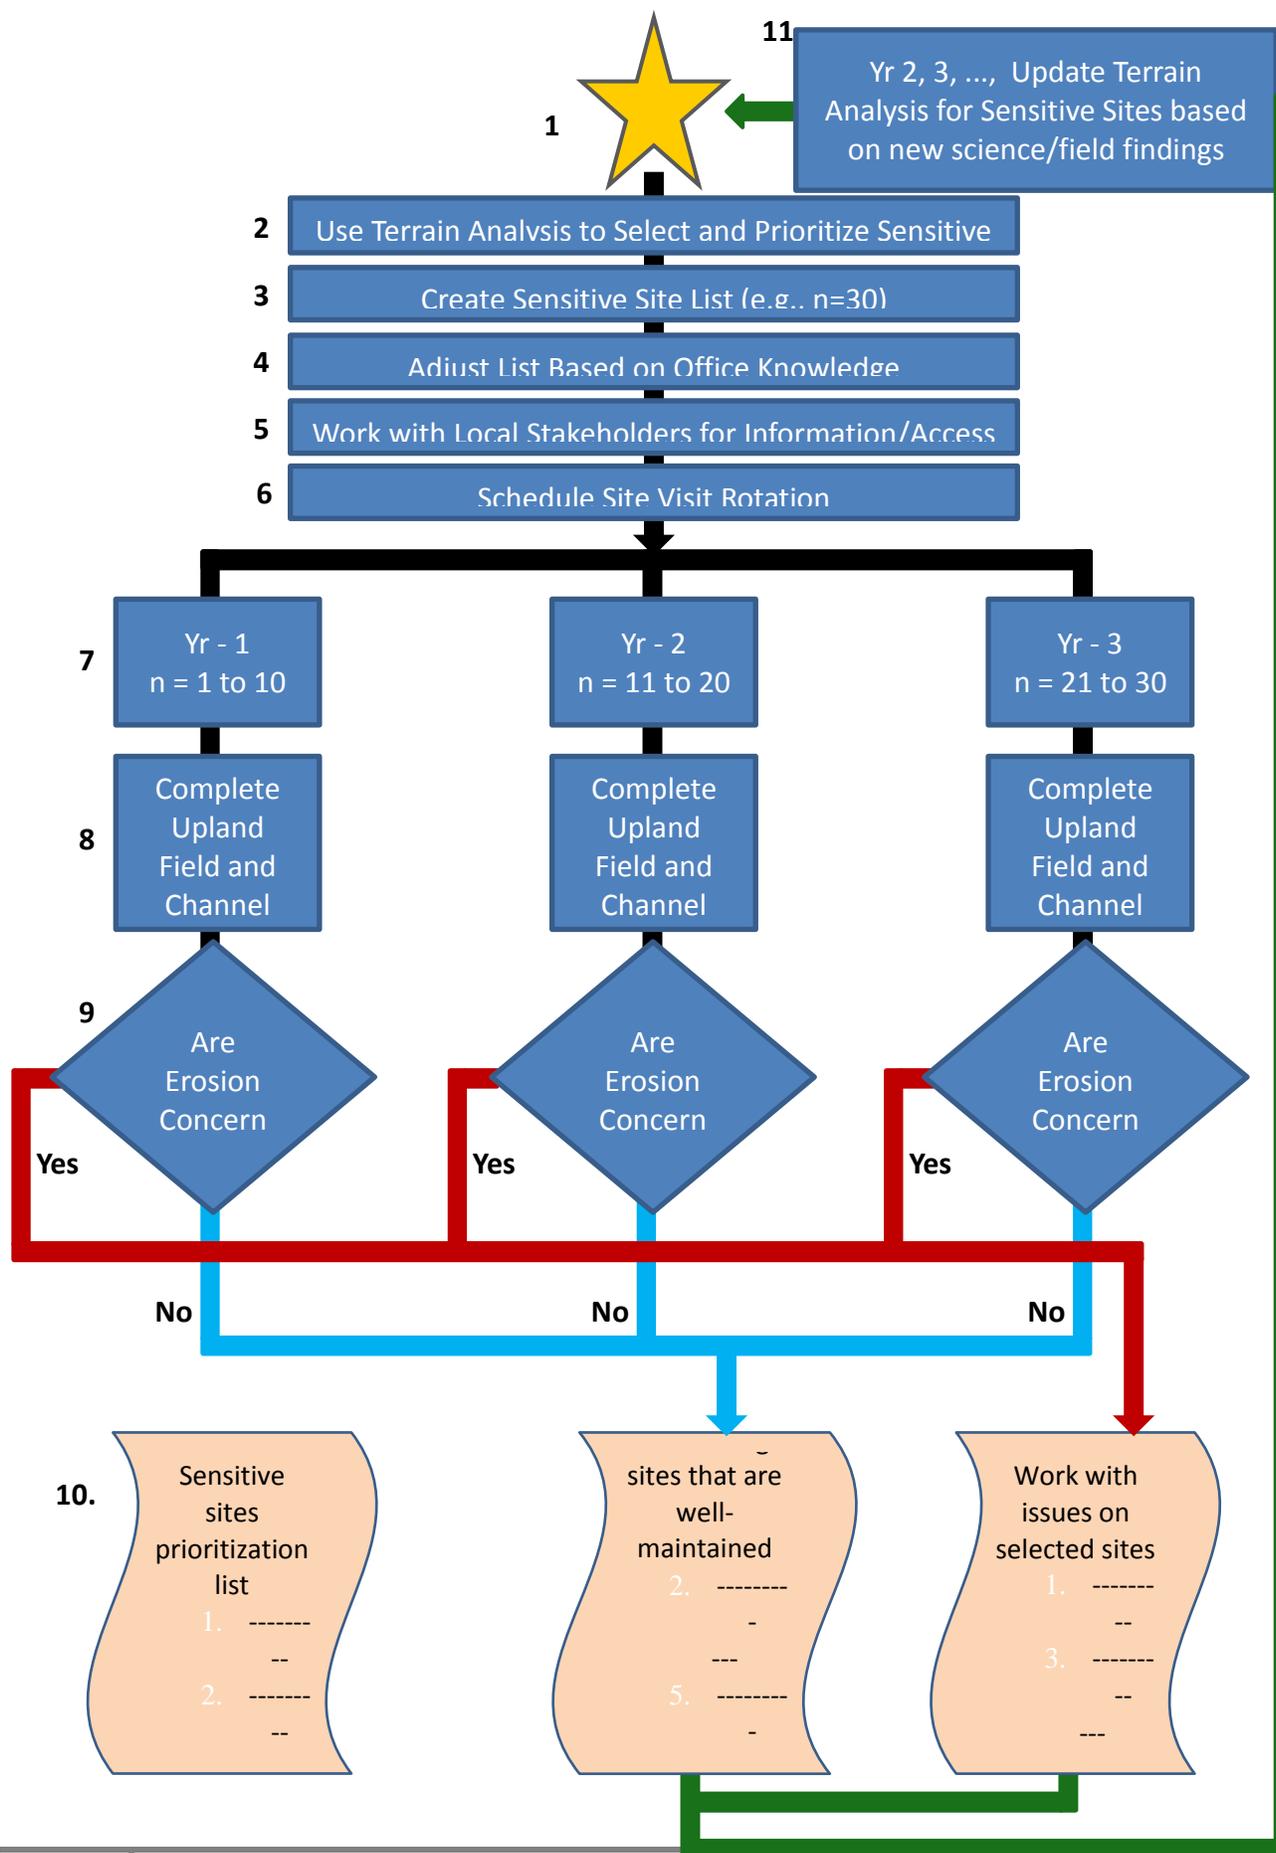
- 1) Section one provides a decision flow chart that provides guidance for selecting sites and tools, as well as conducting field assessments.

1 Start

2 Use Terrain Analysis to Select and Prioritize Sensitive Sites

3 Create Sensitive Site List

4 Adjust List Based on Office Knowledge

5 Work with Local Stakeholders for Information and Access

6 Schedule Site Visit Rotation

7 Visit Sites Selected for Given Year

8 Complete Upland Field and Channel Forms

9 Are Erosion Concerns Present?

10 Generate Acknowledgement and Issue Lists

11 Update Terrain Analysis for Sensitive Sites

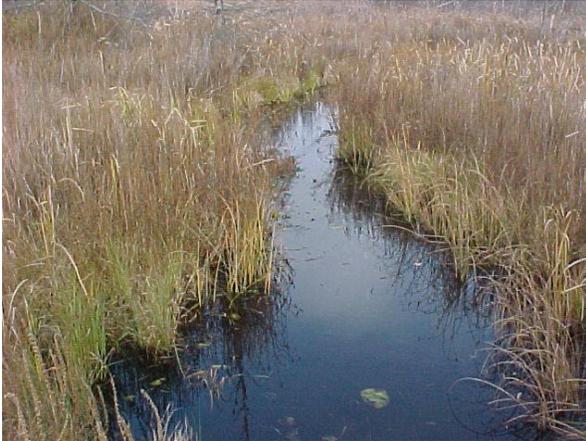
Figure A. Tributary, Kalamazoo River watershed

Figure A depicts a small stable stream setting.

Completing a streambank erosion inventory form at this site would not be necessary. This stream illustrates well-established perennial vegetative cover. The buffer width is > 30 feet.

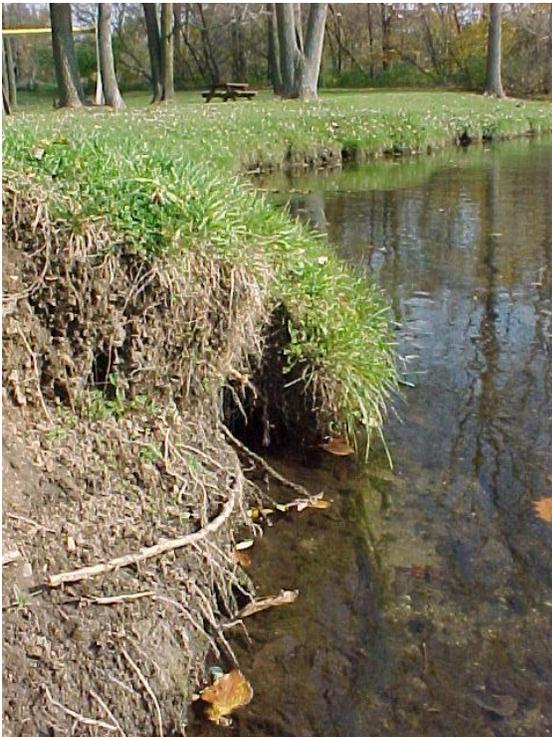
Figure B. Kalamazoo River

Figure B depicts a site with noticeable bank erosion.

Exposed roots indicate active erosion. Slumped soils indicate undercutting typical for erosion induced by channel hydrology. This stream has poor perennial vegetative cover (shallow grass roots and sparse woody vegetation density). The buffer width is < 10 feet.

For this site, the evaluation would measure the bank height using the average dimension along the bank that stretches from submerged toe of the slope to grassed soil horizon.

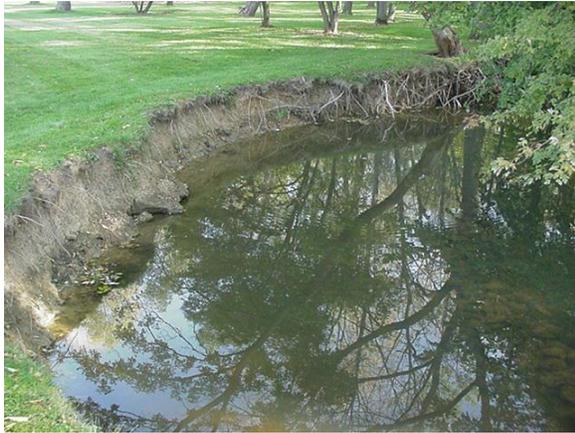
Figure C. Rouge River

Figure C depicts a site with outside bend bank erosion.

For this site, a streambank erosion assessment would be conducted. The erosion illustrated here is typical of erosion induced by channel hydrology. Perennial vegetative cover is poor. The buffer width is < 10 feet.

This site is an interesting example of bank erosion. Grass/woody roots extend to the waterline, but are so few and shallow that they provide minimal bank protection. Also, this site is downstream from a dam (not pictured). Impoundments usually are associated with atypically high erosion due to increased sediment transport capacity as a result of the low sediment concentrations in the water released from the impoundment.

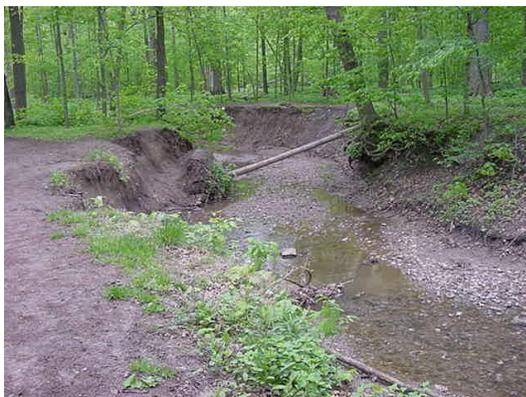
Figure D. Hagar Creek, Ottawa County, MI

Figure D depicts a site with active erosion on at least three bank locations.

The tree root balls shown slumping into the stream (middle of the photo) is typical of erosion induced by channel hydrology. The near bank to the left has poor woody vegetative cover and poor grass understory cover. Buffer width is < 10 feet.

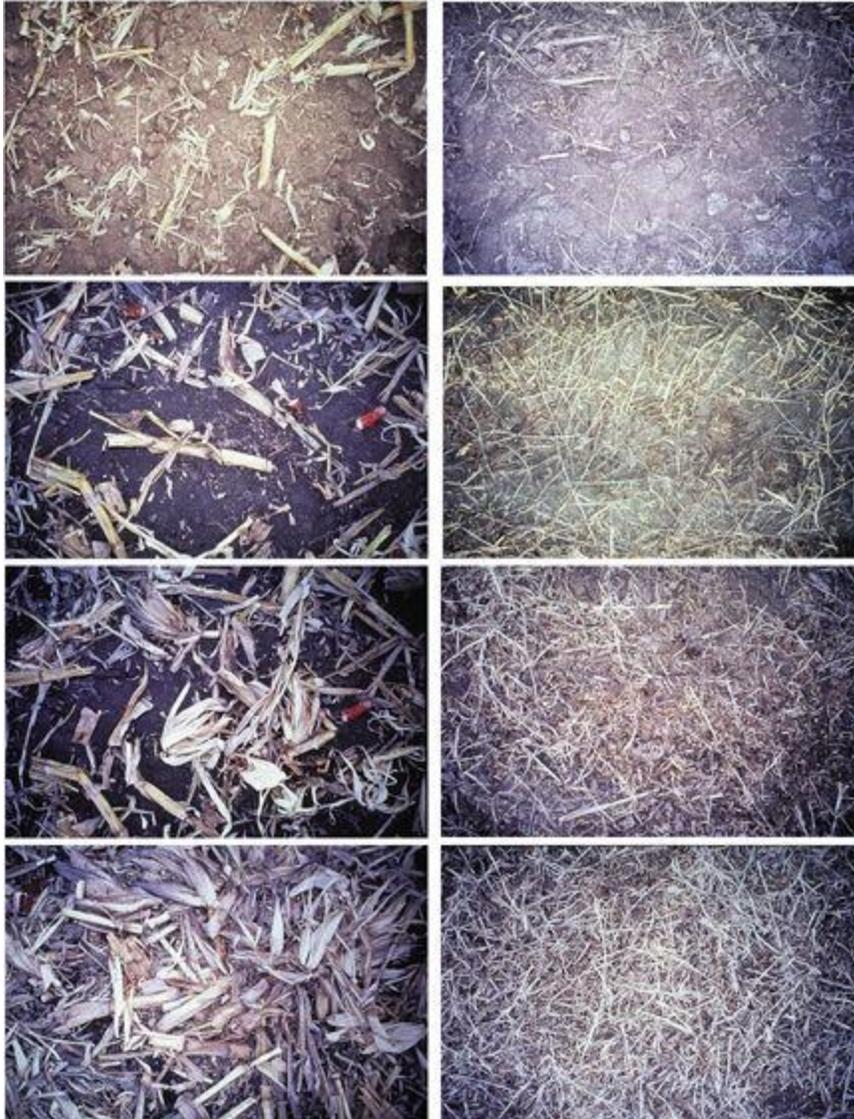
Figure G. Visual crop residue examples

The images in the vertical columns show crop residues for corn (left) and soybean (right) – From top to bottom: 25%, 50%, 75%, 90%

- Determine buffer information. If the feature is located in forested land, these can be ignored unless other buffer concerns exist.
2. **Determine upland field characteristics** – These include land use, tillage, and tile information. Also note any evidence or knowledge of recent or current manure application. For % crop residue, see appendix 2 for a visual example of various percentages.
