2017 LEGACY FUND RESTORATION EVALUATION REPORT

Technical Panel Findings and Recommendations

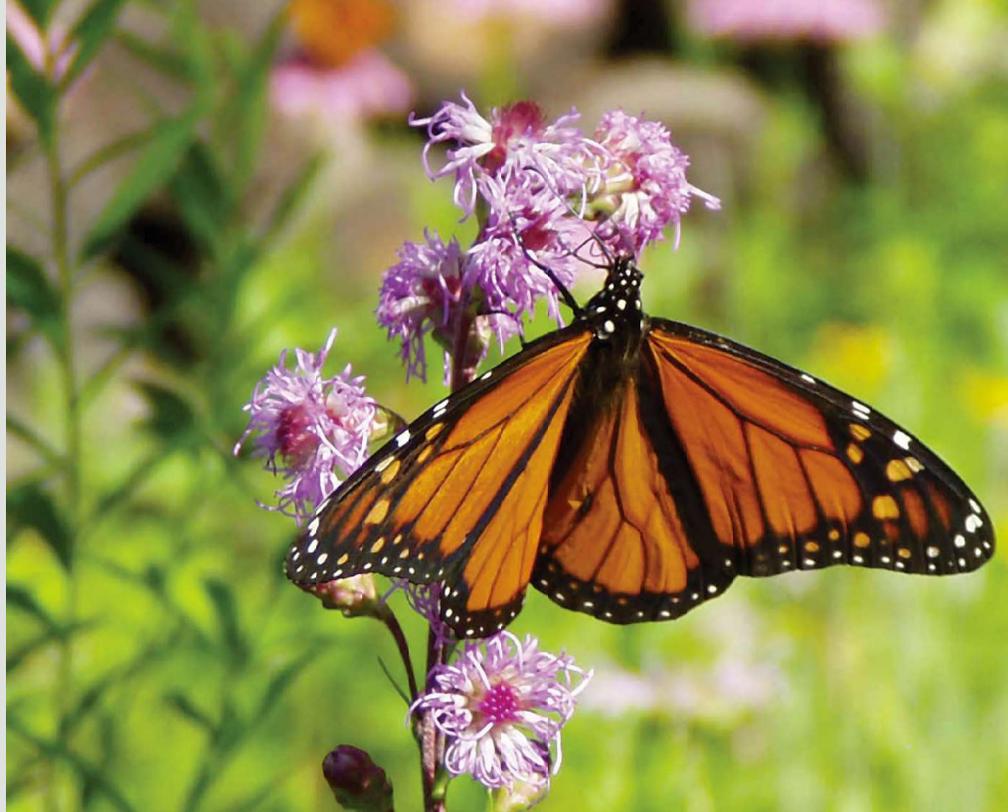
◀ Cover photo: Picha Creek Restoration.

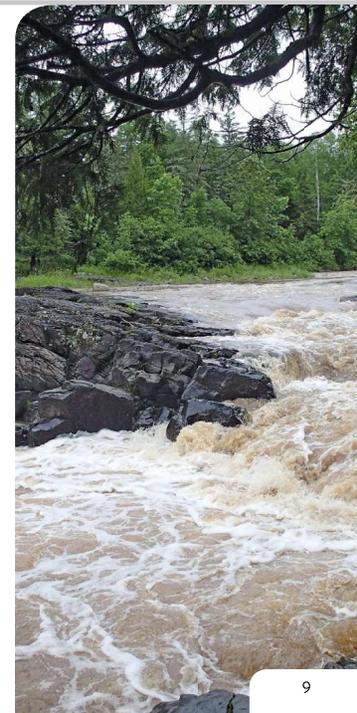
RECOMMENDATIONS continued

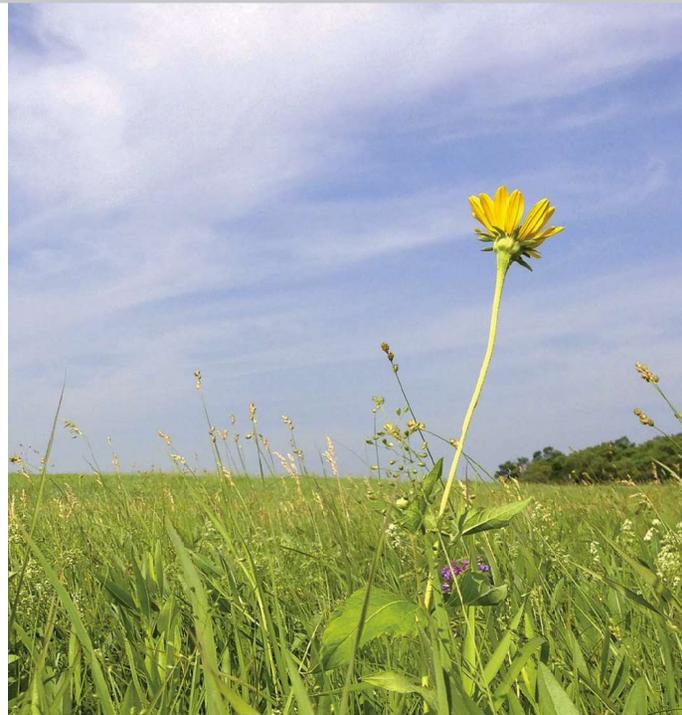
Improved Restoration Training

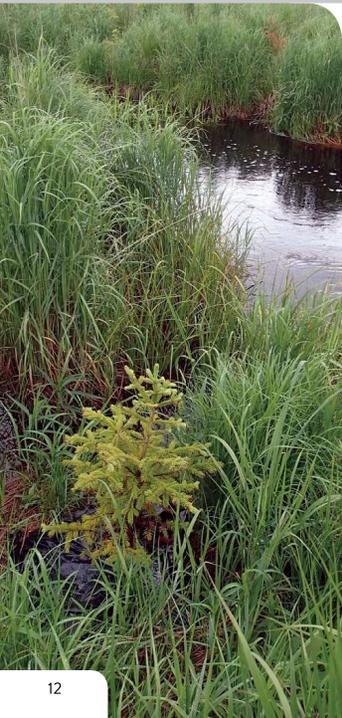
Evaluation Process Improvement

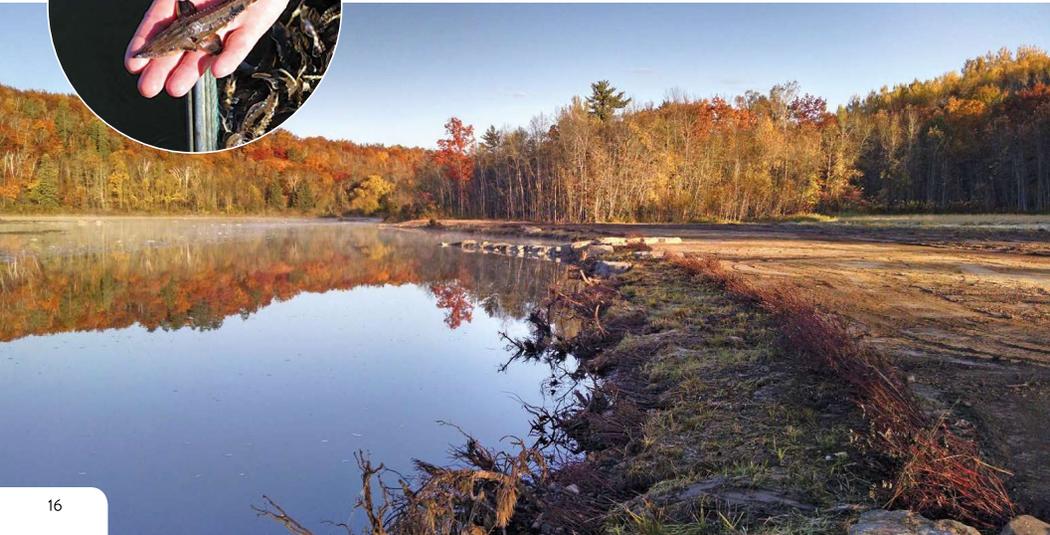
Over a century of unregulated dumping of waste has left a legacy of pollution impacting the 12,000 acres of wetlands, streams and bays making up the St. Louis River Estuary. The extreme degradation of the estuary resulted in it being designated an "Area of Concern" by the United States Environmental Protection Agency. With polluted soils and bays littered with wood waste, the river and estuary were not a safe or healthy place for the citizens of Minnesota or the natural communities that once thrived there.

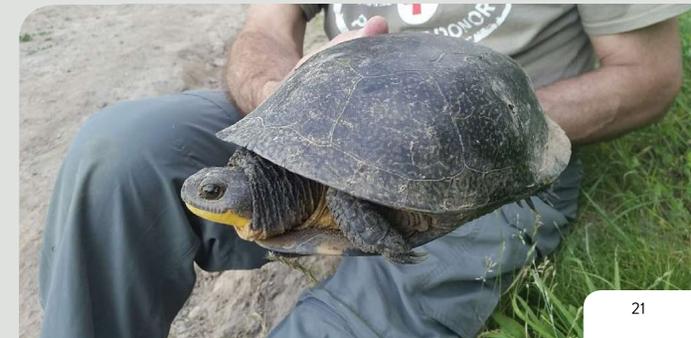
APPENDIX A: STATUTORY REQUIREMENTS *continued*

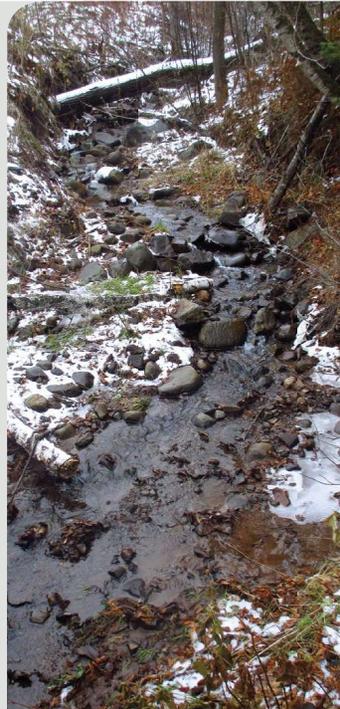
APPENDIX B: EVALUATION PROCESS

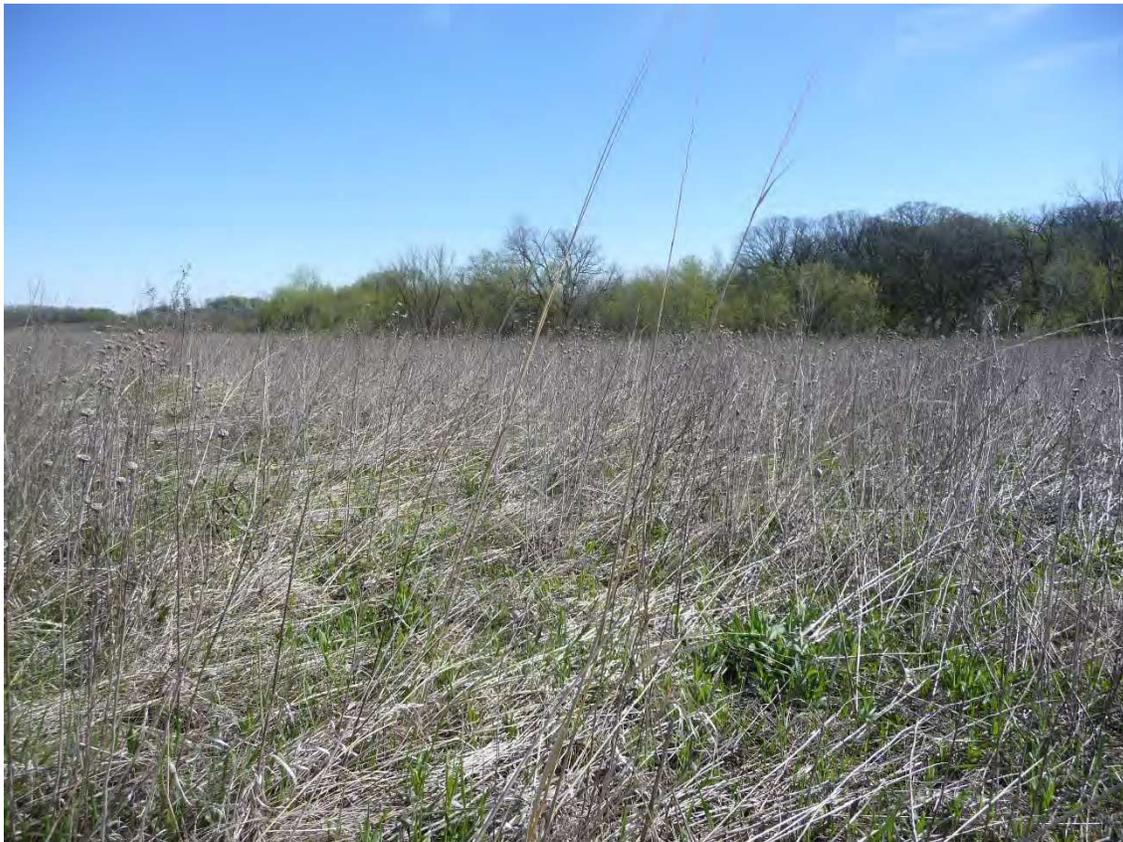
Photo 1-2 - Planting prior to Burn, May 3, 2017.

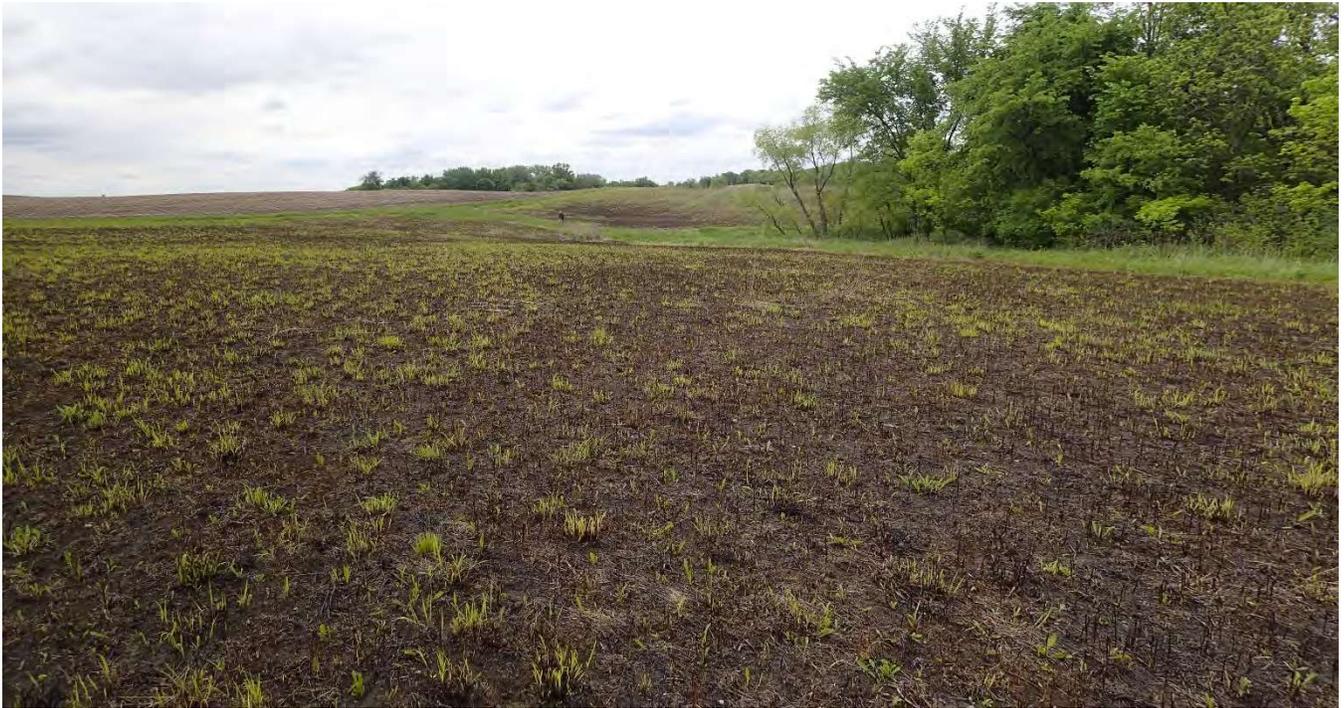
Photo 1-3 - Erickson grassland planting May 24, 2017, three weeks after prescribed burn. Re-sprouts primarily seeded species.

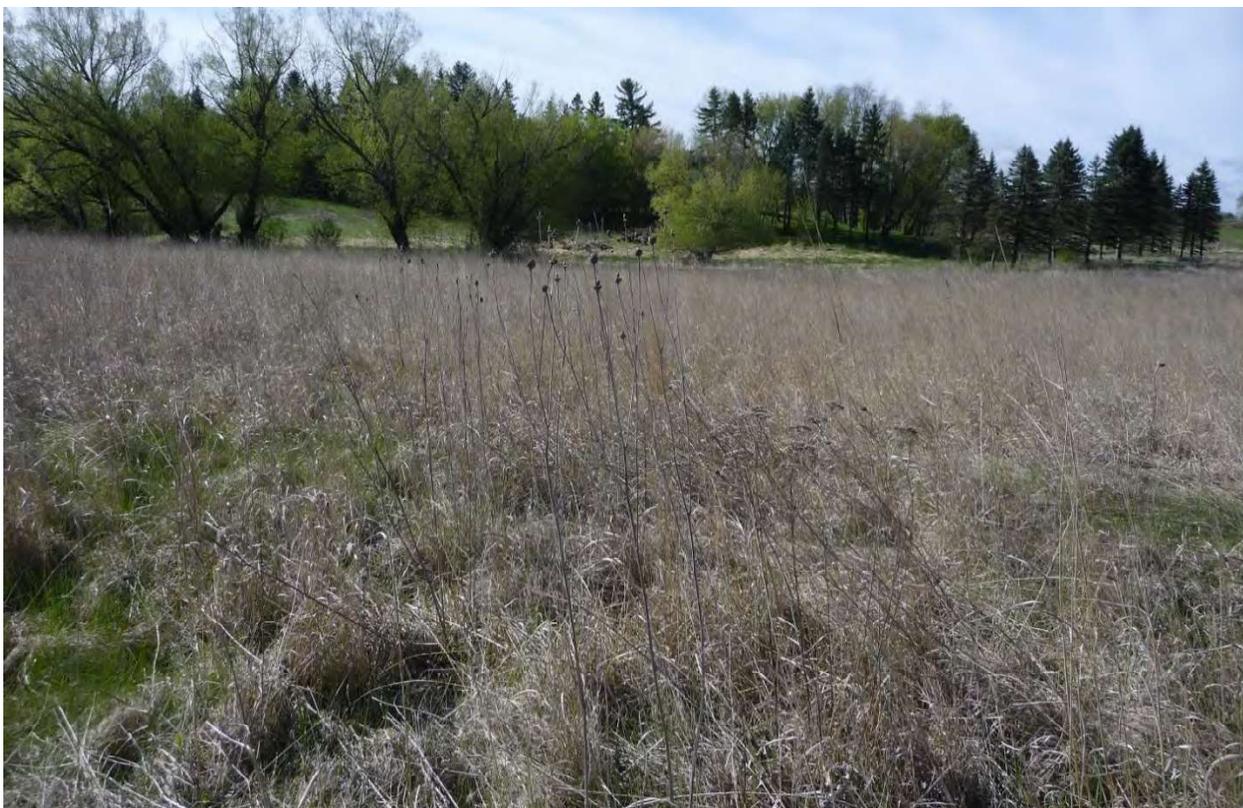
Photo 3-2 - Whipps grassland pre-burn May 3, 2017.

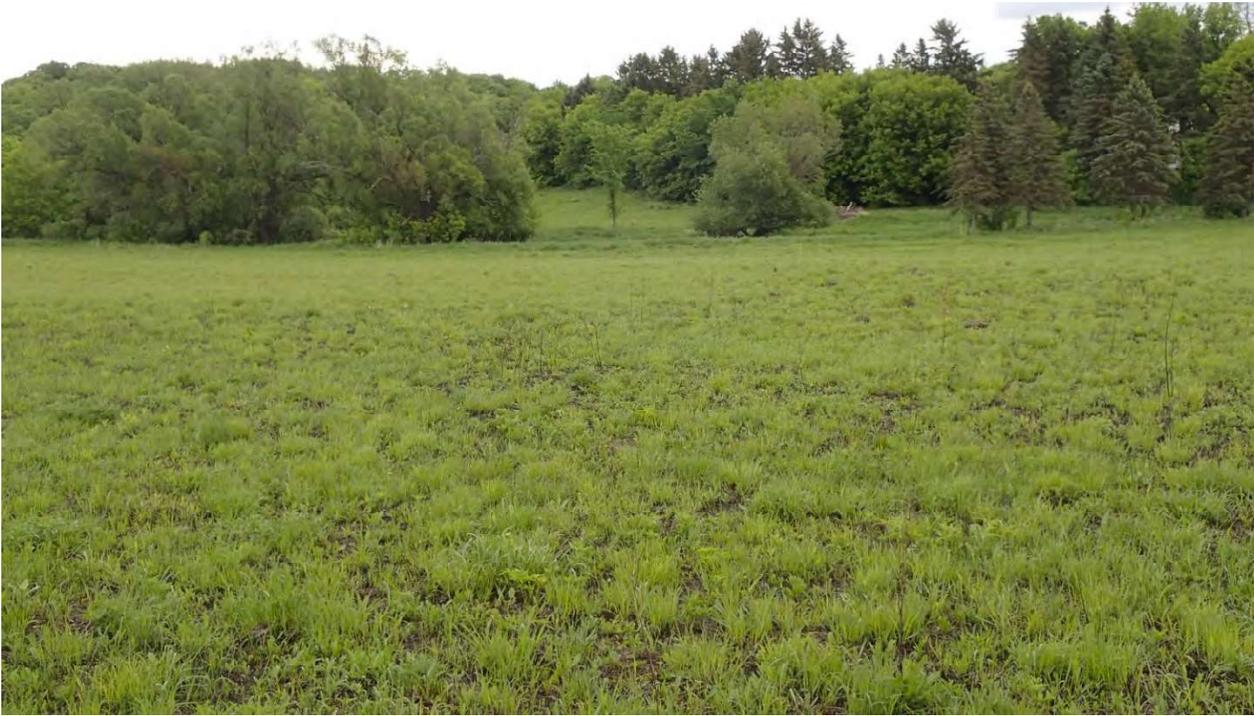
Photo 3-3 - Whipps grassland planting May 24, 2017, three weeks after prescribed burn. Warm season prairie grasses dominate the vegetative cover.

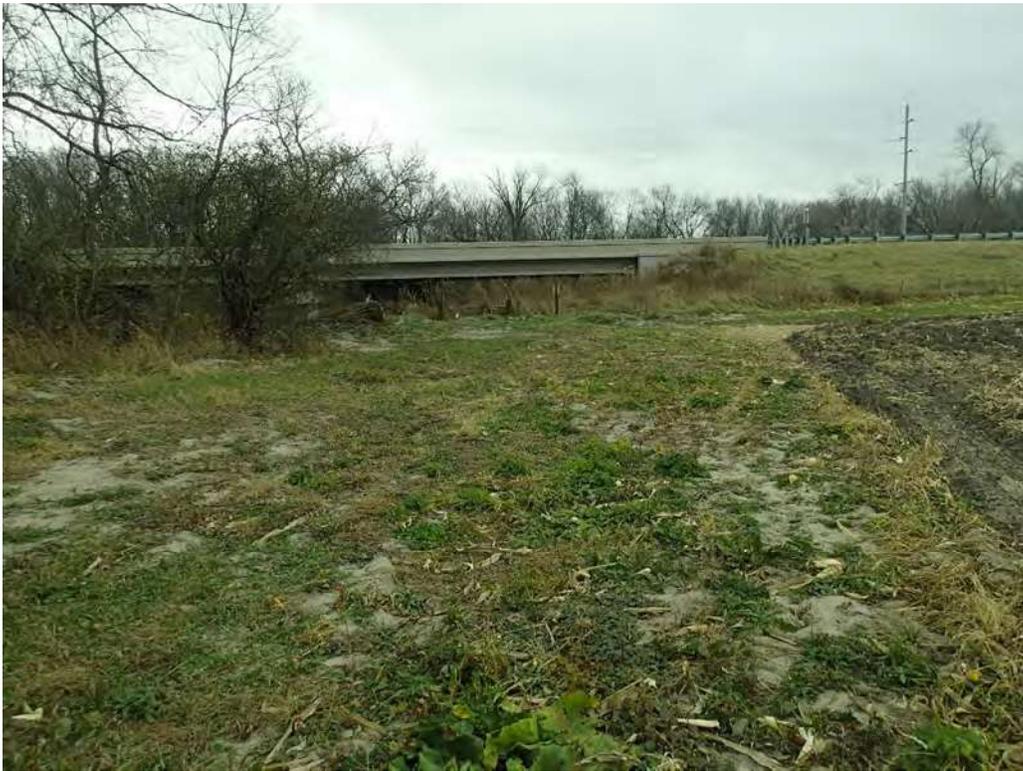
Photo 8-3 - Buffer strip area showing moderate establishment with recent sediment observed. Looking south toward Minnesota Highway 3 November 2015.

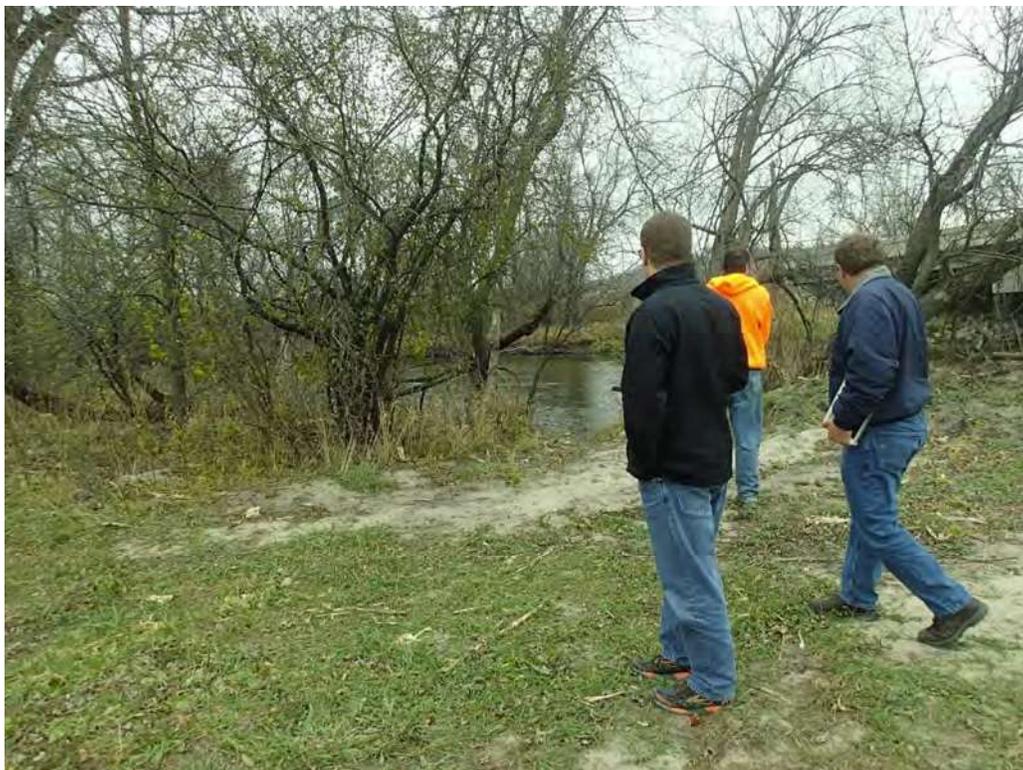
Photo 8-4 – Southwest corner showing recent sedimentation at river edge.

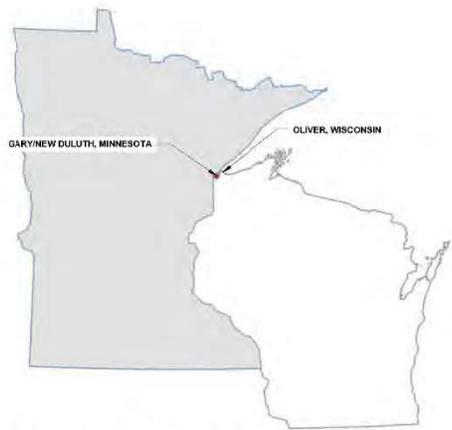
WISCONSIN / MINNESOTA STATE MAPS
NOT TO SCALE

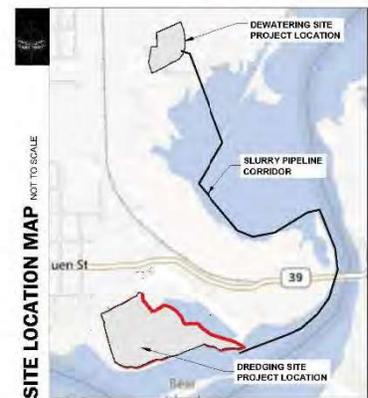
SITE LOCATION MAP
NOT TO SCALE

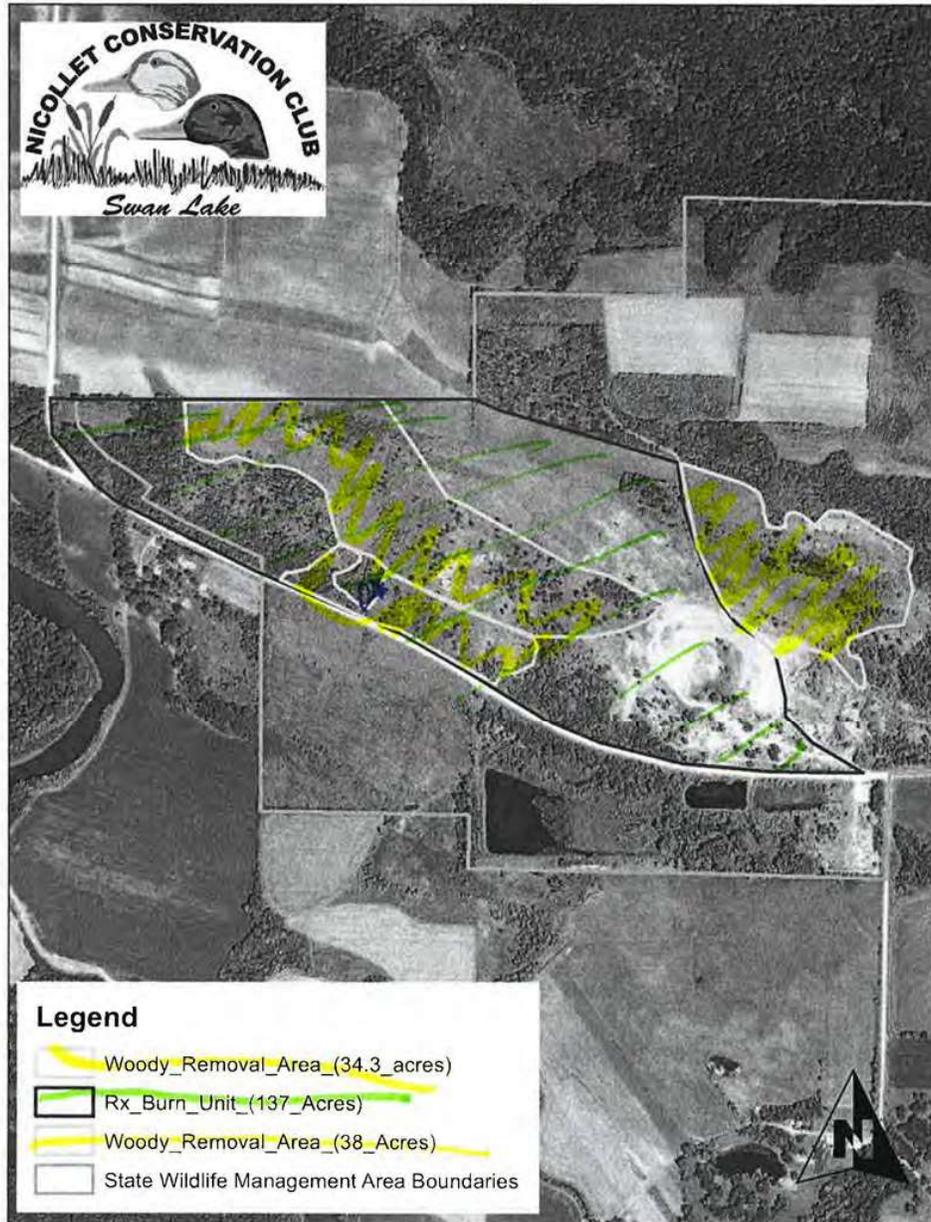
Figure 17-1 – Map illustrating areas of the North Star Unit where invasive tree management and prescribed burn work was completed.

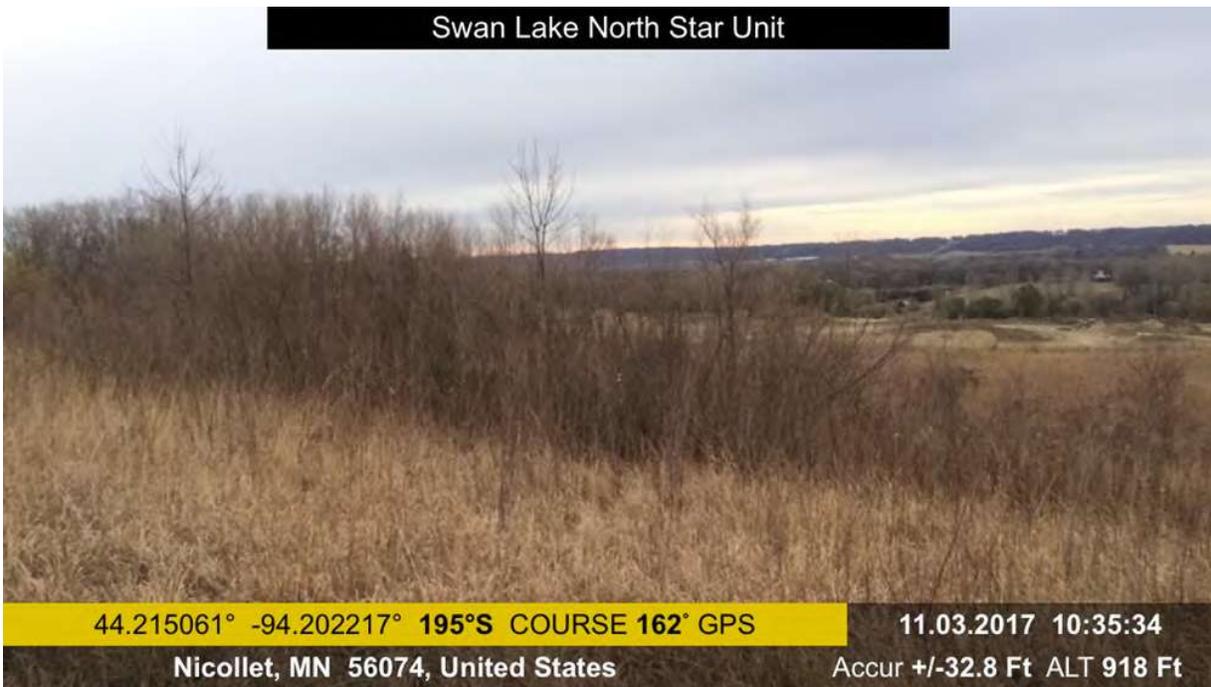
Photo 17-1 – Slope invasive tree clearing area showing persistent brush seedlings following invasive tree clearing and prescribed burn. (North Star Unit, photo taken during site visit 11/03/2017).

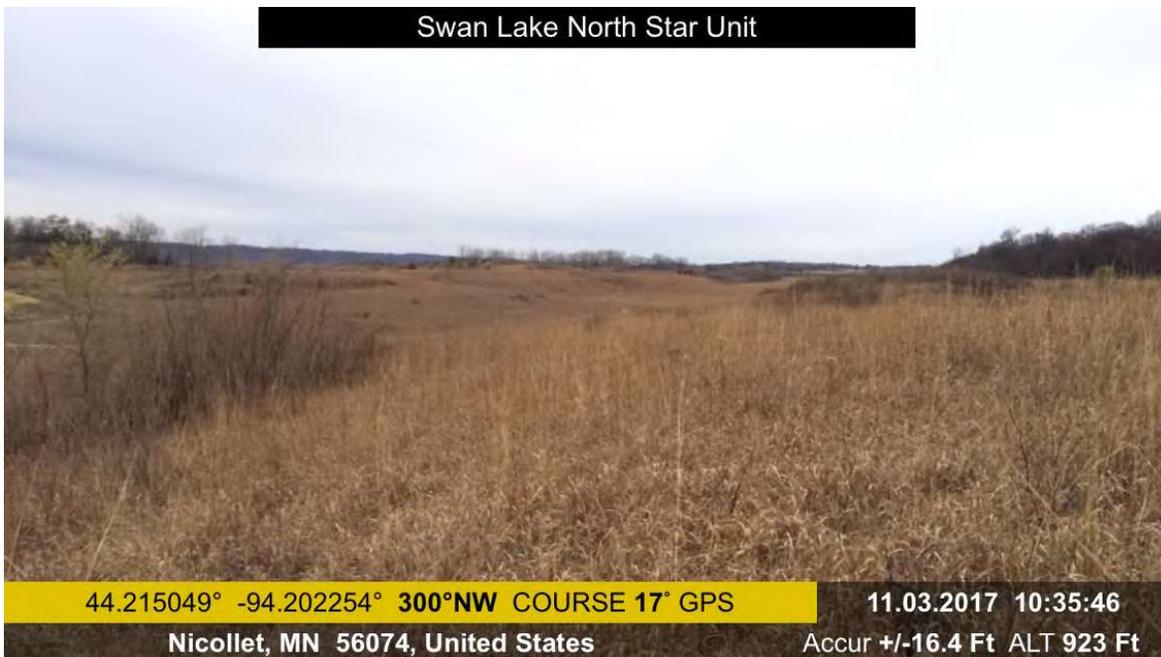
Photo 17-2 – Landscape view looking west across burn unit. Invasive tree clearing area on left showing persistent brush and tree seedlings following invasive tree clearing and prescribed burn.

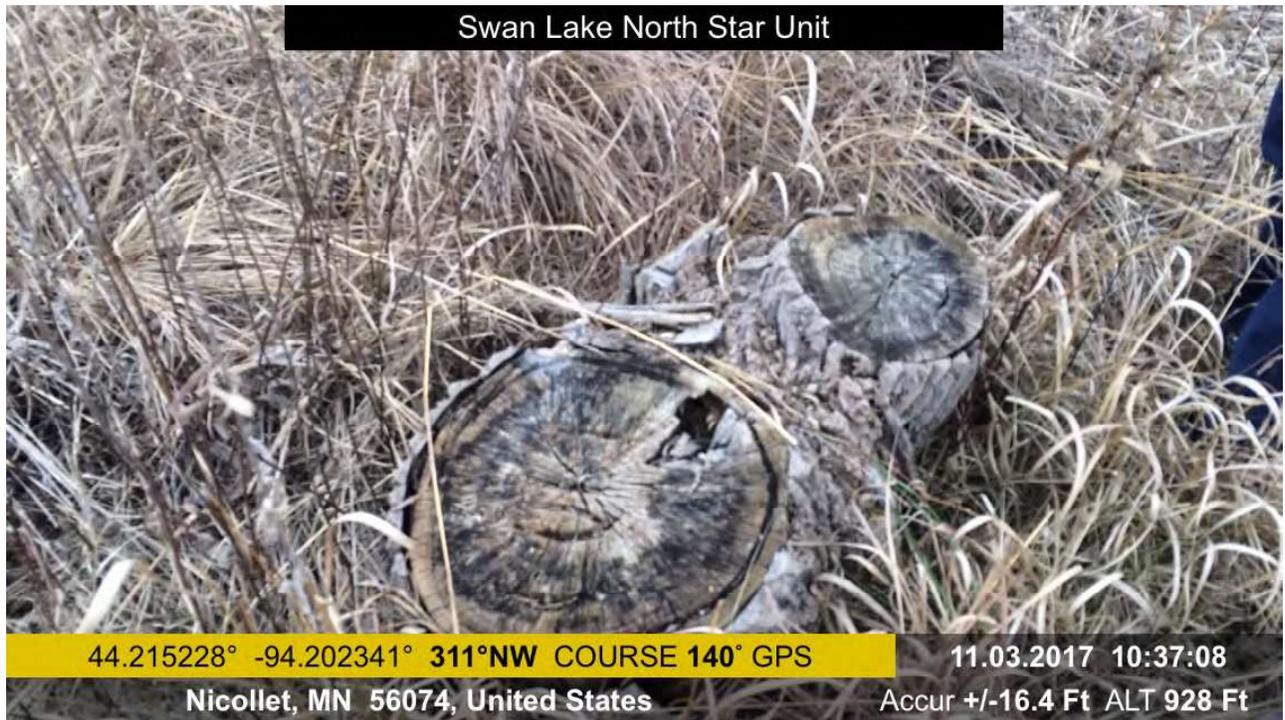
Photo 17-3 – Cut stumps showing burn scars.

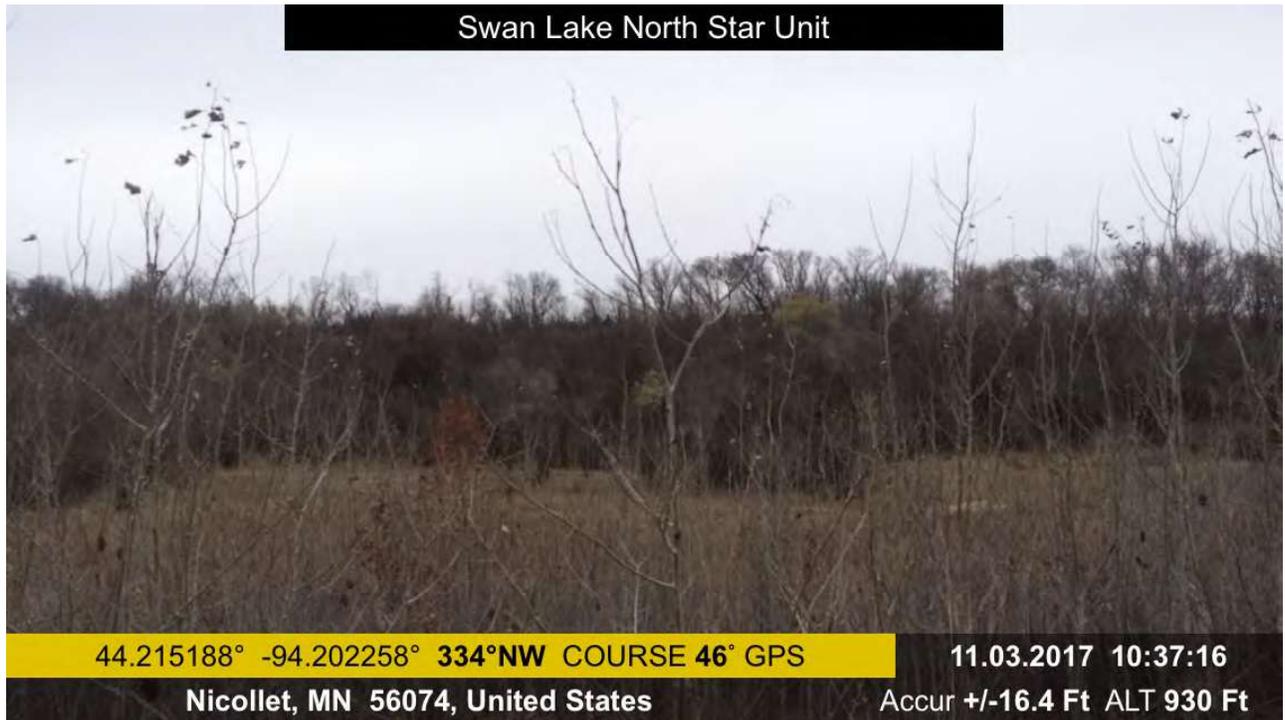
Photo 17-4 – Looking north across burn unit. Siberian elm tree seedlings/saplings dominant in foreground.

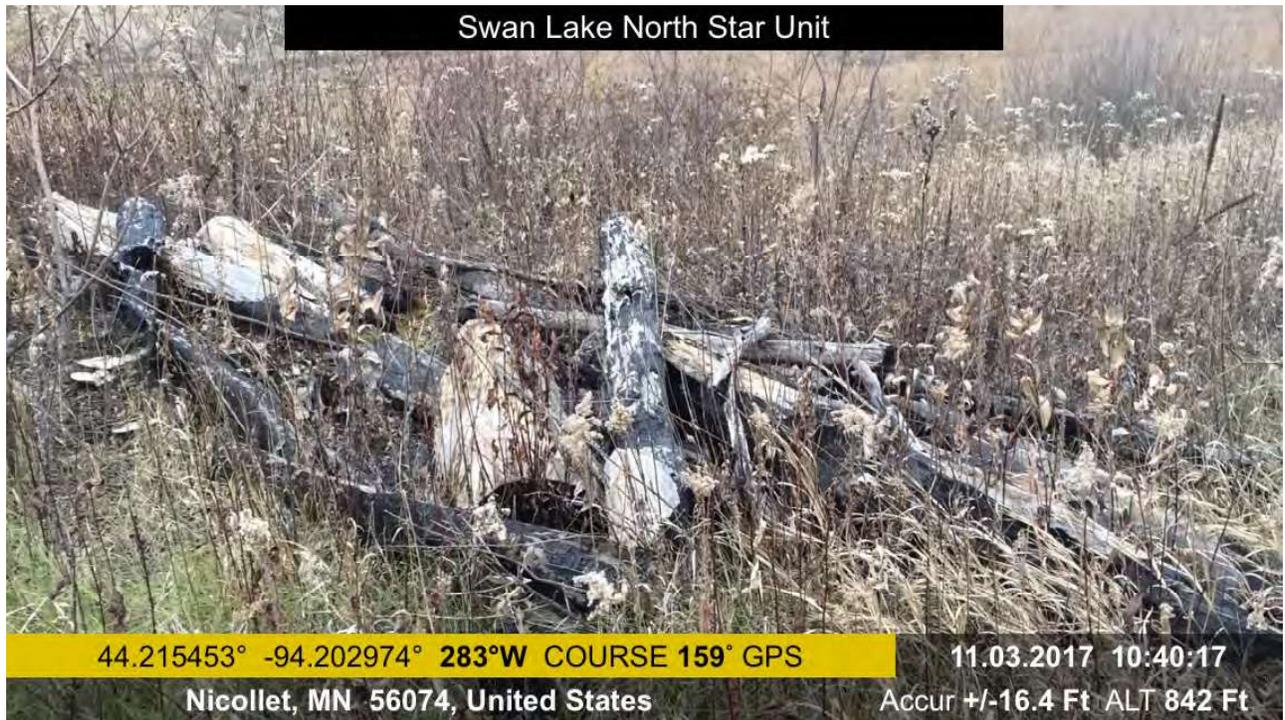
Photo 17-5 – Residual coarse woody debris from cut tree burn pile.

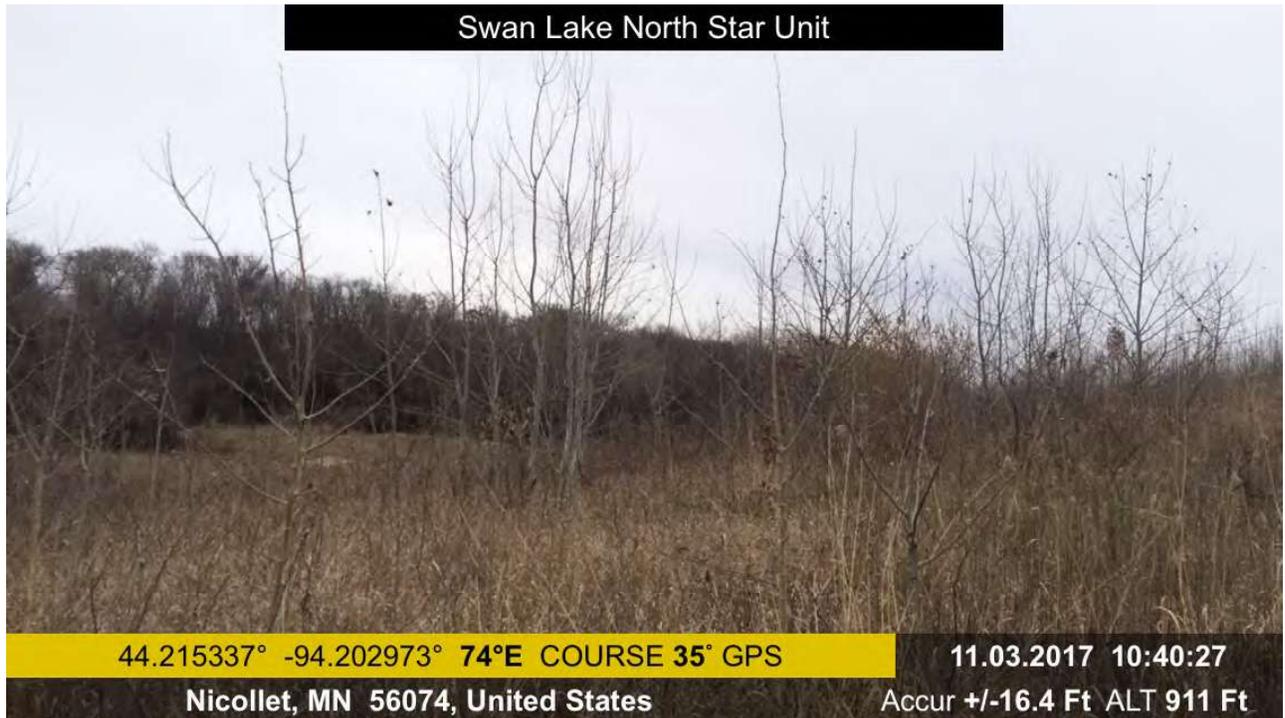
Photo 17-6 – Looking north across burn unit. Cottonwood and Siberian elm tree seedlings/saplings dominant in foreground.

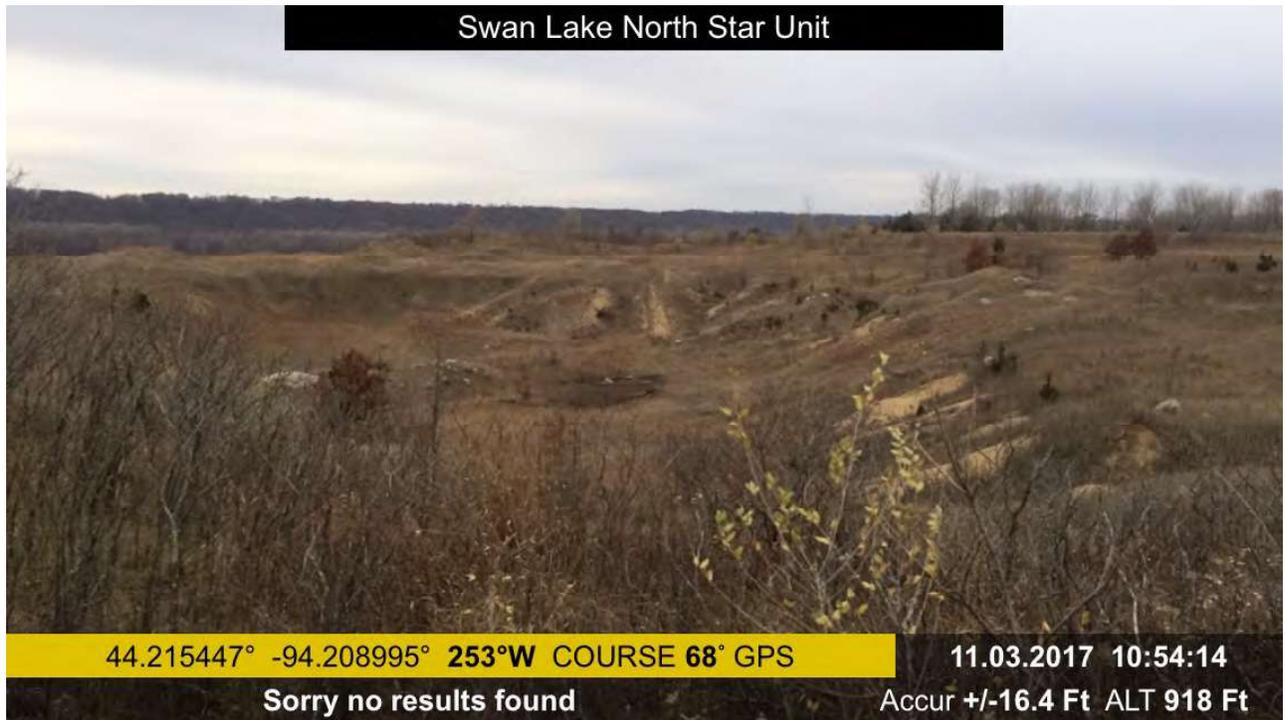
Photo 17-7 – Dormant quarry area inside burn unit. Large burn pile location evident in center of photo.

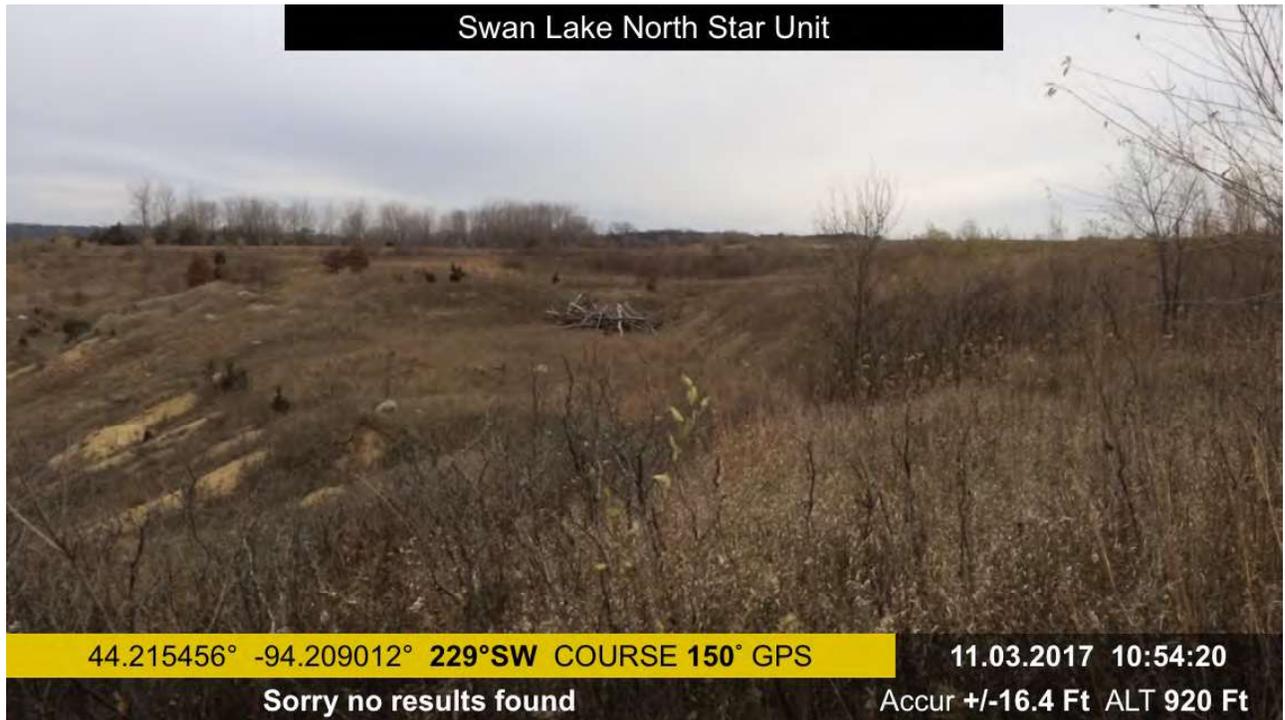
Photo 17-8 – Dormant quarry area inside burn unit. Large unburned tree pile evident in center of photo.

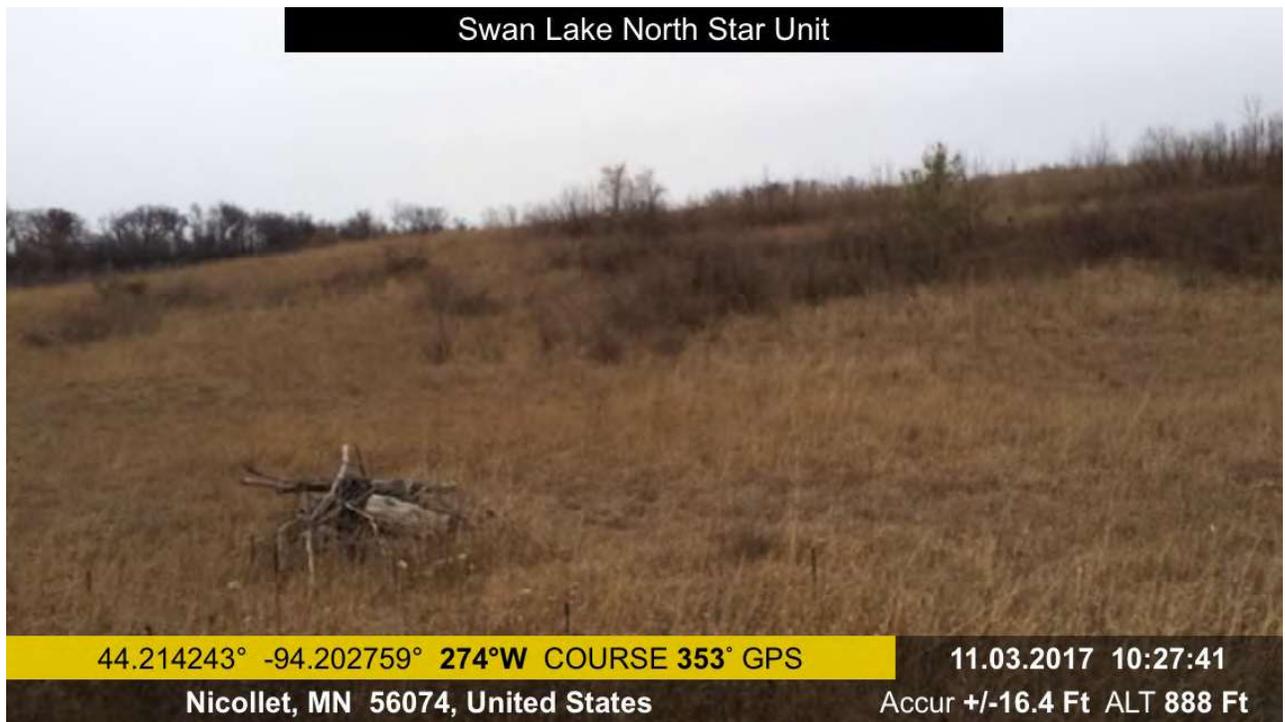
Photo 17-9 – Burn pile location evident in lower-left of photo. Brush patches in upper portion of photo are locations where large, invasive trees were cut/treated.

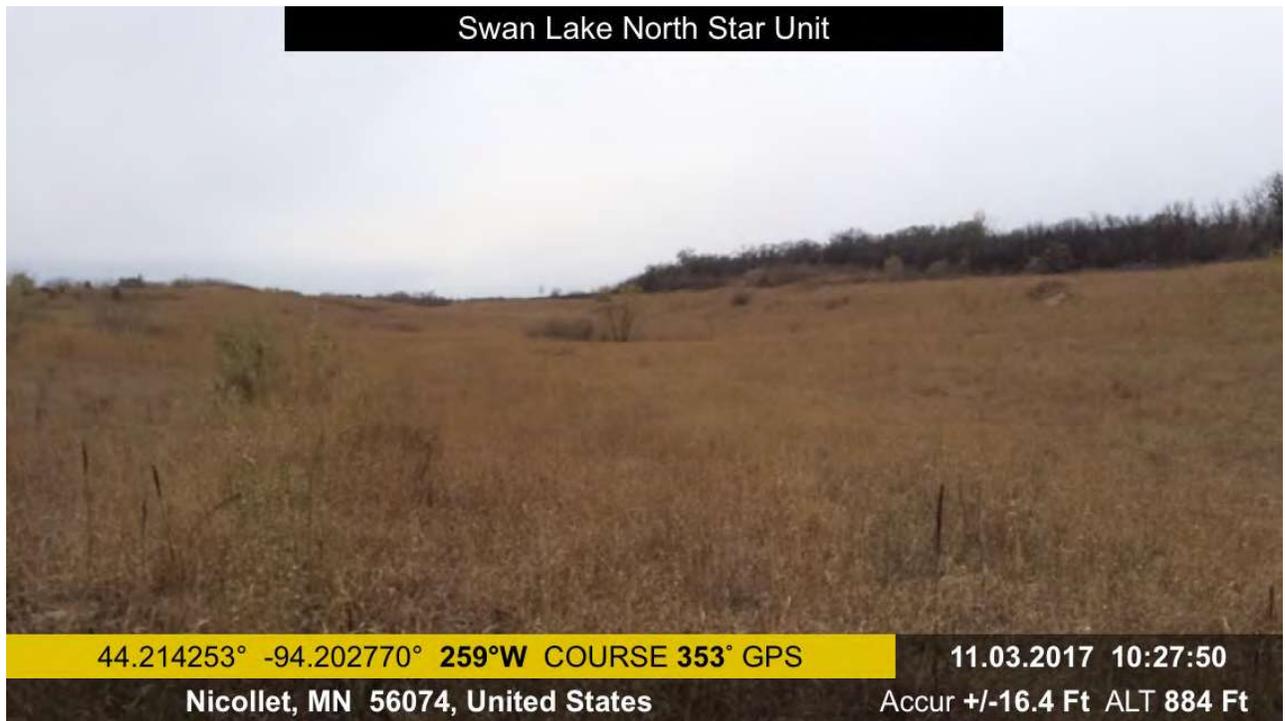
Photo 17-10 – View across burn unit to northwest.

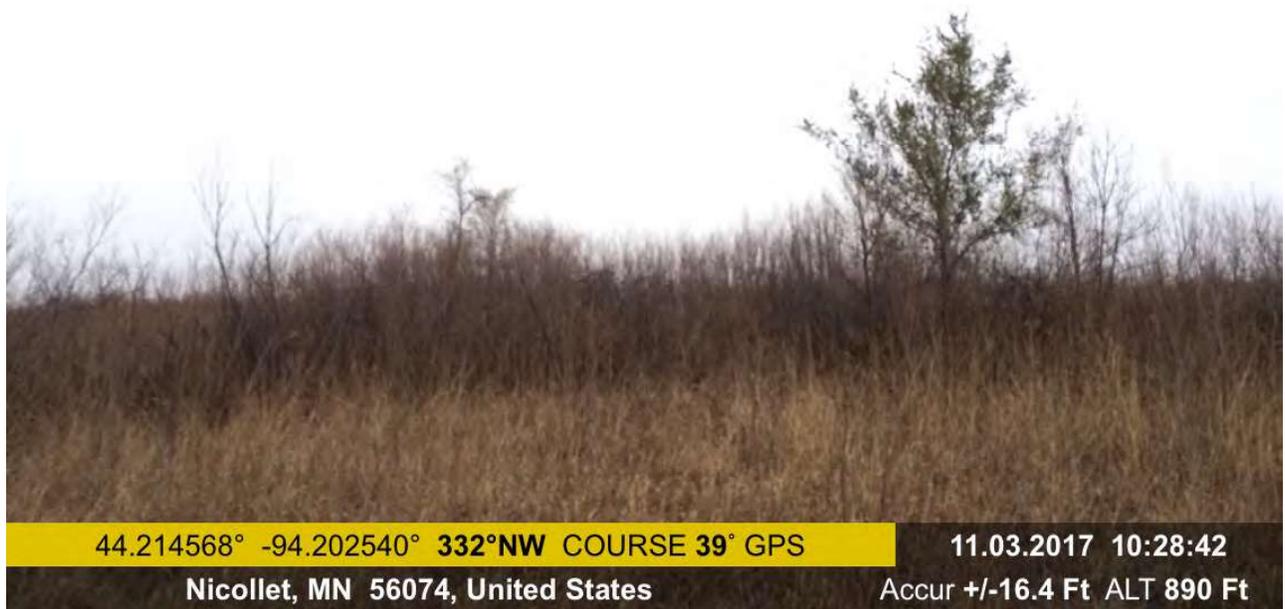
Photo 17-11 – Residual invasive tree seedlings, saplings and brush in area where large trees were cut/treated.

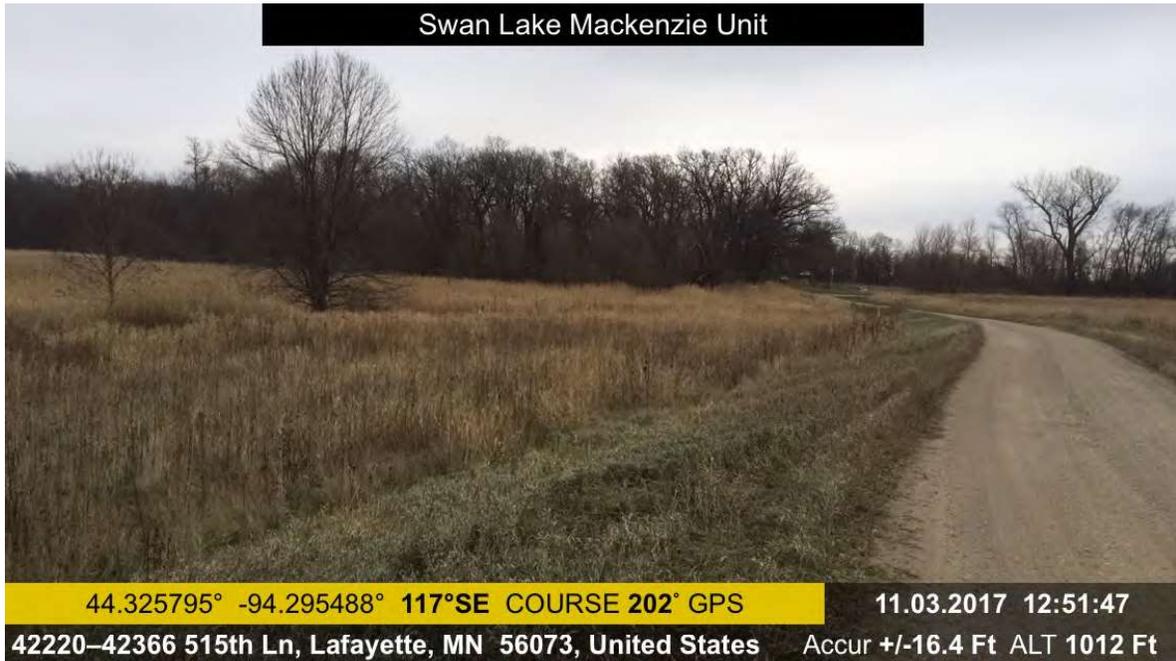
Photo 18-1 - View looking east-northeast. Prairie seeding located between gravel road on right and wetland edge (roughly the two trees) on the left of the photo. (Photo taken during site visit 11/03/2017).

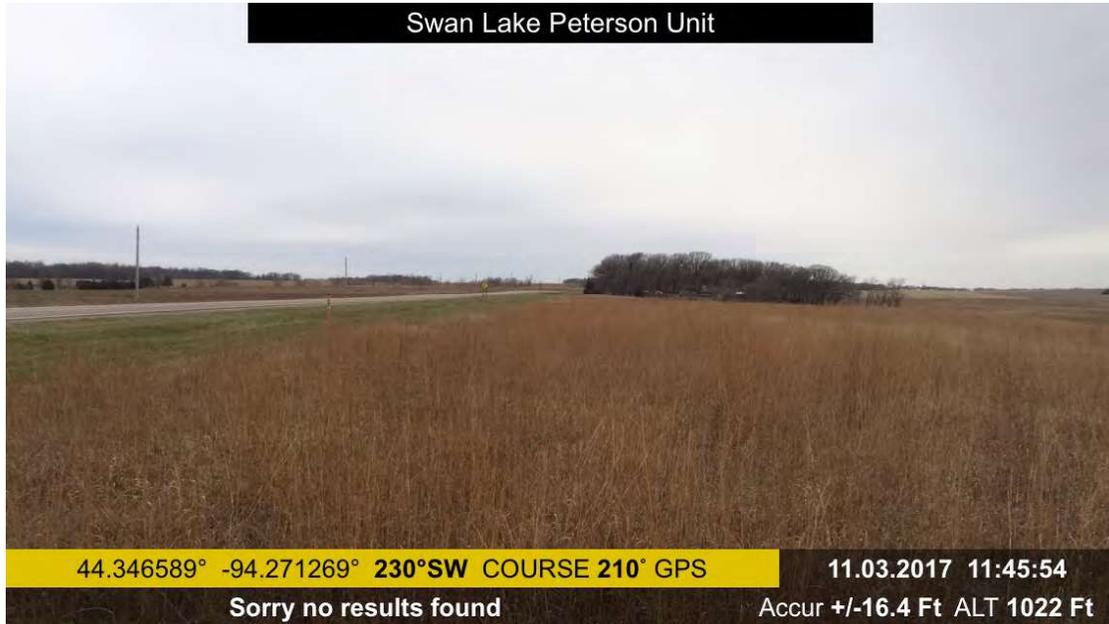
Photo 19-1 – Looking west from WMA parking area, across pollinator plug planting area (photo taken during site visit 11/03/2017).

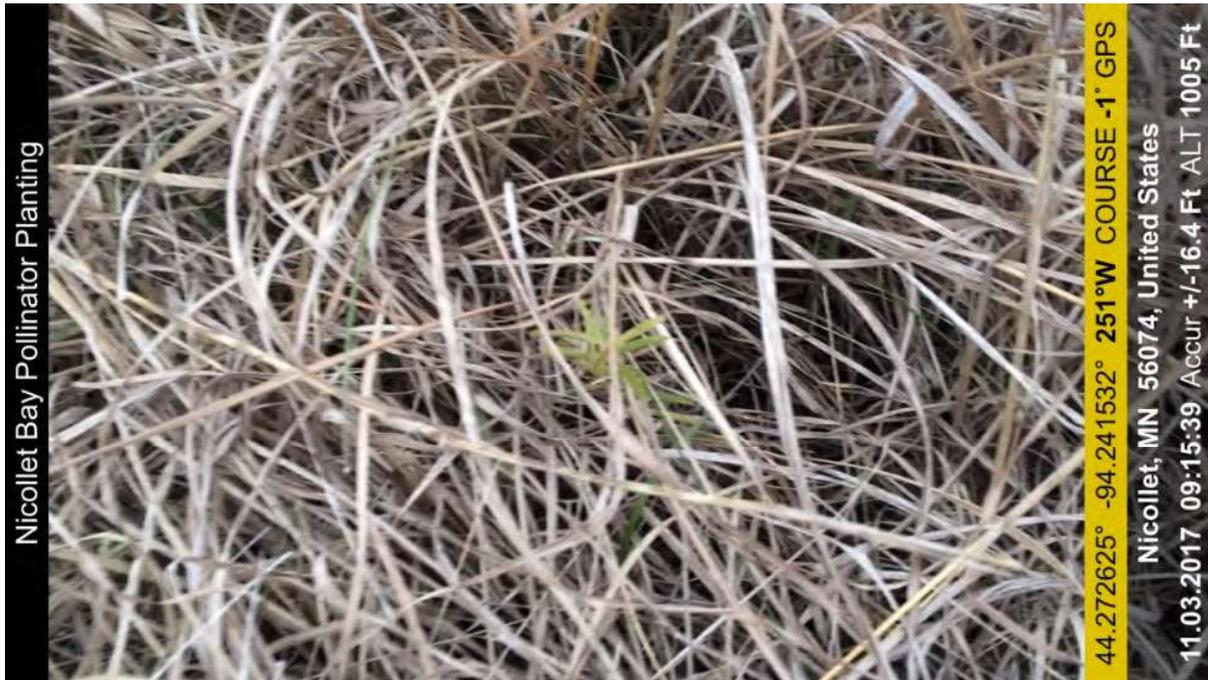
Photo 20-1 – Forb seedling (green plant in center of photo) amid warm season native grasses (photo taken during site visit 11/03/2017).
