2017 LEGACY FUND RESTORATION EVALUATION REPORT

Technical Panel Findings and Recommendations

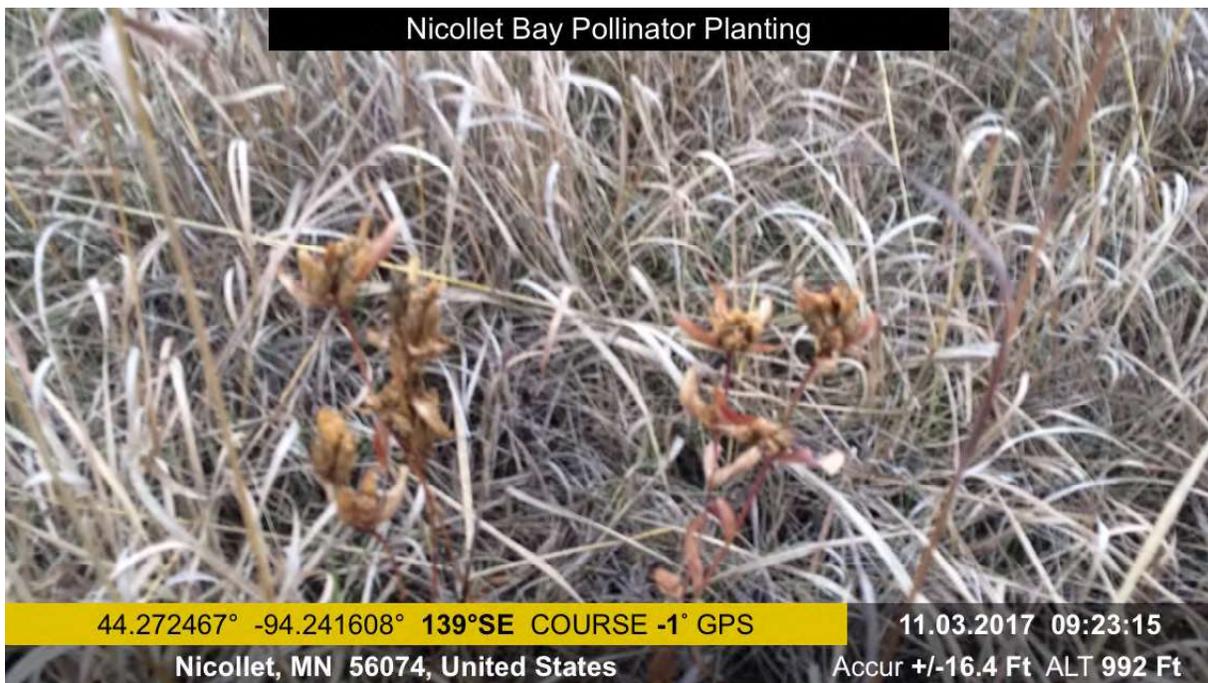
Photo 20-2 – Bottle gentian (*Gentiana andrewsii*) rusty-brown plant in center of photo was one of the forb plugs that showed fair survival at the Swan Lake Unit forb enrichment pollinator planting (photo taken during site visit 11/03/2017).

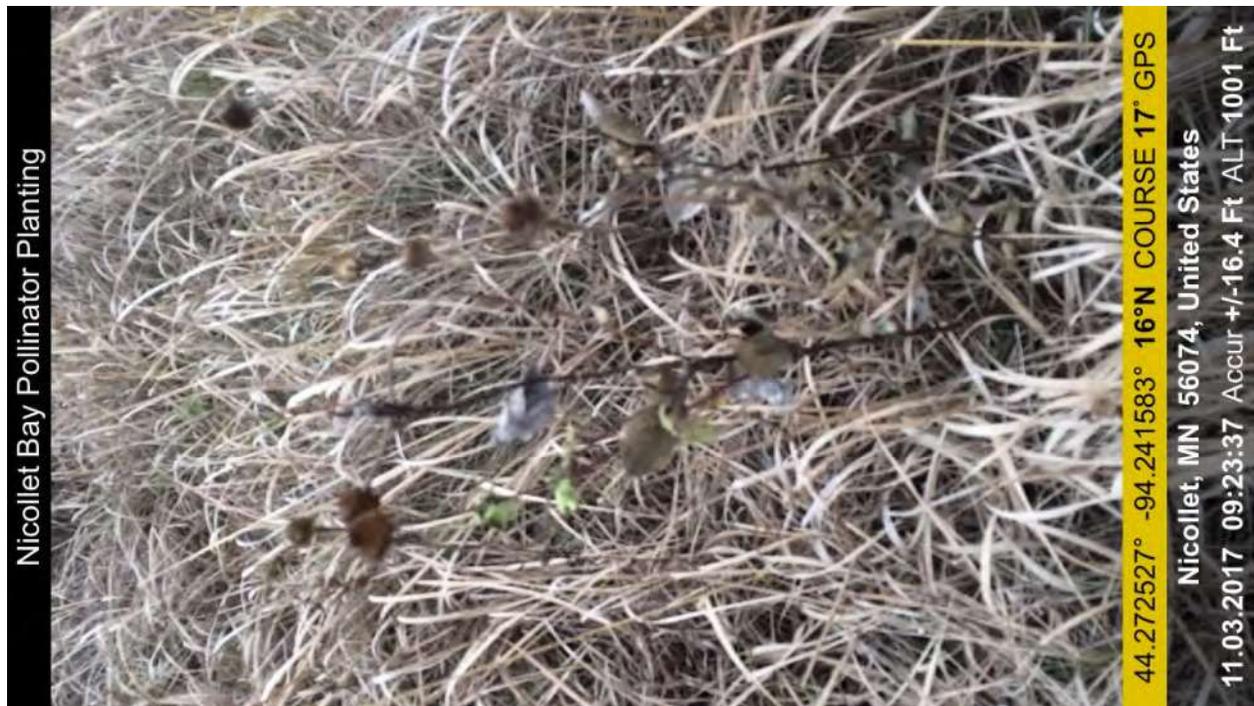
Photo 20-3 – Oxeye false sunflower (*Heliopsis helianthoides*) was also encountered occasionally during the transect survey (photo taken during site visit 11/03/2017).

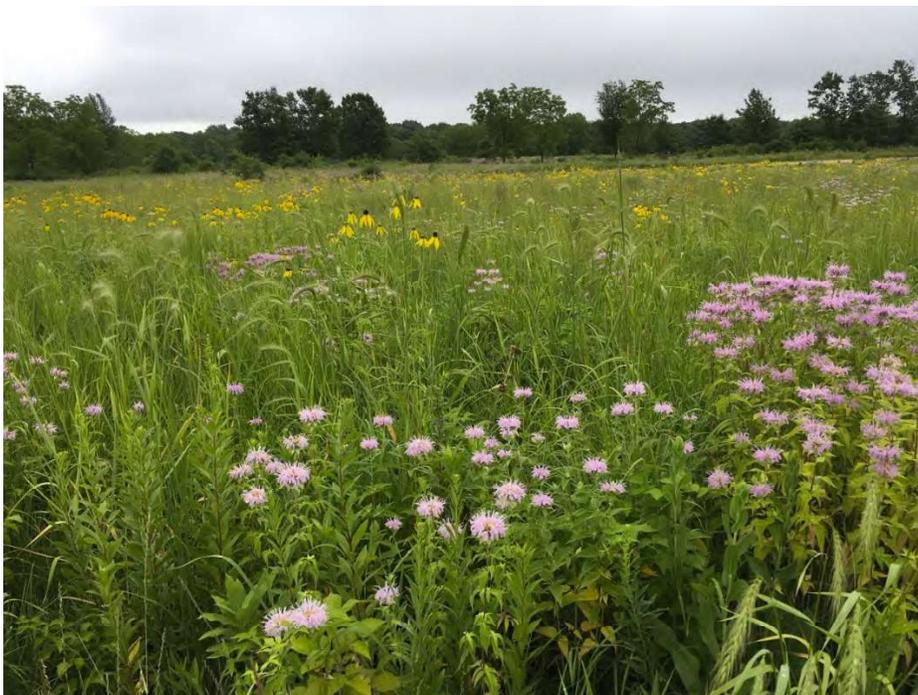
Photo 21-2 – Archery trail prairie/savanna restoration looking east from center of site Archery Trail (summer 2017, following completion of woody removal, disking, planting, 2 years of mowing, and burning; photo courtesy of Karen Schik).

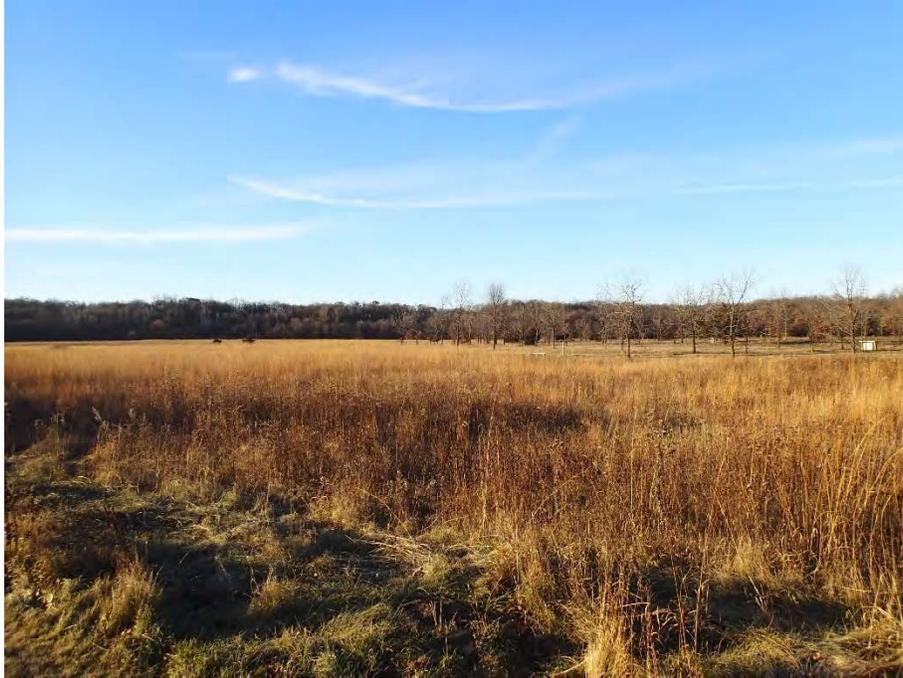
Photo 21-3 – Archery trail prairie/savanna restoration looking east from the parking lot at Archery Trail (11/29/17, photo taken during field evaluation).

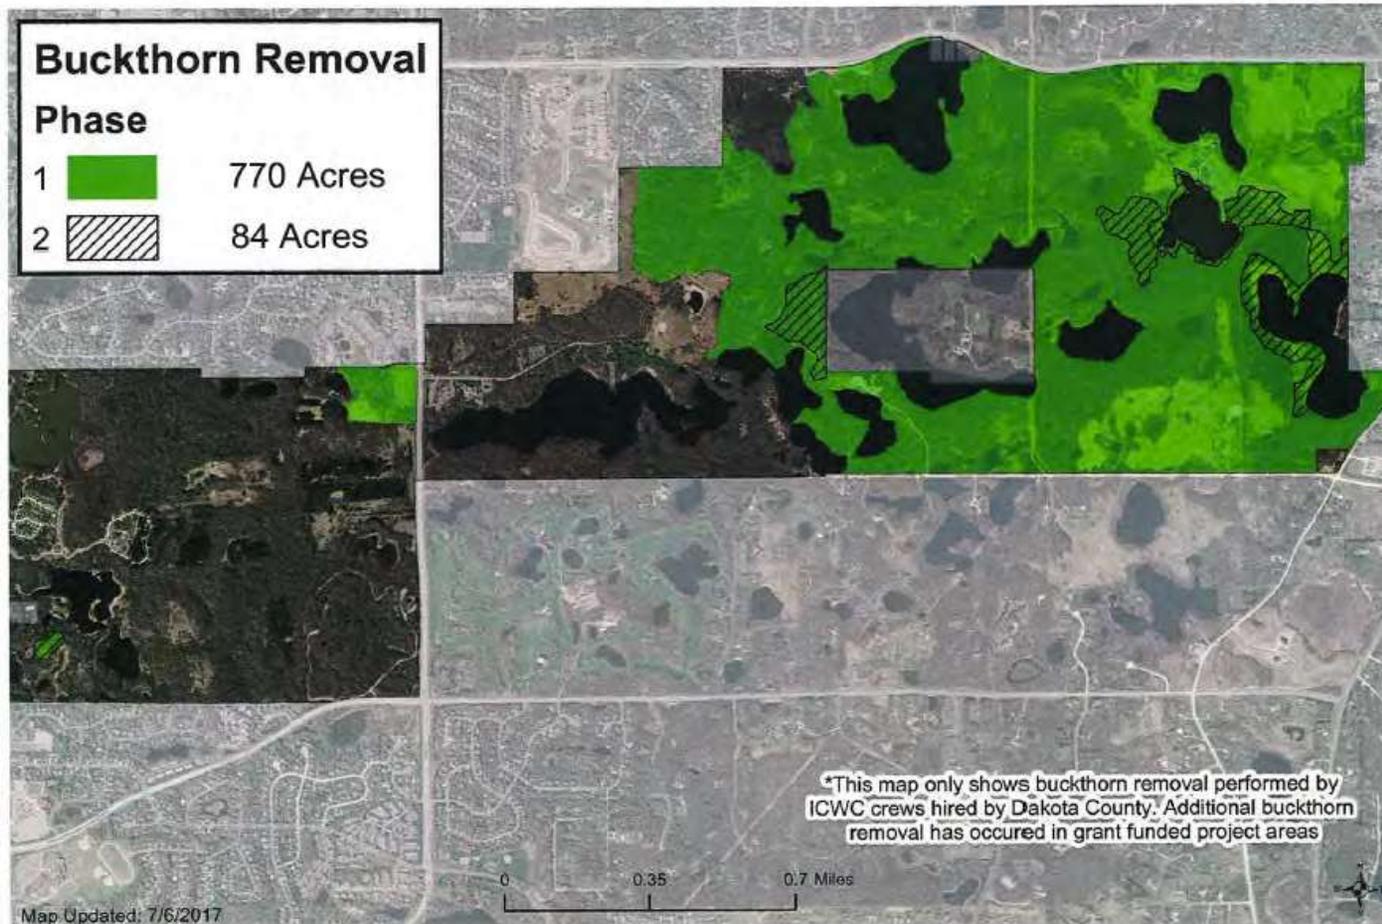
Figure 22-3 – Buckthorn removal completed by ICWC crews hired by Dakota County in and around the McDonough Lake / Visitor Center site. Throughout the site buckthorn removal was staged with activities targeted to be most effective for a given infestation level including cutting, treatment with Garlon, forestry mowing, and foliar spray. Removal or reduction of buckthorn in the project area has allowed Dakota County to focus on grants/activities making progress on some of the other restoration and enhancement priorities in the Lebanon Hills Regional Park Master Plan, 2015. Map provided by Dakota County Parks Natural Resources staff.

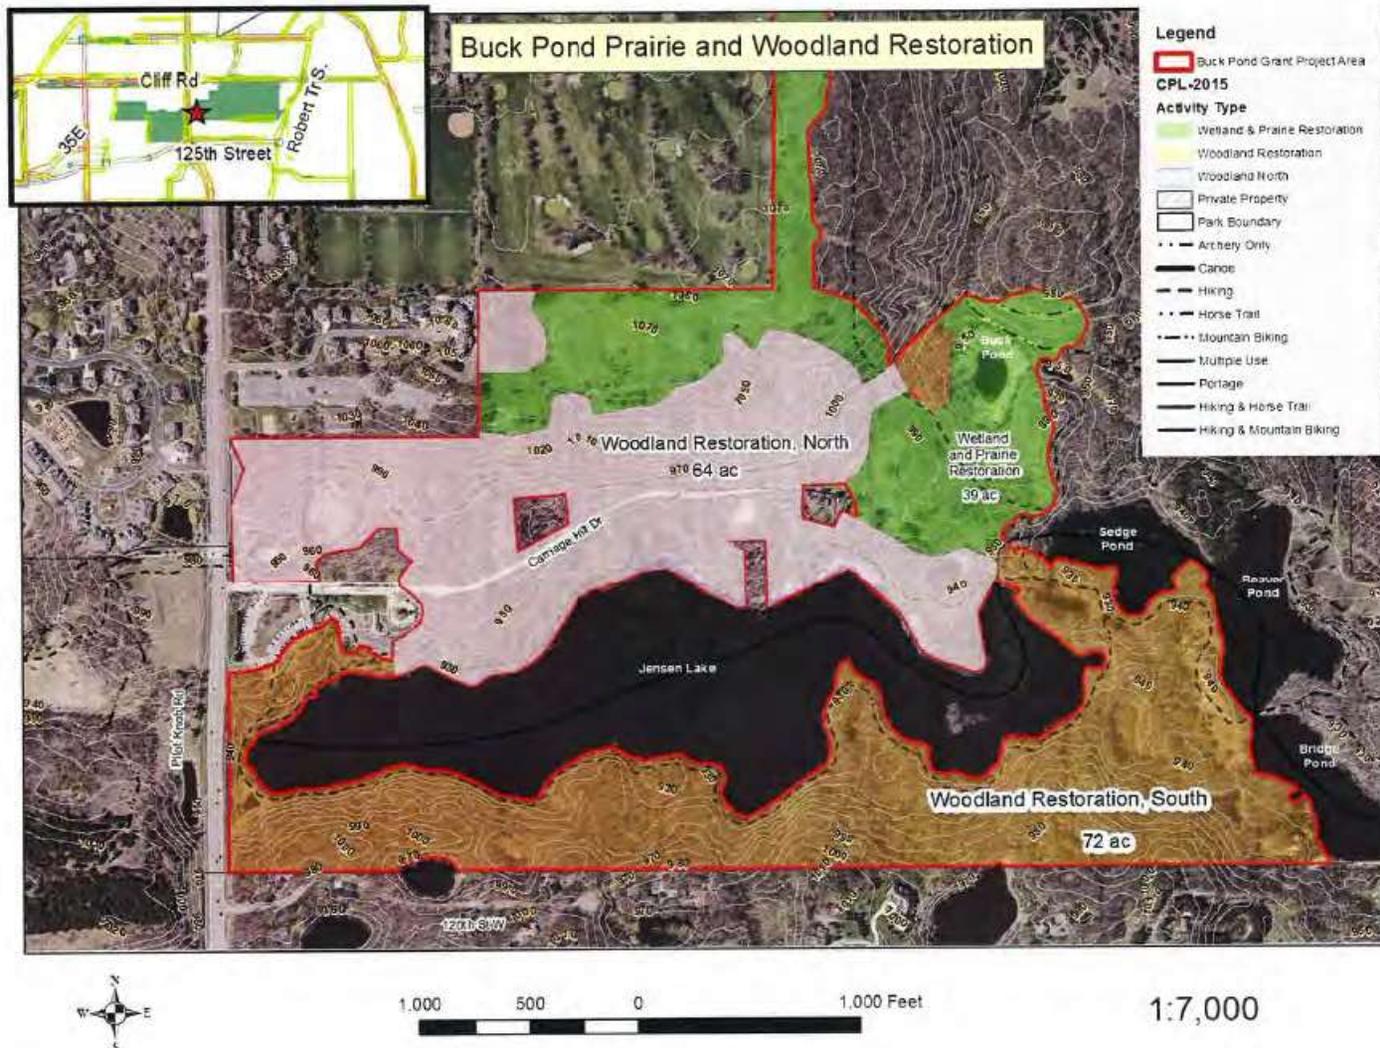
Figure 23-3 – Woody removal has been done and is ongoing in the Buck Pond Prairie and Woodland Restoration Area. Throughout the site buckthorn removal is being staged with activities targeted to be most effective for a given infestation level including cutting, treatment with Garlon, forestry mowing, and foliar spray. Removal or reduction of buckthorn in the project area has allowed Dakota County to focus on grants/activities making progress on some of the other restoration and enhancement priorities in the Lebanon Hills Regional Park Master Plan, 2015. At the time of review Map provided by Dakota County Parks Natural Resources Staff.
