THE TETTEGOUCHE CAMP

A Reuse Study

The Tettegouche Camp Reuse Study

Prepared by Rolf T. Anderson

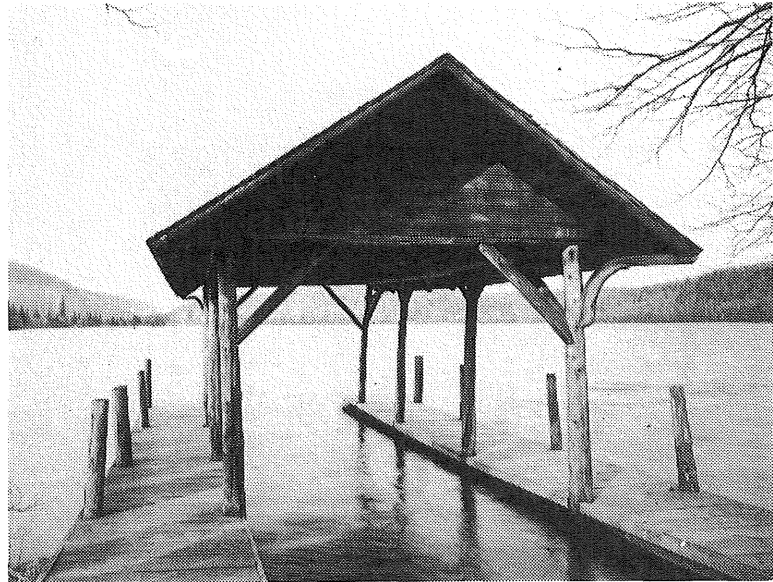
Boat Shelter – looking northeast

One of the most significant structures at the Tettegouche Camp is the Boat Shelter. The building is not only an unusual property type, but its construction is a classic example of Rustic design in the Adirondack tradition.

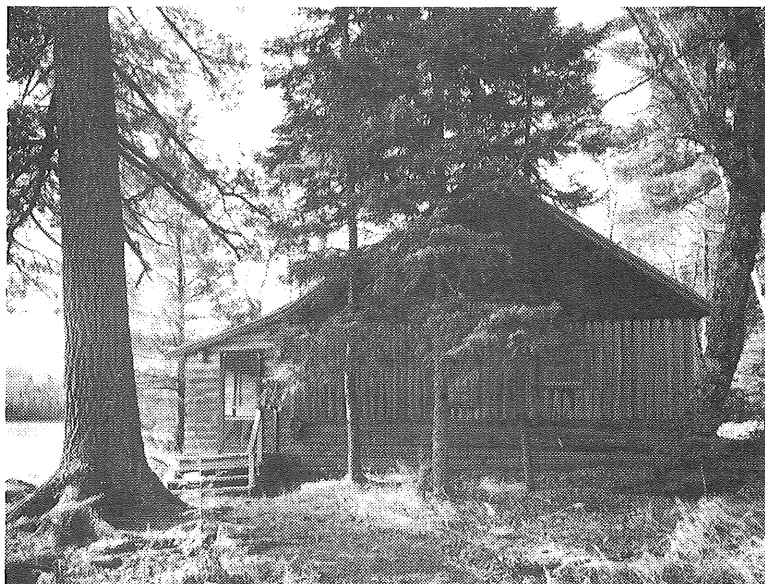
Cabin B – north elevation

The log constructed buildings at the Tettegouche Camp are particularly unique because of their variety of vernacular construction techniques. Both the Lodge and Cabin B, for example, combine both horizontal and vertical log construction. The Garage features palisade construction, utilizing vertical half-logs. The Filers' Shack is built with hewn timbers joined at the corners with half dovetail notches.

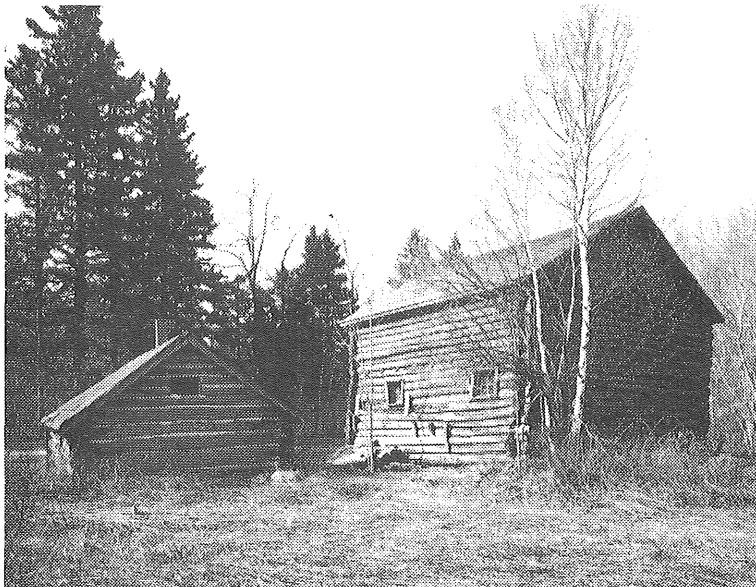
Barn and Filers' Shack – looking southwest

Many of the buildings at the Tettegouche Camp are entering a critical state of deterioration. Typical conditions include rotting sill logs, shifting foundations, and problems associated with a gradual increase in grade around the buildings. However, at the present time, only the Filers' Shack and the Garage are considered beyond repair.

Due to their unsafe condition, the Filers' Shack and Garage should be removed from the site.

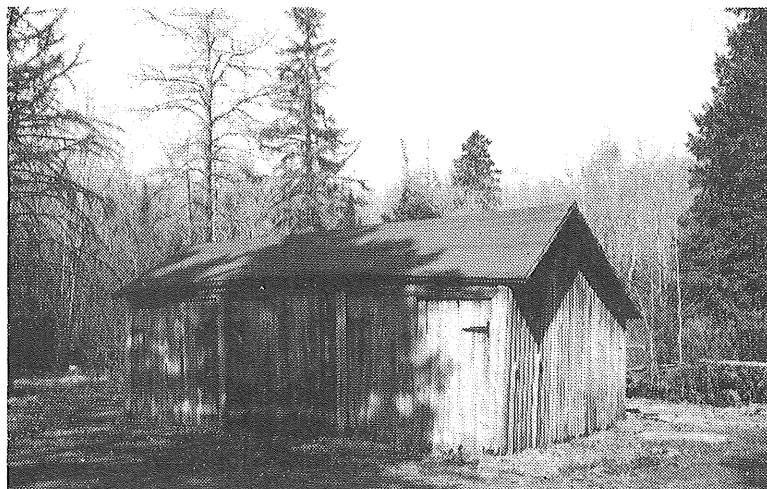
Garage – looking southwest

The garage is a half-log building broken into three stalls having half-log hinged doors. It is one story and rectangular. Rolled asphalt is used on the gable roof.

Demolish - condition unsafe

- The construction of a new sanitation building is recommended, possibly on the site of the garage.
- A limited yet viable means of access should be determined.
- The original furniture should be returned to the site.
- Consideration should be given to low cost alternatives to conventional restoration. ■
