## BLUE MOUND STATE PARK

Richard Otten  
Certified Energy Manager, #16973  
Association Energy Engineers  
608 North Freeman  
Luverne, MN 56156  
(507) 227-5103  
[richaradaotten@yahoo.com](mailto:richaradaotten@yahoo.com)

## CONTENTS OF REPORT

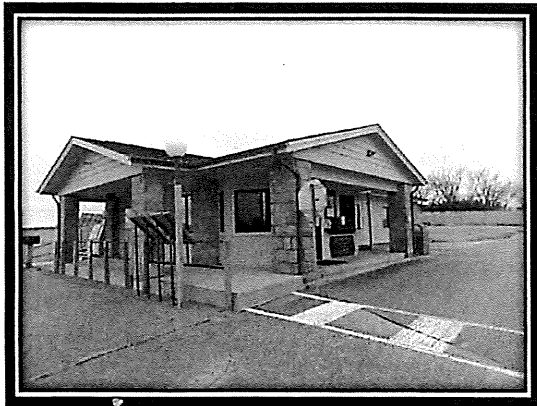
**Contact Station**

The contact station is located on the northwest area of the park. The building is 1,366 sq ft. The blower door reading is 1,275 cfm @ 50 pa. This could be safely reduced to 800 cfm with typical occupancy & without an air exchanger. The foundation is slab on grade and the walls are 2x4 construction with newer windows and doors. The attic has approximately 8" blown fiberglass insulation, so additional attic insulation is recommended.

The attic needs additional insulation. I recommend blown cellulose fiber. Install 3" rigid insulation to attic hatch and weather-strip around the ledge.

The attic ductwork could have additional insulation added with boxing around existing insulation. The payback is higher because of the increased temperature difference from the ductwork air and the ambient air in the attic. I recommend 1 1/2" thermax with the joints and seams taped.

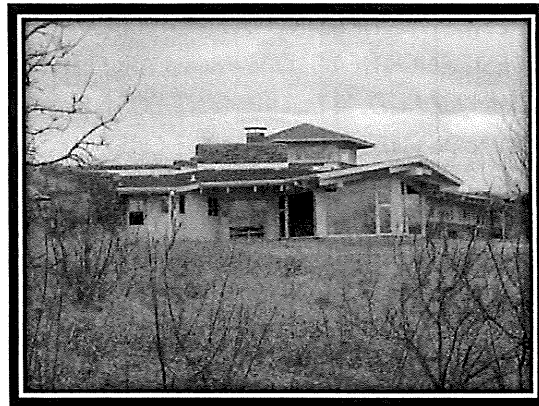
**Interpretive Center**

The interpretive center was built in the late 1950's and is located on the southern edge of the park. The building is 3,225 sq ft. The construction is slab on grade and built into the side of a granite hill. The design of the building has some good and negative energy aspects. During the winter, there is significant solar gain from the large area of south glass and there is also some geothermal heating that occurs from the exposed stone. During the summer, the solar gain is a negative as well as the higher natural humidity created by the stone exposure.

Most of the lighting is reflector incandescent lighting which can easily be replaced with LED units with motion sensors where possible.

A large amount of dehumidifying is done by 2 dehumidifiers which run many hours during summer. I would recommend down sizing the 4 ton SEER 10 unit to a 2.5 ton modulating unit. This will run more but do a better job of dehumidifying the area.

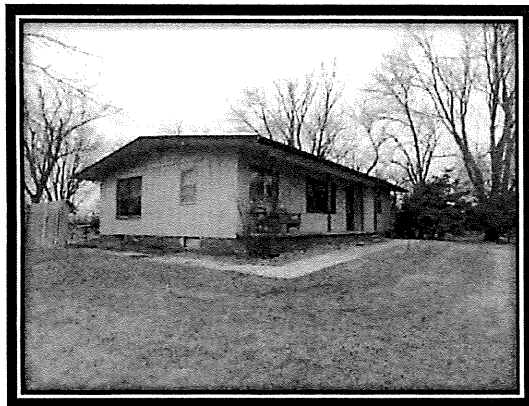
**Ranger Residence**

The ranger residence was built in the mid 1950's and is located on the northwest area of the park, south of the contact station. The building is 1348 sq ft. The blower door reading 1,870 @ 50 pa which would be high considering the square footage. It consists of a full basement which is 2x4 construction. The wall cavities are partially insulated, along with some of the foundation walls. The occupant says the basement stays cold. The attic needs additional insulation.

Reducing the air infiltration is done by dense packing the walls, possible replacing the windows. Sometimes the windows can be caulked but I believe that these windows are beyond caulking. Sealing the attic bypasses is also important. The rim joists are still leaking air with fiberglass installed and foam insulation is recommended in the rim joist areas.

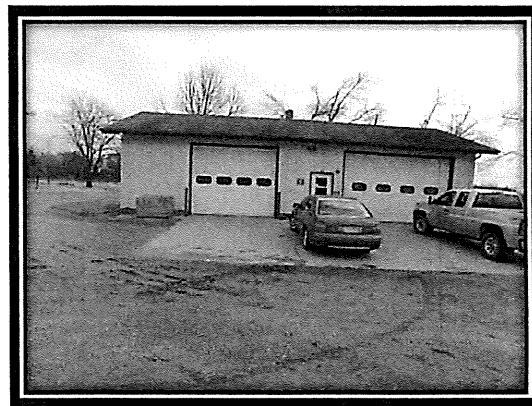
**Repair Shop**

The shop is located south of the contact station. The shop is 1,508 sq ft built in the 1970s. There are 2 south overhead doors. The ceiling height is 11'4" and has 8" of blown insulation. The foundation is exposed block. The primary heat source is wood with a propane furnace as a backup.

Bringing a controlled source of fresh combustion air will improve the performance of the wood burner by not pulling out heated air. This should be done with an air trap to ensure that air is not "free flowing" into the shop when it is not needed.

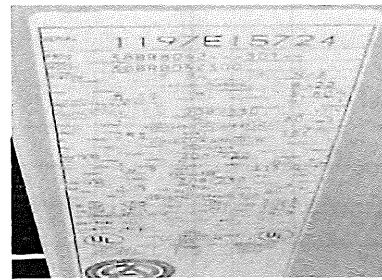
The air conditioner is a 3.5 ton, designed seer of 10, built in 1997. A seer of 14 or 15 will result in a 30 to 40 percent in air conditioning costs. Note that the unit is over sized by about 1 ton. Oversizing results in less run time which reduces dehumidification.
