M.L. 201 4, Chp. 226, Sec. 2, Subd. 06d Project Abstract

For the Period Ending June 30, 2017

PROJECT TITLE: Northeast Minnesota White Cedar Restoration – Phase 2

Final Technical Report prepared for Environment and Natural Resources Trust Fund

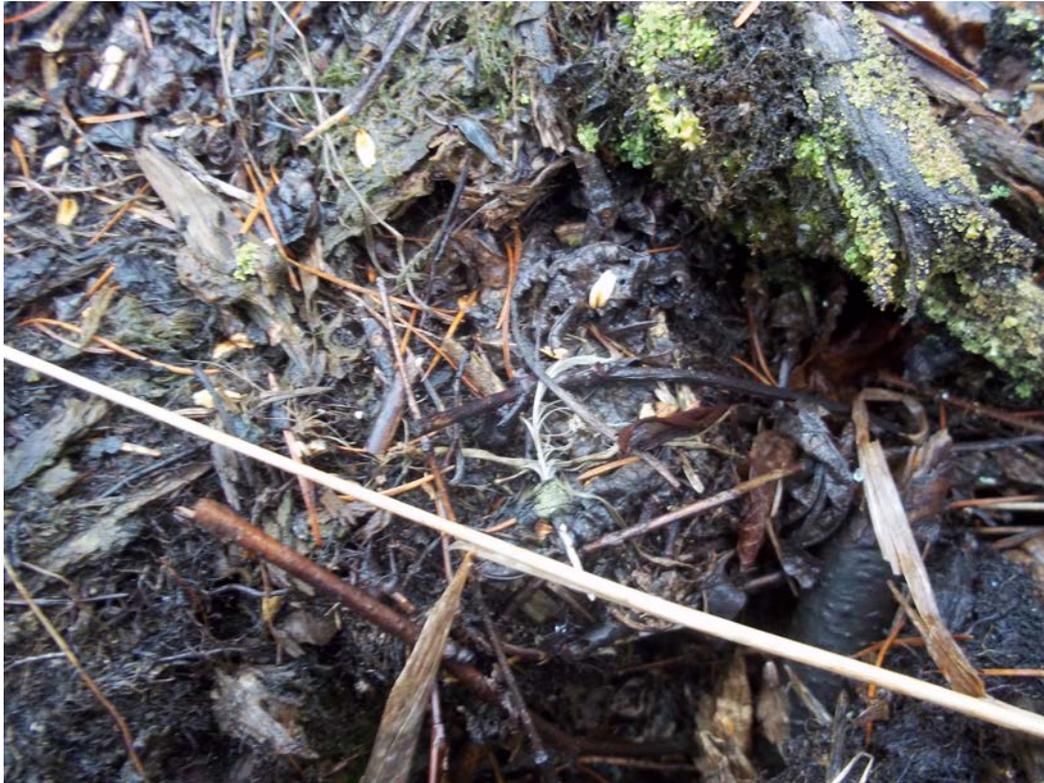
We found no seeds germinated at any site during the initial visits in the spring of 2014 (Figure 15). However, some seeds were seen germinating by the next sampling trip in the late spring. It appears that the seeds over summered and wintered before germinating.

Figure 15. Photo showing ungerminated cedar seed.

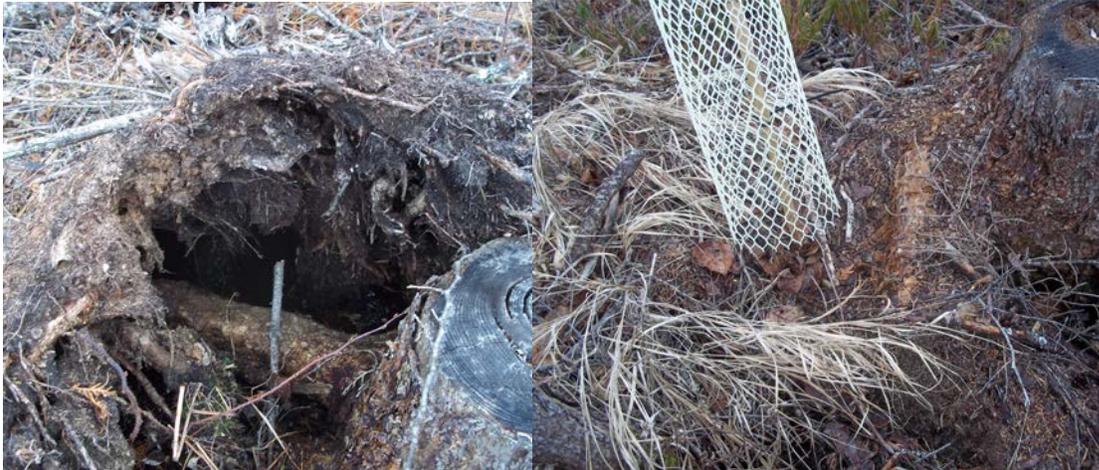
Certain hummocks, however, can be too dry to encourage cedar survival. For instance, at site #649, the many of the hummocks planted were actually perched root mats with lots of air space under them. The effect of this was that cedar roots were dried out, and the trees often died when planted on these hollow root mats (Figure 23).

Figure 23. Planted cedar dead on top of hummock root mat. Notice the large air space between water table and peat in left photo.

Some areas were also found to be too dry for NWC. The best example of this is when NWC were planted in root mats with an air pocket below the roots. This resulted in high mortality of planted NWC. Site level hydrological conditions also appear to have been altered by roads and may end up explaining tree growth and mortality across sites. However, it is too early to assess this yet.

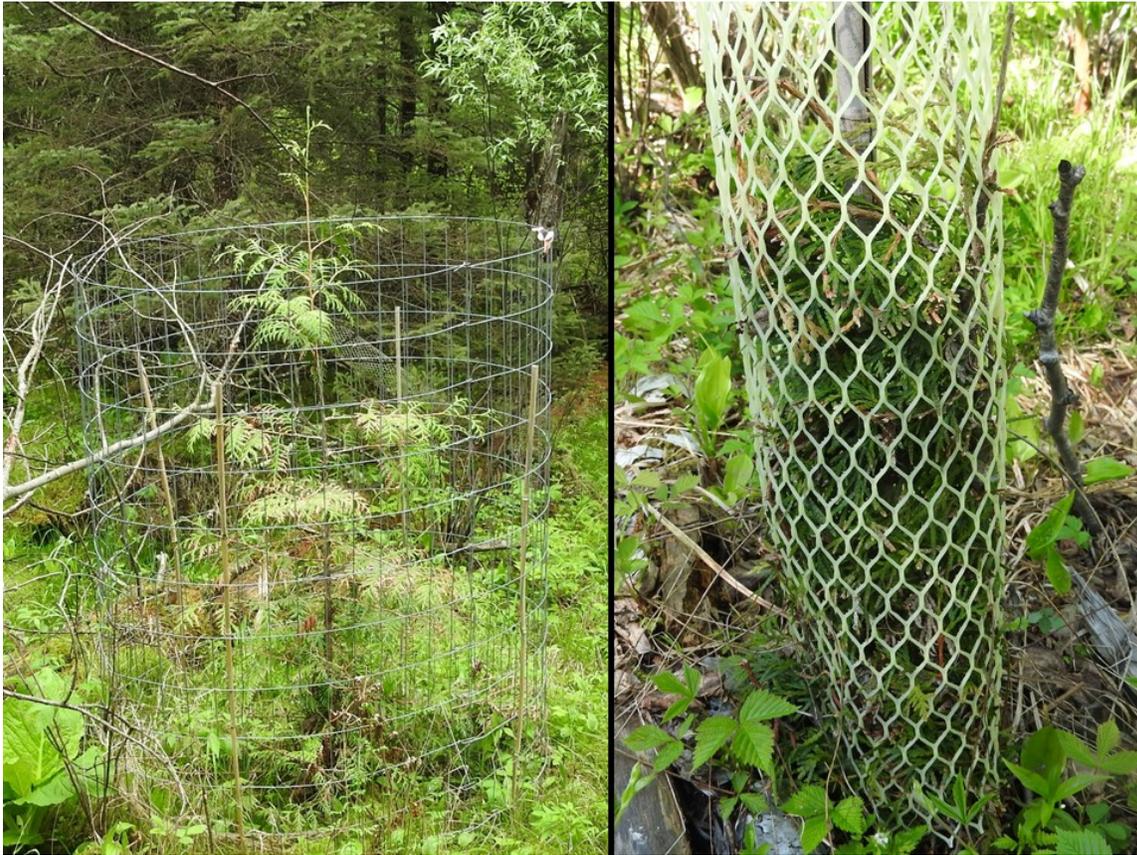
Figure 32. Photos of cedar in wire and plastic protectors.

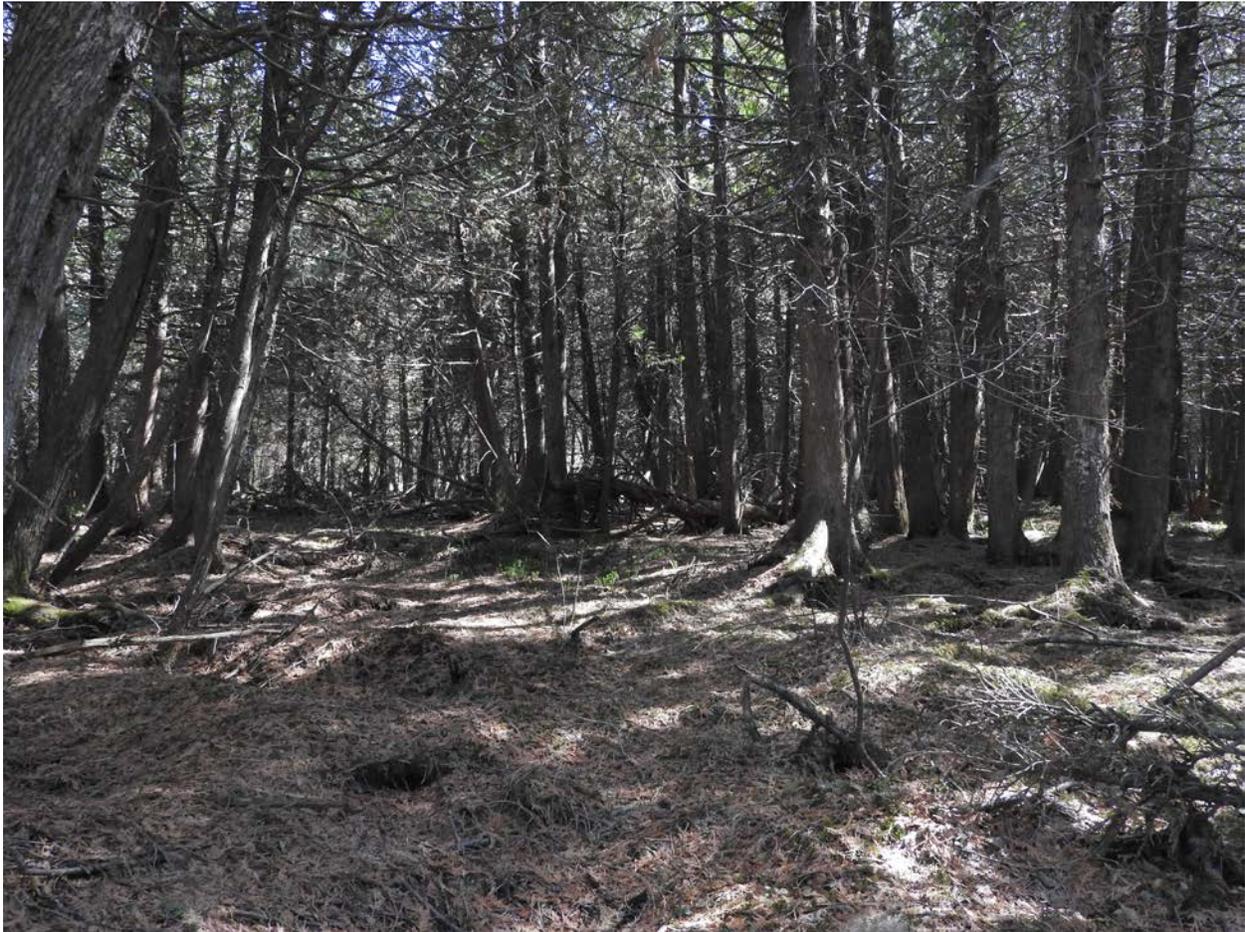
Figure 35. Very shady conditions hampered cedar seedling growth, but moderate light was fine.

Light levels also appear to play a role in successful cedar enrichment plantings. At very low light levels, like seen at site #28 (Figure 35), cedar growth was very low. This indicates that planting cedar under dense canopies are likely to not be successful, planting at moderate light levels are fine as cedar is shade tolerant.

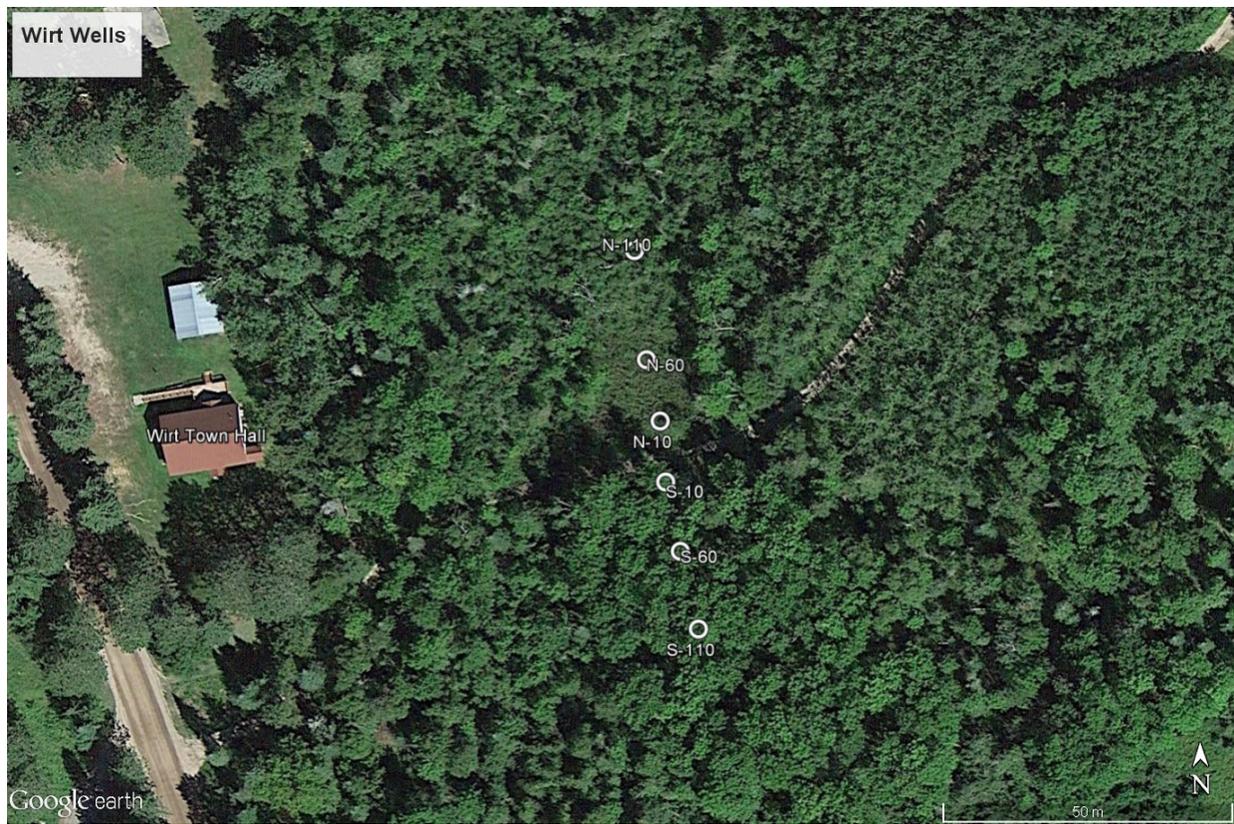
A transect of groundwater monitoring wells were installed perpendicular to the road in October of 2014 (Figure 39). Wells were monitored periodically by hand and three pressure transducers were installed for daily automatic readings.

Figure 39. Wirt site with well placements.

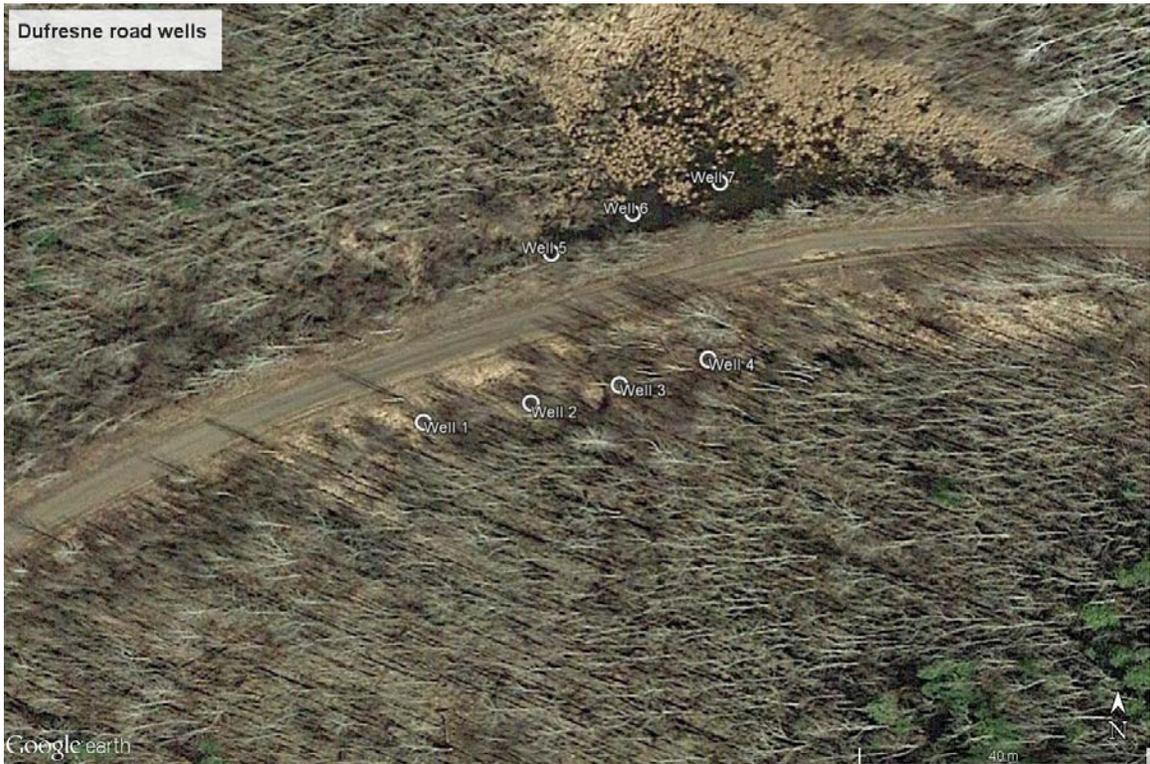
Two transects of groundwater monitoring wells were installed parallel to the road in 2015 (Figure 44). Wells were monitored periodically by hand and three pressure transducers were installed for daily automatic readings.

Figure 44. Defrense site with well placements.

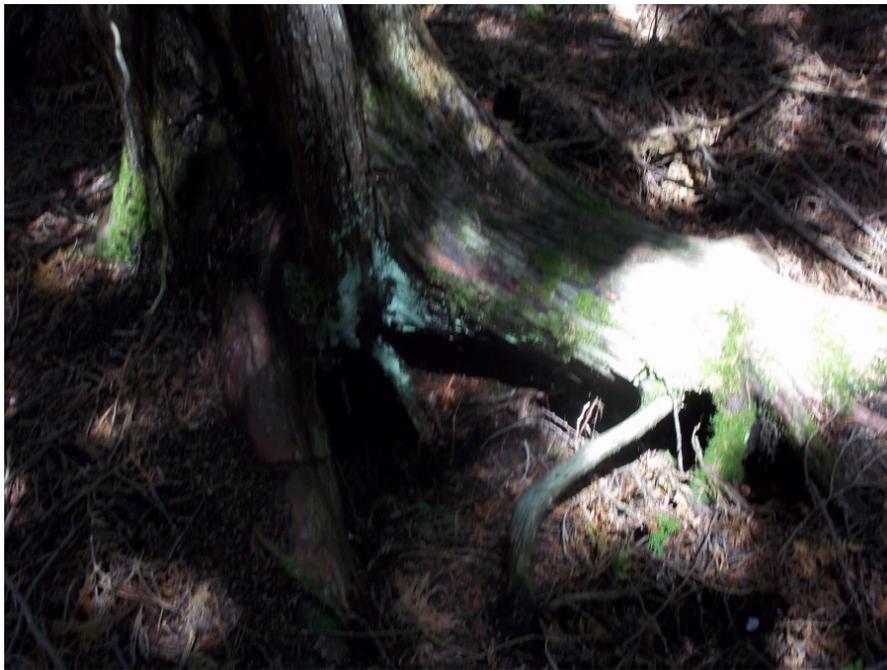
1. Give a name or location for site. Also add location for each site (GPS or google earth)
2. Date of assessment
3. GPS coordinates, list what coordinate system you are using
4. Who owns the property?
5. Size of NW cedar stand being assessed.
6. If you have a pH meter, take reading of groundwater. If not, do not worry about it
7. Are you assessing a cedar, ash or tamarack swamp? Give MN NPC class if known.
8. Is the surface of the soil dry in mid-summer (discount this if it is in the spring or after a heavy rain)
9. Can you see the large cedar roots easily? This is an indication of drying and peat subsidence. See below photo for example.

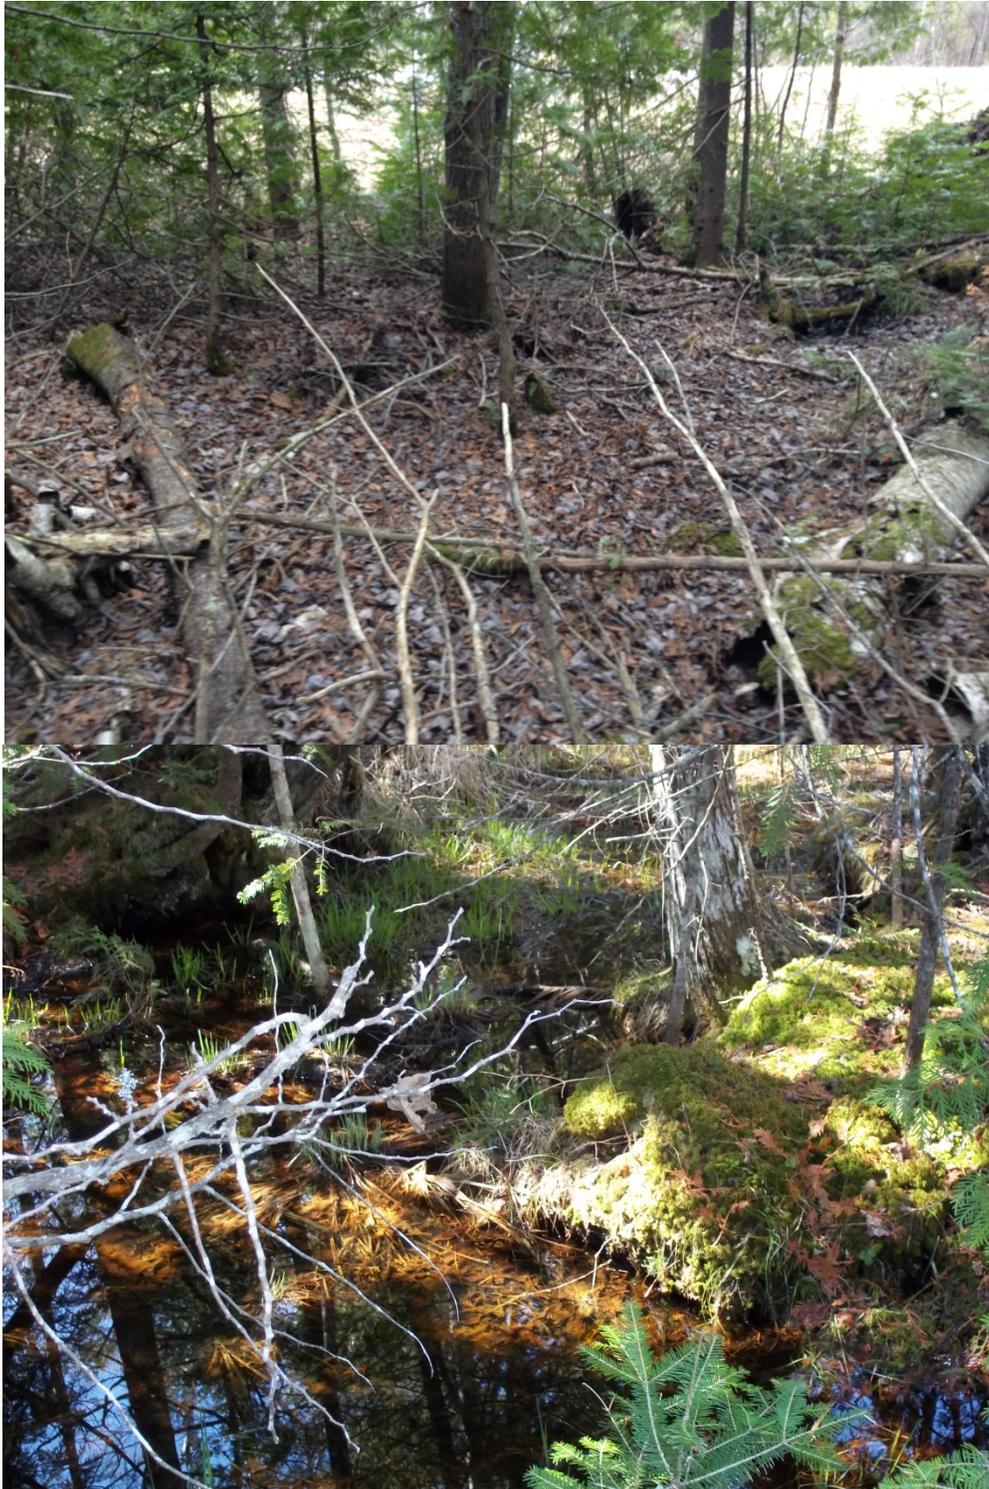
10. Mosses are a good indicator of drainage. Put yes if there is less than 50% cover of mosses on the ground. This could be a sign that the site has undergone drainage and is drier than should be. The two photos below show sites with no mosses (drained from road), and one with lots on mosses in undisturbed site.

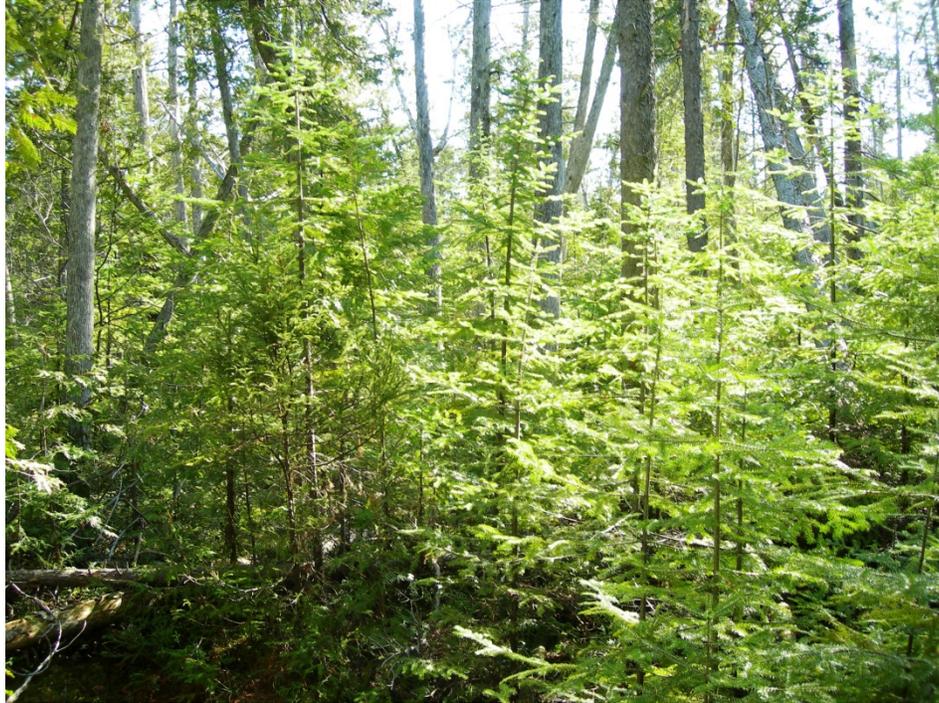
12. Are there drainage ditches in the swamp?
13. Look at maps or walk site to see if there is impeded groundwater drainage from roads, train tracks, power lines right of ways, large ditches, or anything that alters ground water flow.
14. Given from what you have seen, and answers to above questions, do you think this swamp’s hydrology (movement of water) has been altered?
15. What percentage of the swamp is hydrologically altered? Give a guess, does not have to be precise.
16. Was the site harvested recently (< 50 yrs ago)? Look for stumps or paper trail.
17. Are there as many cedar trees here as would expect given the ecotype? Is the basal area greater than 100 ft²/acre for cedar? If not, put no. Is most of the basal area in balsam fir, tamarack or alder? They typically replace cedar if cedar is removed. See photo below for balsam fir replacing cedar for an example.

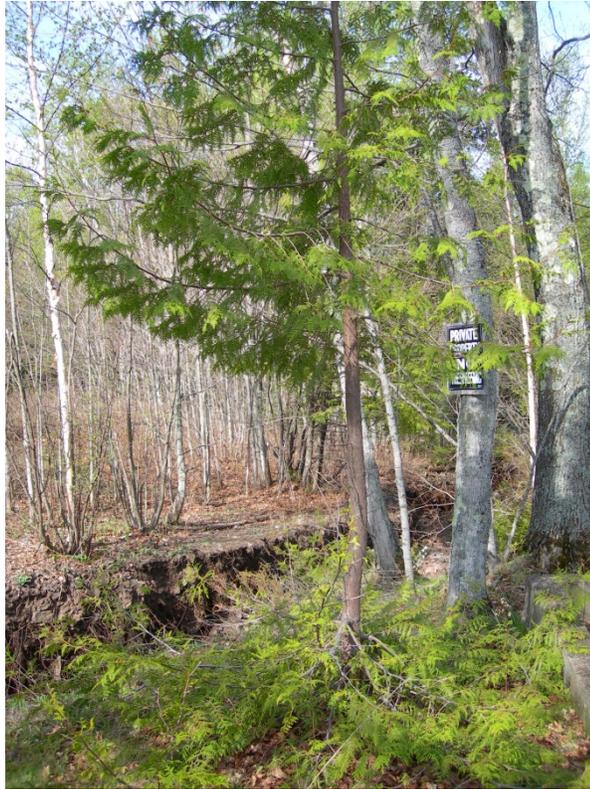
19. Are the cedar trees showing a "browse line". See photo below for an example of a cedar tree browsed, except for the bottom which was under the snow.
