State Office Building and Parking Deck Preservation, Restoration and Repairs Predesign **FINAL DRAFT**

21 Dec 2012

Updated 19 April 2013 - Predesign Addendum 1

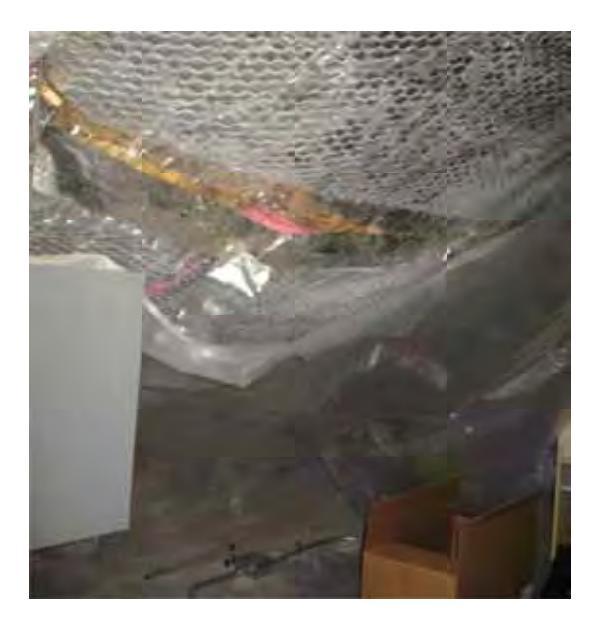
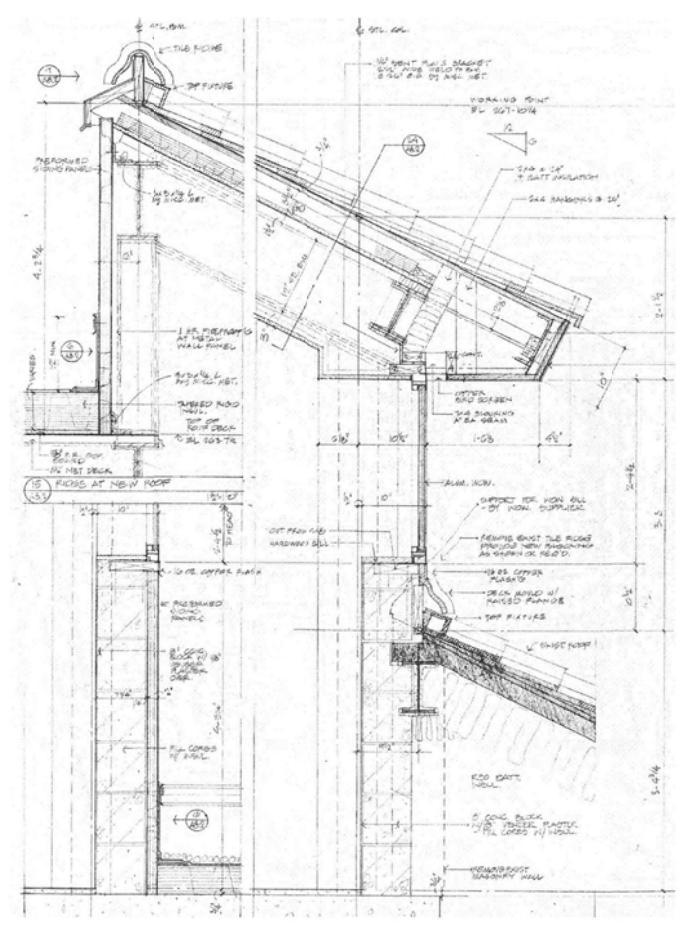
The 1985 addition of the upper floors was constructed of concrete block and metal framing with prefinished siding and batt insulation with no vapor barrier. The interior of the block is finished in veneer plaster applied directly to the block. The only insulation at these upper levels is at the underside of the roof. It is identified on the 1985 drawings as R30 batt. It appears that chicken wire and poly sheeting has been added since to secure the batt to the underside of the roof.

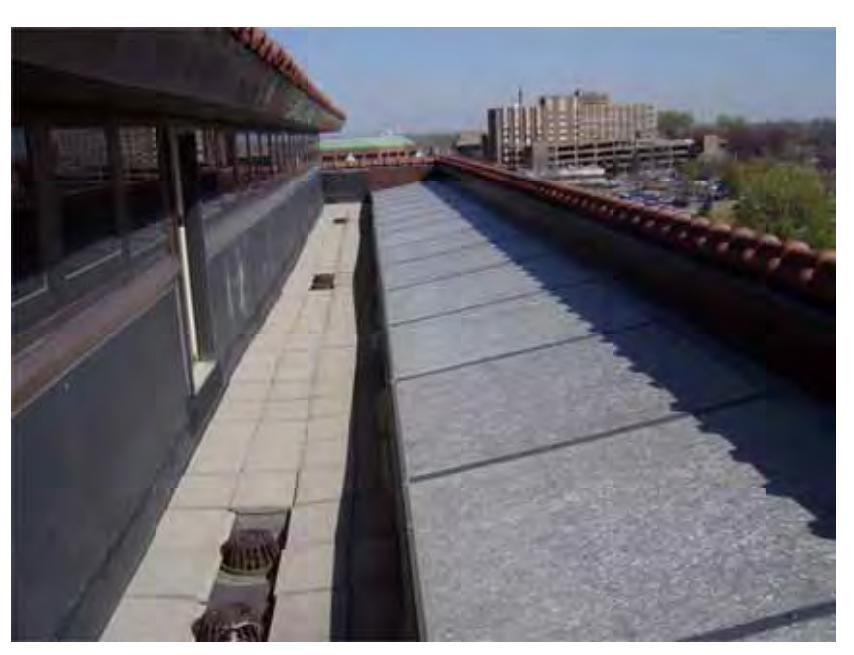
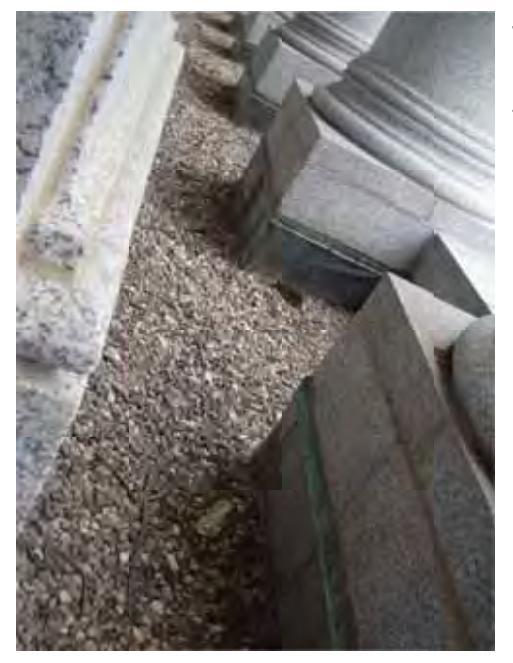
The fully pavered EPDM roofs on the main building were installed in 1998 and are 14 years old. There is an upper roof level and then two narrow roofs on the east and west ends of the building. They have a 15 year manufacturer's warranty that is still in effect. The roofs are generally in fair to good condition. Repairs have been performed in the past on some of the flashing seams. Currently the seams appear water tight and the pavers are not deteriorated. There were no deficiencies noted that would require immediate attention and/or be covered under the remaining manufacturer's warranty. The seams should be continued to be monitored as they age.

However, each of the narrow EPDM roofs at the 4<sup>th</sup> floor level are adjacent to a long translucent panel skylight. These skylights are deteriorated and would not be expected to perform satisfactorily for long - see skylight review above. Although the narrow EPDM should roofs perform adequately for a few more years, it would make sense to replace them at the same time as the skylights.

There is a small rock ballasted EPDM roof area at the east end of the building at the second floor level. The flashing and sealants are in poor condition and this roof area should be replaced when possible.

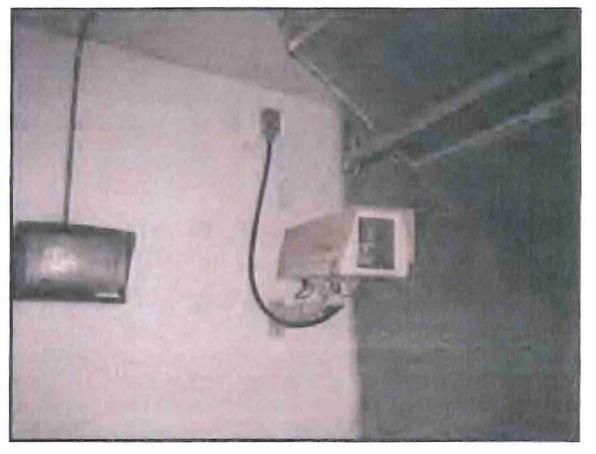
#### D5038 - Security Cameras

Name	Category	Priority	Inspector	Action Date	Cost
Security Cameras Renewal	Beyond Useful Life	2- Potentially Critical	System Renewal	11/08/2012	427,971
				Total	427,971

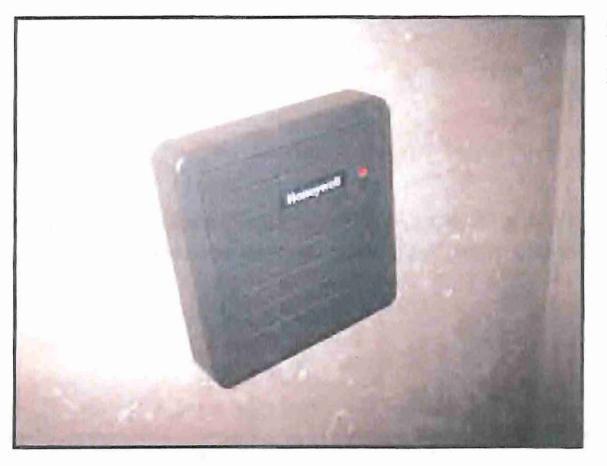
### D5038 - Access Control System

Name	Category	Priority	Inspector	Action Date	Cost
Access Control System Renewal	Beyond Useful Life	2- Potentially Critical	System Renewal	11/08/2012	232,588
				Total	232 588

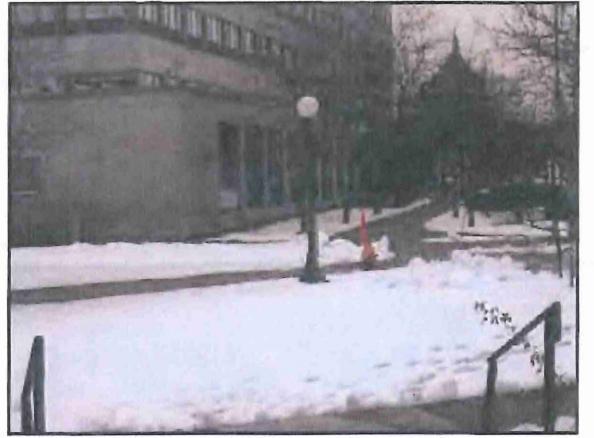
G4020 - Site Lighting

Name	Category	Priority	Inspector	Action Date	Cost
Site Lighting Renewal	Beyond Useful Life	2- Potentially Critical	System Renewal	11/08/2012	265,951
				Total	265,951

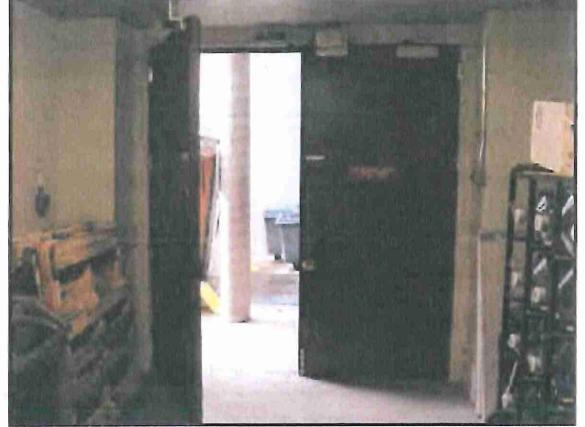
System:	B2030-Exterior Doors	Lifetime:	30			
Name:	Door Assembly - 6 x 7 HM - 1985	Years Remaining:	5 (Observed)			
Quantity:	1	% Used:	83 (Observed)			
Unit Cost:	3,960.14	Year Installed:	1985			
Replacement Cost:	3,960	Date Inspected:	11/08/2010			
Unit of Measure:	Each	SCI:	1.25			
RENEWAL						
Renewal FY:	2016	Renewal Cost:	4,950			
% Renew:	125

Door Assembly - 6 x 7 HM - 1985 Renewal Door Assembly - 6 x 7 HM - 1985 Renewal

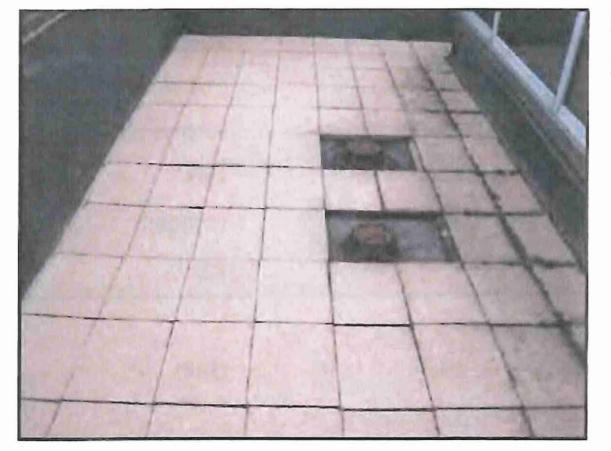
System:	B30-Roofing	Lifetime:	25		
	Name:	Single-Ply EPDM with Pavers on Roof - 1985	Years Remaining:	5 (Observed)		
	Quantity:	3,985	% Used:	80 (Observed)		
	Unit Cost:	41.25	Year Installed:	1985		
	Replacement Cost:	164,390	Date Inspected:	11/08/2010		
	Unit of Measure:	SF	SCI:	1.25		
RENEWAL						
	Renewal FY:	2016	Renewal Cost:	205,487		
	% Renew:	125

Single-Ply EPDM with Pavers on Roof - 1985 Renewal Single-Ply EPDM with Pavers on Roof - 1985 Renewal

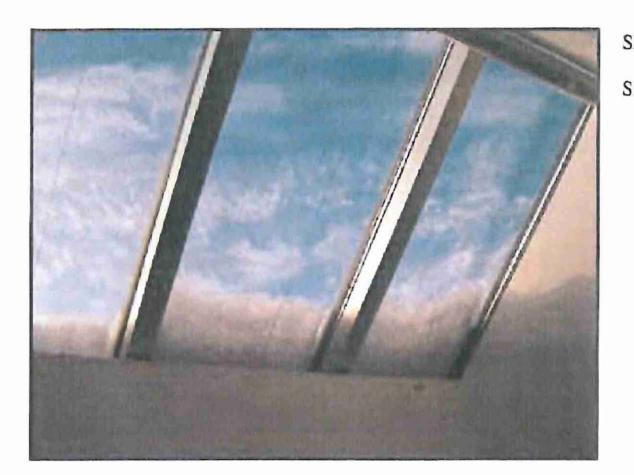
System:	B3021-Glazed Roof Openings	Lifetime:	30	
Name:	Skylights - Unit Types - 1985	Years Remaining:	5 (Observed)	
Quantity:	1,787	% Used:	83 (Observed)	
Unit Cost:	108.37	Year Installed:	1985	
Replacement Cost:	193,657	Date Inspected:	11/08/2010	
Unit of Measure:	SF	SCI:	1.25	
RENEWAL				
Renewal FY:	2016	Renewal Cost:	242,071	
% Renew:	125			
DESCRIPTION

Skylights - Unit Types - 1985 Renewal Skylights - Unit Types - 1985 Renewal

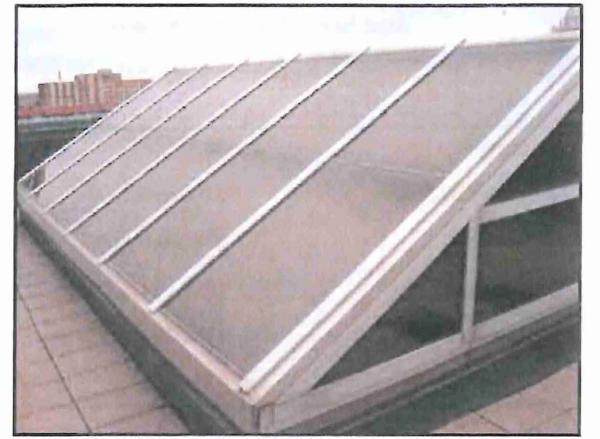
1					
	System:	B3021-Glazed Roof Openings	Lifetime:	30	
	Name:	Skylights - Monumental - 1985	Years Remaining:	5 (Observed)	
	Quantity:	340	% Used:	83 (Observed)	
	Unit Cost:	128.90	Year Installed:	1985	
	Replacement Cost:	43,826	Date Inspected:	11/08/2010	
	Unit of Measure:	SF	SCI:	1.25	
RENEWAL					
	Renewal FY:	2016	Renewal Cost:	54,783	
	% Renew:	125

Skylights - Monumental - 1985 Renewal Skylights - Monumental - 1985 Renewal

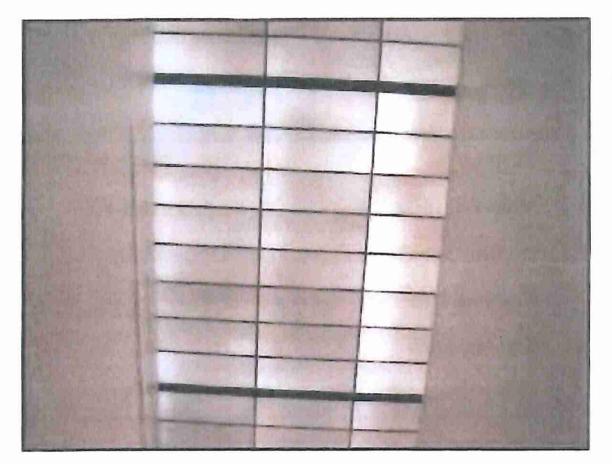
System:	B3021-Glazed Roof Openings	Lifetime:	30		
Name:	Skylights - Kalwall Types - 1985	Years Remaining:	5 (Observed)		
Quantity:	509	% Used:	83 (Observed)		
Unit Cost:	136.17	Year Installed:	1985		
Replacement Cost:	69,311	Date Inspected:	11/08/2010		
Unit of Measure:	SF	SCI:	1.25		
RENEWAL					
Renewal FY:	2016	Renewal Cost:	86,638		
% Renew:	125

Skylights - Kalwall Types - 1985 Renewal Skylights - Kalwall Types - 1985 Renewal

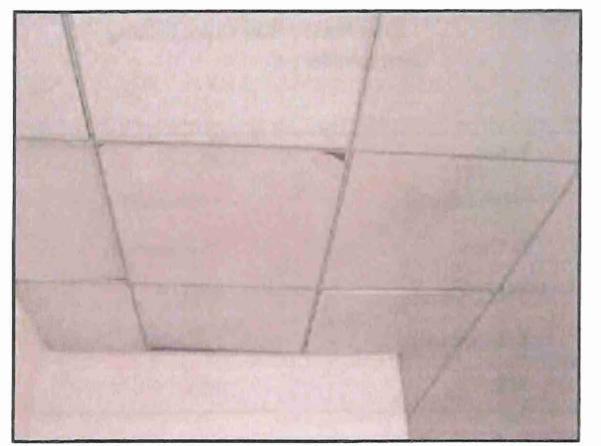
System:	C3030-Ceiling Finishes	Lifetime:	20
Name:	ACT System - Standard - 1985	Years Remaining:	5 (Observed)
Quantity:	58,000	% Used:	75 (Observed)
Unit Cost:	4.96	Year Installed:	1985
Replacement Cost:	287,680	Date Inspected:	11/08/2010
Unit of Measure:	SF	SCI:	1.25
RENEWAL			
Renewal FY:	2016	Renewal Cost:	359,600
% Renew:	125

ACT System - Standard - 1985 Renewal ACT System - Standard - 1985 Renewal

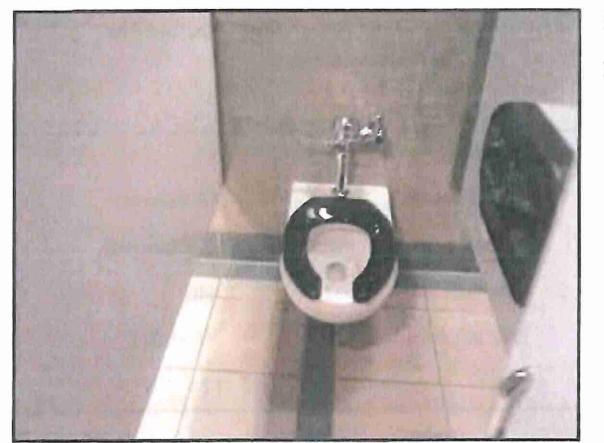
System:	D2010-Plumbing Fixtures	Lifetime:	30
Name:	Restroom Fixtures	Years Remaining:	5 (Observed)
Quantity:	290,000	% Used:	83 (Observed)
Unit Cost:	0.92	Year Installed:	1985
Replacement Cost:	266,701	Date Inspected:	11/08/2010
Unit of Measure:	SF	SCI:	1.25
RENEWAL			
Renewal FY:	2016	Renewal Cost:	333,376
% Renew:	125

Restroom Fixtures Renewal

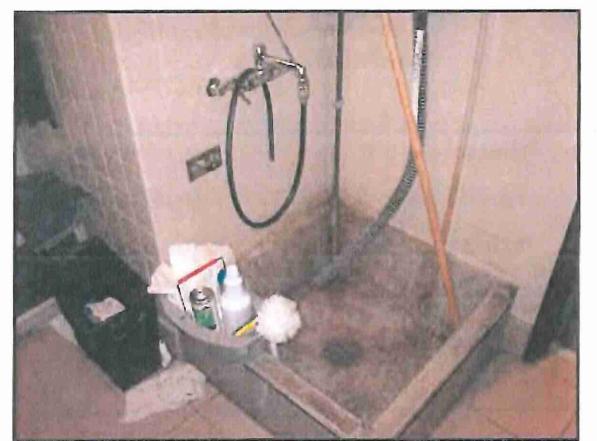
ſ	System:	D2010-Plumbing Fixtures	Lifetime:	30
	Name:	Custodial/Utility Sinks	Years Remaining:	5 (Observed)
	Quantity:	9	% Used:	83 (Observed)
	Unit Cost:	3,180.72	Year Installed:	1985
	Replacement Cost:	28,626	Date Inspected:	11/08/2010
	Unit of Measure:	Each	SCI:	1.25
F	RENEWAL			-
	Renewal FY:	2016	Renewal Cost:	35,783
	% Renew:	125

Custodial/Utility Sinks Renewal Custodial/Utility Sinks Renewal

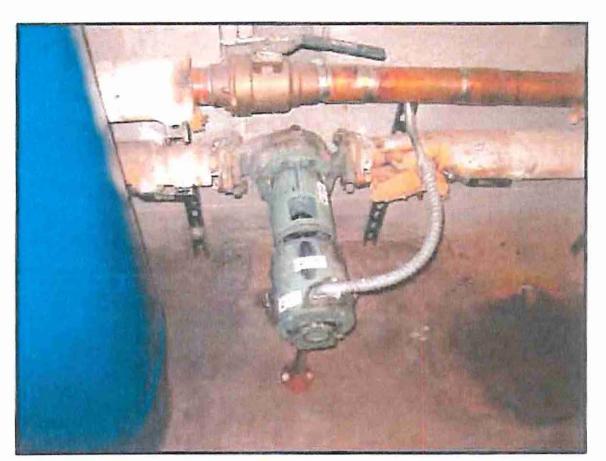
System:	D2020-Domestic Water Distribution	Lifetime:	30
Name:	Water Dist Complete	Years Remaining:	5 (Observed)
Quantity:	290,000	% Used:	83 (Observed)
Unit Cost:	2.06	Year Installed:	1985
Replacement Cost:	597,302	Date Inspected:	11/08/2010
Unit of Measure:	SF	SCI:	1.13
RENEWAL			
Renewal FY:	2016	Renewal Cost:	671,965
% Renew:	113

Water Dist Complete Renewal Water Dist Complete Renewal

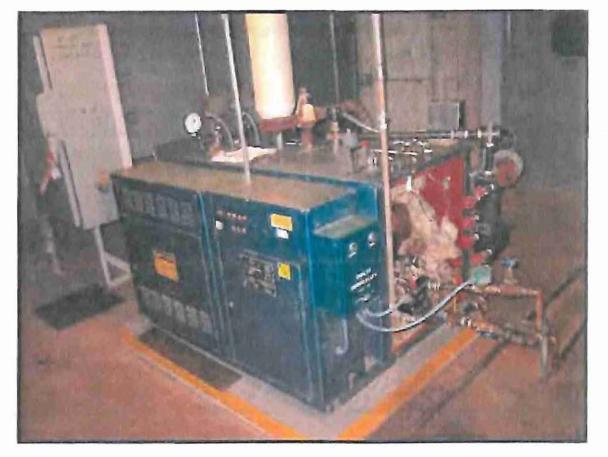
System:	D3020-Heat Generating Systems	Lifetime:	30
Name:	Boiler Steam - Humidification	Years Remaining:	5 (Observed)
Quantity:	2	% Used:	83 (Observed)
Unit Cost:	41,206.55	Year Installed:	1985
Replacement Cost:	82,413	Date Inspected:	11/08/2010
Unit of Measure:	Each	SCI:	1.25
RENEWAL			
Renewal FY:	2016	Renewal Cost:	103,016
% Renew:	125

The building has two 240kW electric steam boilers used for humidification.

Name	Category	Priority	Inspector	Action Date	Cost
Boiler Steam - Humidification Renewal	Beyond Useful Life	3- Necessary - Not Yet Critical	System Renewal	11/08/2015	103,016
				Total	103,016

Boiler Steam - Humidification Renewal Boiler Steam - Humidification Renewal

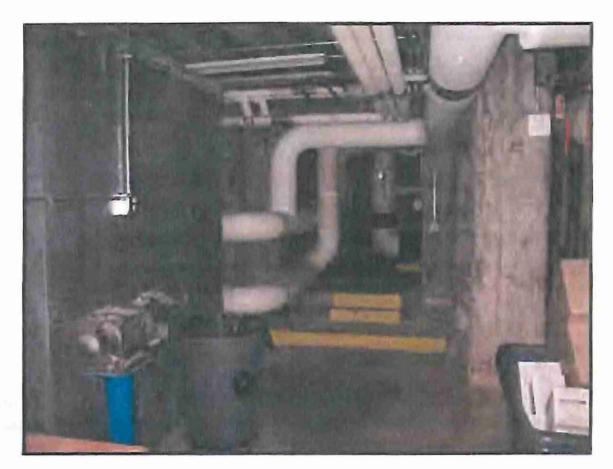
System:	D3040-Distribution Systems	Lifetime:	30	
Name:	Four Pipe Distribution System w/Pump	Years Remaining:	5 (Observed)	
Quantity:	290,000	% Used:	83 (Observed)	
Unit Cost:	15.72	Year Installed:	1985	
Replacement Cost:	4,559,168	Date Inspected:	11/08/2010	
Unit of Measure:	SF	SCI:	1.25	
RENEWAL				
Renewal FY: % Renew:	2016 125	Renewal Cost:	5,698,959

Name	Category	Priority	Inspector	Action Date	Cost
Four Pipe Distribution System w/Pump Renewal	Beyond Useful Life	3- Necessary - Not Yet Critical	System Renewal	11/08/2015	5,698,959
				Total	5.698.959

Four Pipe Distribution System w/Pump Renewal

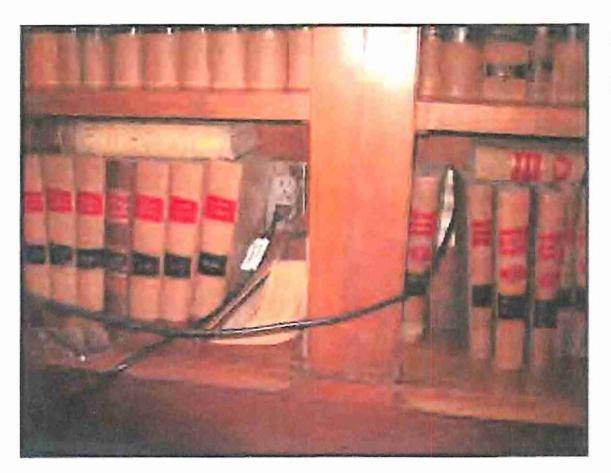
There are an insufficient number of receptacle outlets in many areas of the Ground Floor resulting in widespread use of extension cords and power strips. Specific locations include but are not necessarily limited to Room G13.

Branch Wiring - Insufficient Outlets - Ground Floor

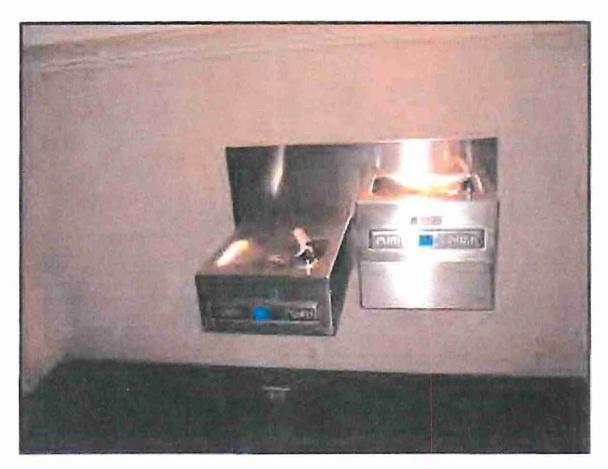
Auto generated renewal requirement for Water Coolers - Wall-Mount Dual-Height. System Description: Plumbing fixtures include dual-height water coolers.

Water Coolers - Wall-Mount Dual-Height Renewal

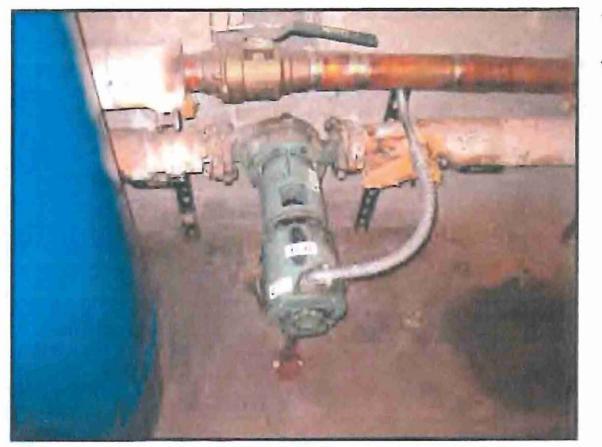
Auto generated renewal requirement for Water Dist Complete. System Description: The building domestic water distribution system includes a three inch main line, water meter, rpz backflow preventer, with rough ins included. This system does not include a water heater.

Water Dist Complete Renewal

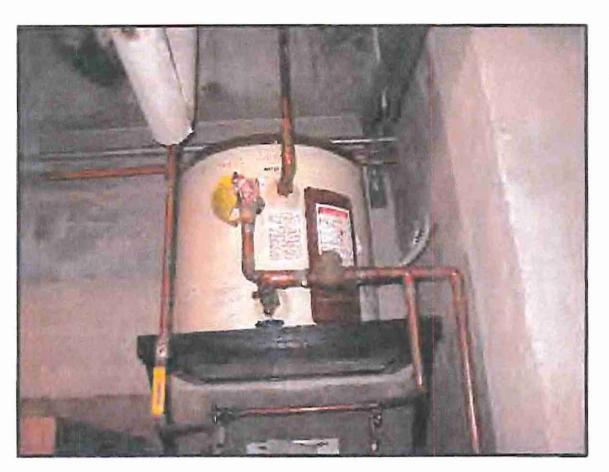
Auto generated renewal requirement for Water Heater - Elec - 10 Gal - 2004. System Description: The domestic hot water system is supplemented by 10 gallon electric water heaters located near their point of use, typically in janitorial closets. This system is for the water heater installed in 2004.

Water Heater - Elec - 10 Gal - 2004 Renewal Water Heater - Elec - 10 Gal - 2004 Renewal

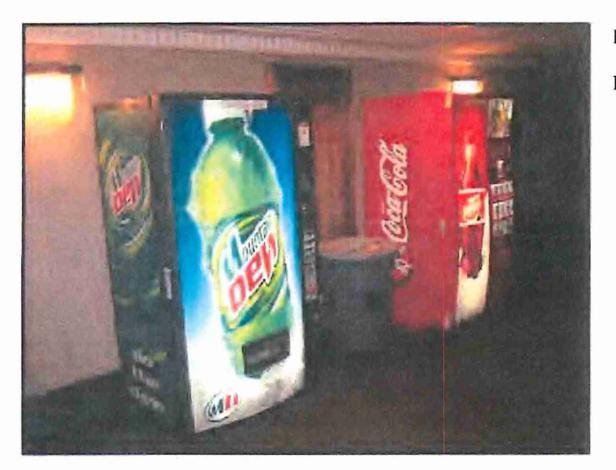
Note: Vending machines may already have factory installed internal GFCI protection. This could not be determined during site assessment. If field verified, this requirement should be deleted.

Branch Wiring - Outlets at Vending Machines Not GFCI Type - Basement Branch Wiring - Outlets at Vending Machines Not GFCI Type - Basement

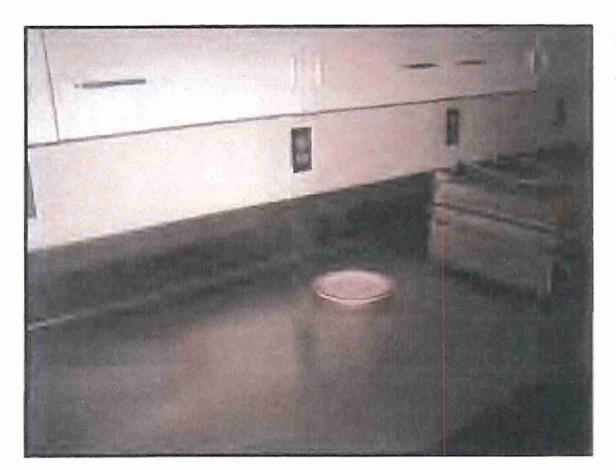
Outlets in the Cafeteria kitchen in the Basement are not GFCI type as required by NFPA 70 (2005) Article 210.8.B (2).

Branch Wiring - Outlets in Kitchen Not GFCI Type Branch Wiring - Outlets in Kitchen Not GFCI Type

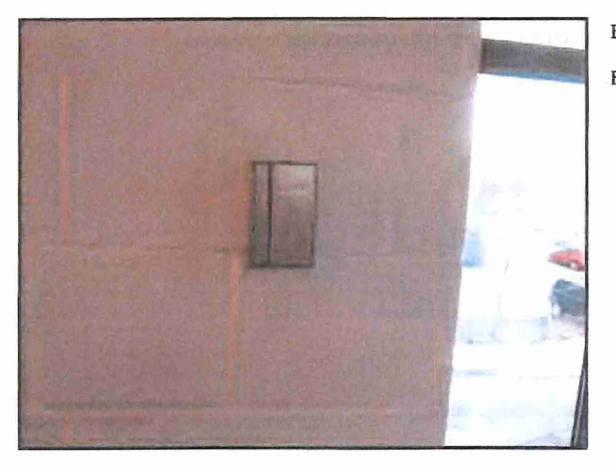
Auto generated renewal requirement for Electric Controls - Average. System Description: The building has electric wall-mounted thermostats, and a basic local HVAC control system. These controls work specifically with the electric fan coil cabinet heaters and unit heater. The square footage of this system has been adjusted to reflect the limited area that this system covers.

Electric Controls - Average Renewal Electric Controls - Average Renewal

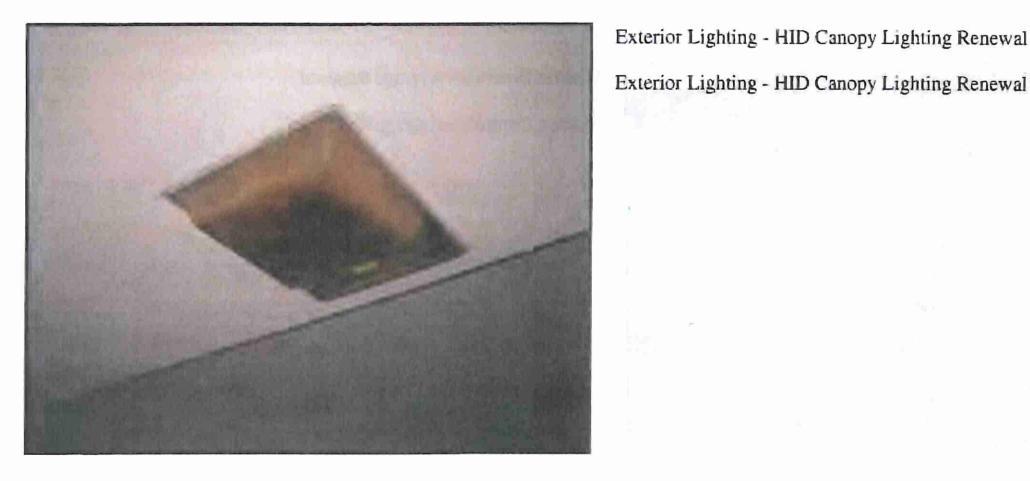
Auto generated renewal requirement for Exterior Lighting - HID Canopy Lighting. System Description: Recessed HID lighting is installed under the upper level parking canopies.

Exterior Lighting - HID Canopy Lighting Renewal

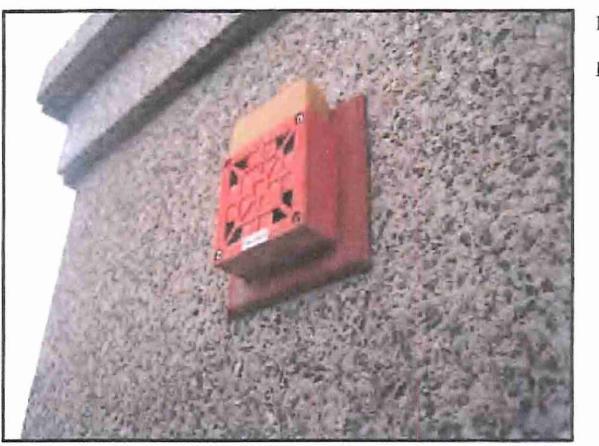
Auto generated renewal requirement for Fire Alarm System. System Description: There are a minimal number of fire alarm devices in the parking structure. Devices are monitored by the adjacent State Office Building.

Fire Alarm System Renewal

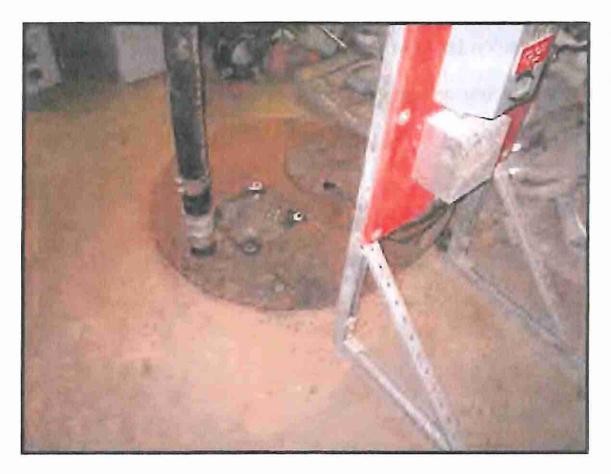
Auto generated renewal requirement for Sump Pump - Submersible - 1/2 HP. System Description: The water drainage system includes duplex sump 1/2 HP submersible pumps. Note: available Means cost line items for alarm system selected for budgetary purposes only.

Sump Pump - Submersible - 1/2 HP Renewal

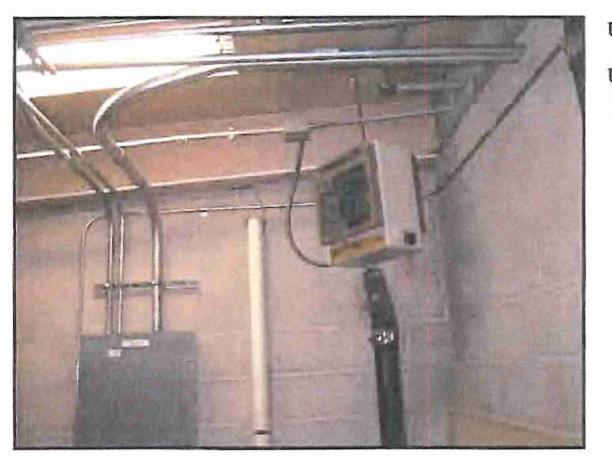
Auto generated renewal requirement for Unit Heaters - Electric. System Description: Supplemental heating is provided by a suspended electric unit heater. This heater is located in the storage room.

Unit Heaters - Electric Renewal

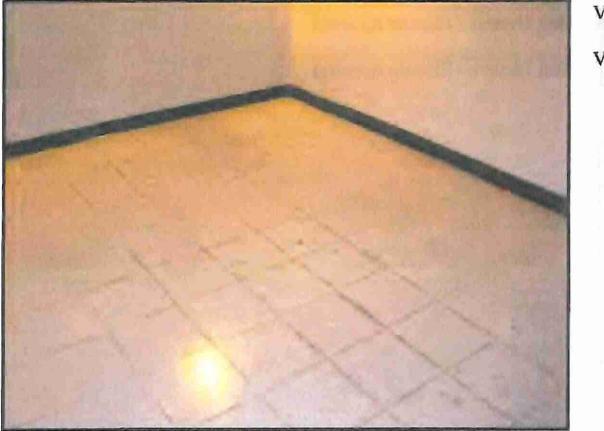
Auto generated renewal requirement for VCT - Average. System Description: Floor finishes include areas of standard VCT flooring and related base at stair towers.

VCT - Average Renewal

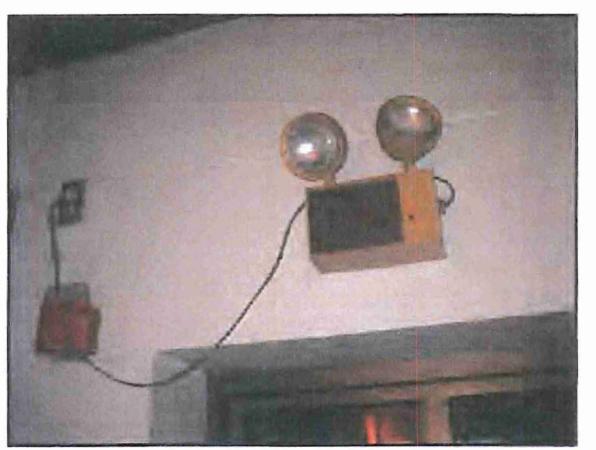
Auto generated renewal requirement for Emergency Lighting. System Description: There are a minimal number of emergency battery units in the stairwells.

Emergency Lighting Renewal

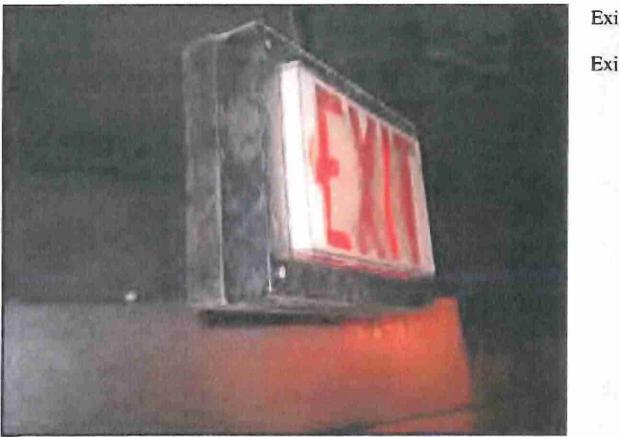
Auto generated renewal requirement for Exit Signs. System Description: Exit signs are a combination of incandescent and LED type signs. Most units do not have emergency battery backup. It is assumed exit signs are connected to emergency power panels.

Exit Signs Renewal

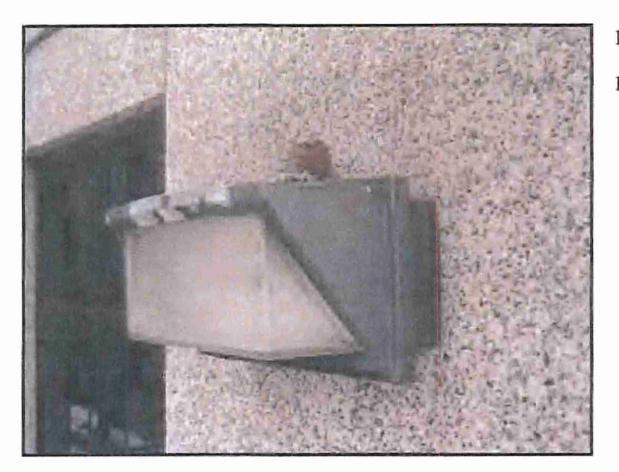
Auto generated renewal requirement for Interior Lighting - HID Wall Packs. System Description: HID wall packs are installed in the stairwells and on the upper level.

Interior Lighting - HID Wall Packs Renewal

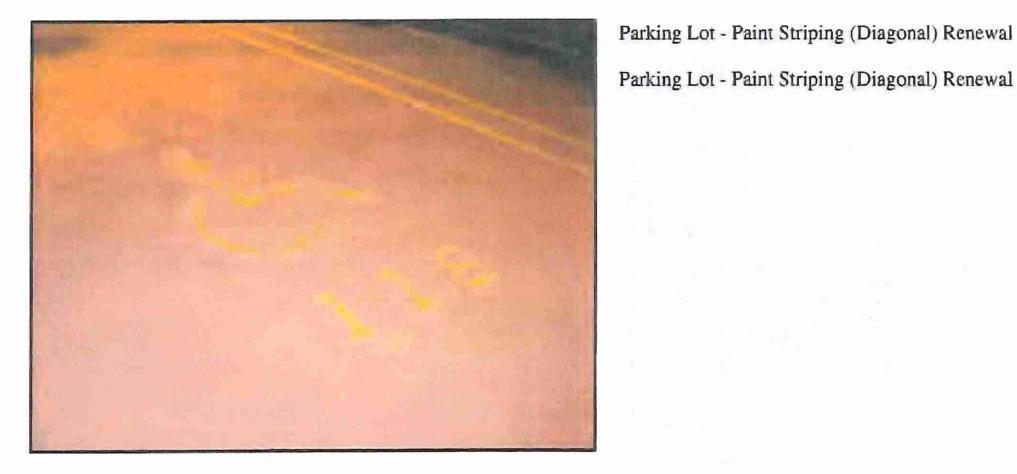
Auto generated renewal requirement for Parking Lot - Paint Striping (Diagonal). System Description: Paint striping per vehicle stall. Includes budget allowance for handicap accessible parking symbols and other signage.

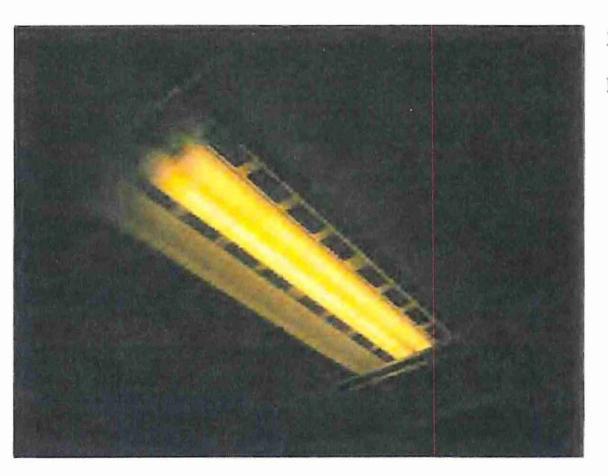
Fluorescent lighting in the electrical/mechanical room on the lower level utilizes aged and inefficient T12 lamps and magnetic ballasts.

Fluorescent Lighting - Aged and Inefficient

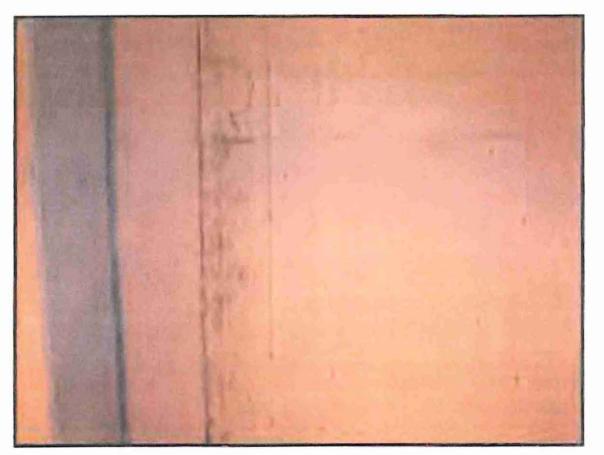
Paint Masonry/Epoxy Finish - Economy Renewal

Auto generated renewal requirement for Paint Masonry/Epoxy Finish - Economy. System Description: Wall finishes include paint on CMU or CIP concrete and minimum hi-build epoxy finish at stair towers and underground parking area walls.
