TEN YEARS OF SCULPTURE AND MONUMENT CONSERVATION ON THE MINNESOTA STATE CAPITOL MALL

Paul S. Storch

Senior/Lead Objects Conservator
Daniels Objects Conservation Laboratory
Minnesota Historical Society
St. Paul, MN

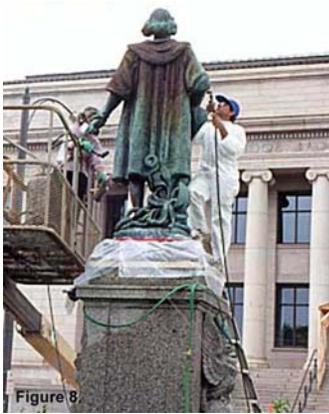
The detailed tests on the self-base of the Columbus statue to determine which pressures higher than 1000 psi could be used (See Fig. 9) included the following objectives: to remove the soluble corrosion products from the surface and the pits in the bronze without removing metal. The test methods included pressurized water at 1000, 2000, 3000 and 4000 psi, in comparison with 10.5 AD walnut shell powder at 35 psi. All cleaning method tests were reviewed at 37.5x magnification using an Olympus stereomicroscope and photo-documented with color slides and black and white film.

The technique that removed the soluble, active corrosion from the surface and pits of the bronze was 4000 psi using a 25 degree fan tip. The surface retained a light green corrosion layer and was not stripped to bright bronze.

Figure 9. Self-base of “Christopher Columbus” masked off for the cleaning tests, 1992.

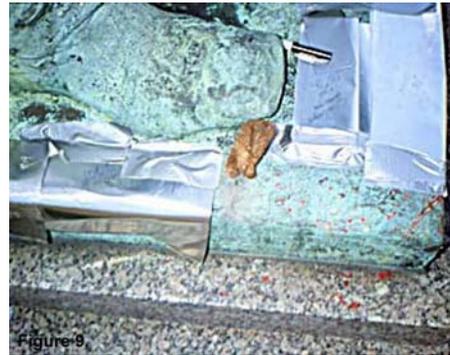
night by vandals who doused it with an oil-based red paint. An emergency cleaning effort early the next morning by the State Department of Administration Plant Management Division used an outside non-conservation-trained local contractor. The contractor removed the paint in time for the holiday, but damaged the wax and Inralac layer to the extent that it had to be chemically stripped and replaced in the summer of 1993, and the statue re-treated in 1994 (Fig. 10). Since then, yearly maintenance has preserved the patina and surface coatings in a satisfactory manner (See Fig. 11). This incident called out the need to create a useable monument and sculpture disaster response plan so that everyone

Figure 10. Chest area of “Christopher Columbus” showing metal surface after solvent stripping the Incralac and wax layers for spot treating to repair paint vandalism damage in 1994.

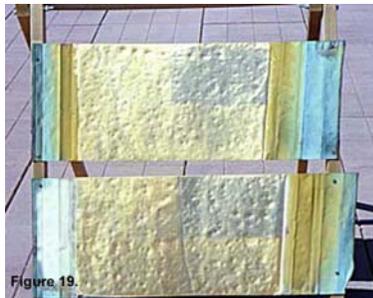
gilded and set up in a test rack in late 2001. Each panel was divided into quadrants. One quadrant was left uncoated as a control, and the other three were protected with various combinations of waxes, pigments, and lacquers (Fig. 19). By the Spring of 2002, the test panels indicated that the type of weathering and wear that was seen

on the Quadriga is a natural result of the conditions to which the surface is exposed, rather than an effect of workmanship or material from a previous treatment. The waxes and lacquers did not enhance corrosion on the test panels. The rack will be left in place as a control and reference to track on-going weathering effects on the Quadriga.

Figure 19. Gilding test panel set-up on SC roof to track weathering changes, 2001.

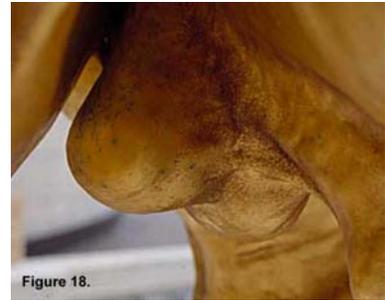
The normal life-span of a gilt sculpture in a temperate climate is approximately 20 years. The observations and research done as part of the sculpture conservation and maintenance program show that the failure of the gilt layers is progressive over that period and may proceed at different rates depending on the location of the surface in terms of environmental exposure and moisture condensation. From a fiscal management perspective, the decision was made to spot treat each of the corroded areas at this time and to continue the annual maintenance regime of washing and re-waxing (Fig. 20). Spot re-treatment, which includes removal of the corrosion (Fig. 21), and re-gilding (See Figures 22 and 23) is a more efficient use of funds and will extend the life-span of the surface layers over the long term. Cleaning and re-waxing, while effective to an extent, will not prevent the need for re-gilding at some point. Incremental regilding, along with the stabilization and repair of failed joints, for example, will maintain both the structural and aesthetic aspects of the

Figure 21. Detail of the corroded surface on the rear of the chariot, 2001.
