A Minnesota Department of Public Safety
State Fire Marshal Division Report

LESSONS LEARNED: The November 2019 Minneapolis High-Rise Fire

Narrative Report

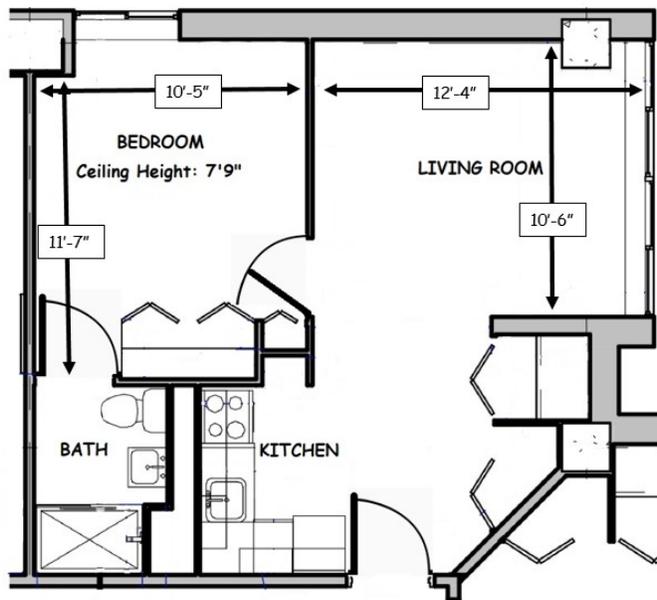
Figure 5: Typical apartment layout (apartment 1407 resembled this)

All apartments appeared to be similar in size and shape. Some were mirror images of the others, depending on their location around the building's perimeter. Every fourth story had slightly different configurations than the previous three (the 14th story was one of those). On these stories, the windows were located in slightly different locations due to outcroppings or cantilevered areas on the building's exterior walls. Apartment 1407's configuration was similar to Figure 5. All dimensions are approximate.

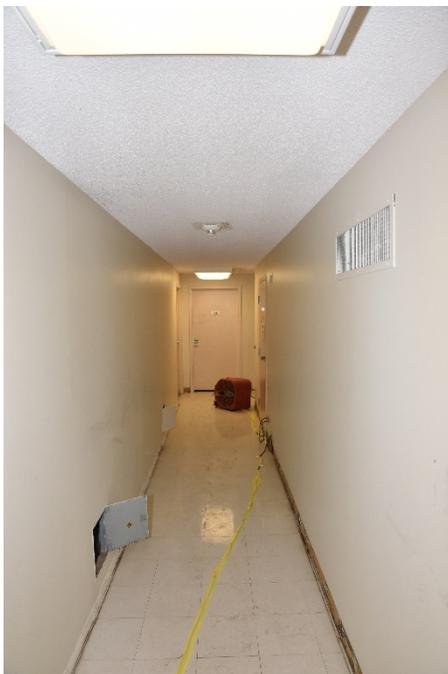
Figure 11: Typical corridor

Figure 10 shows the damage to the corridor on the 14th story. Figure 11 shows a typical corridor from another story.
