EXTRANEEOUS VOLTAGE

EVALUATION OF TEST DATA

Farms of Lonnie Nelson and Darrell Franze

ASE Project No. 702:9307

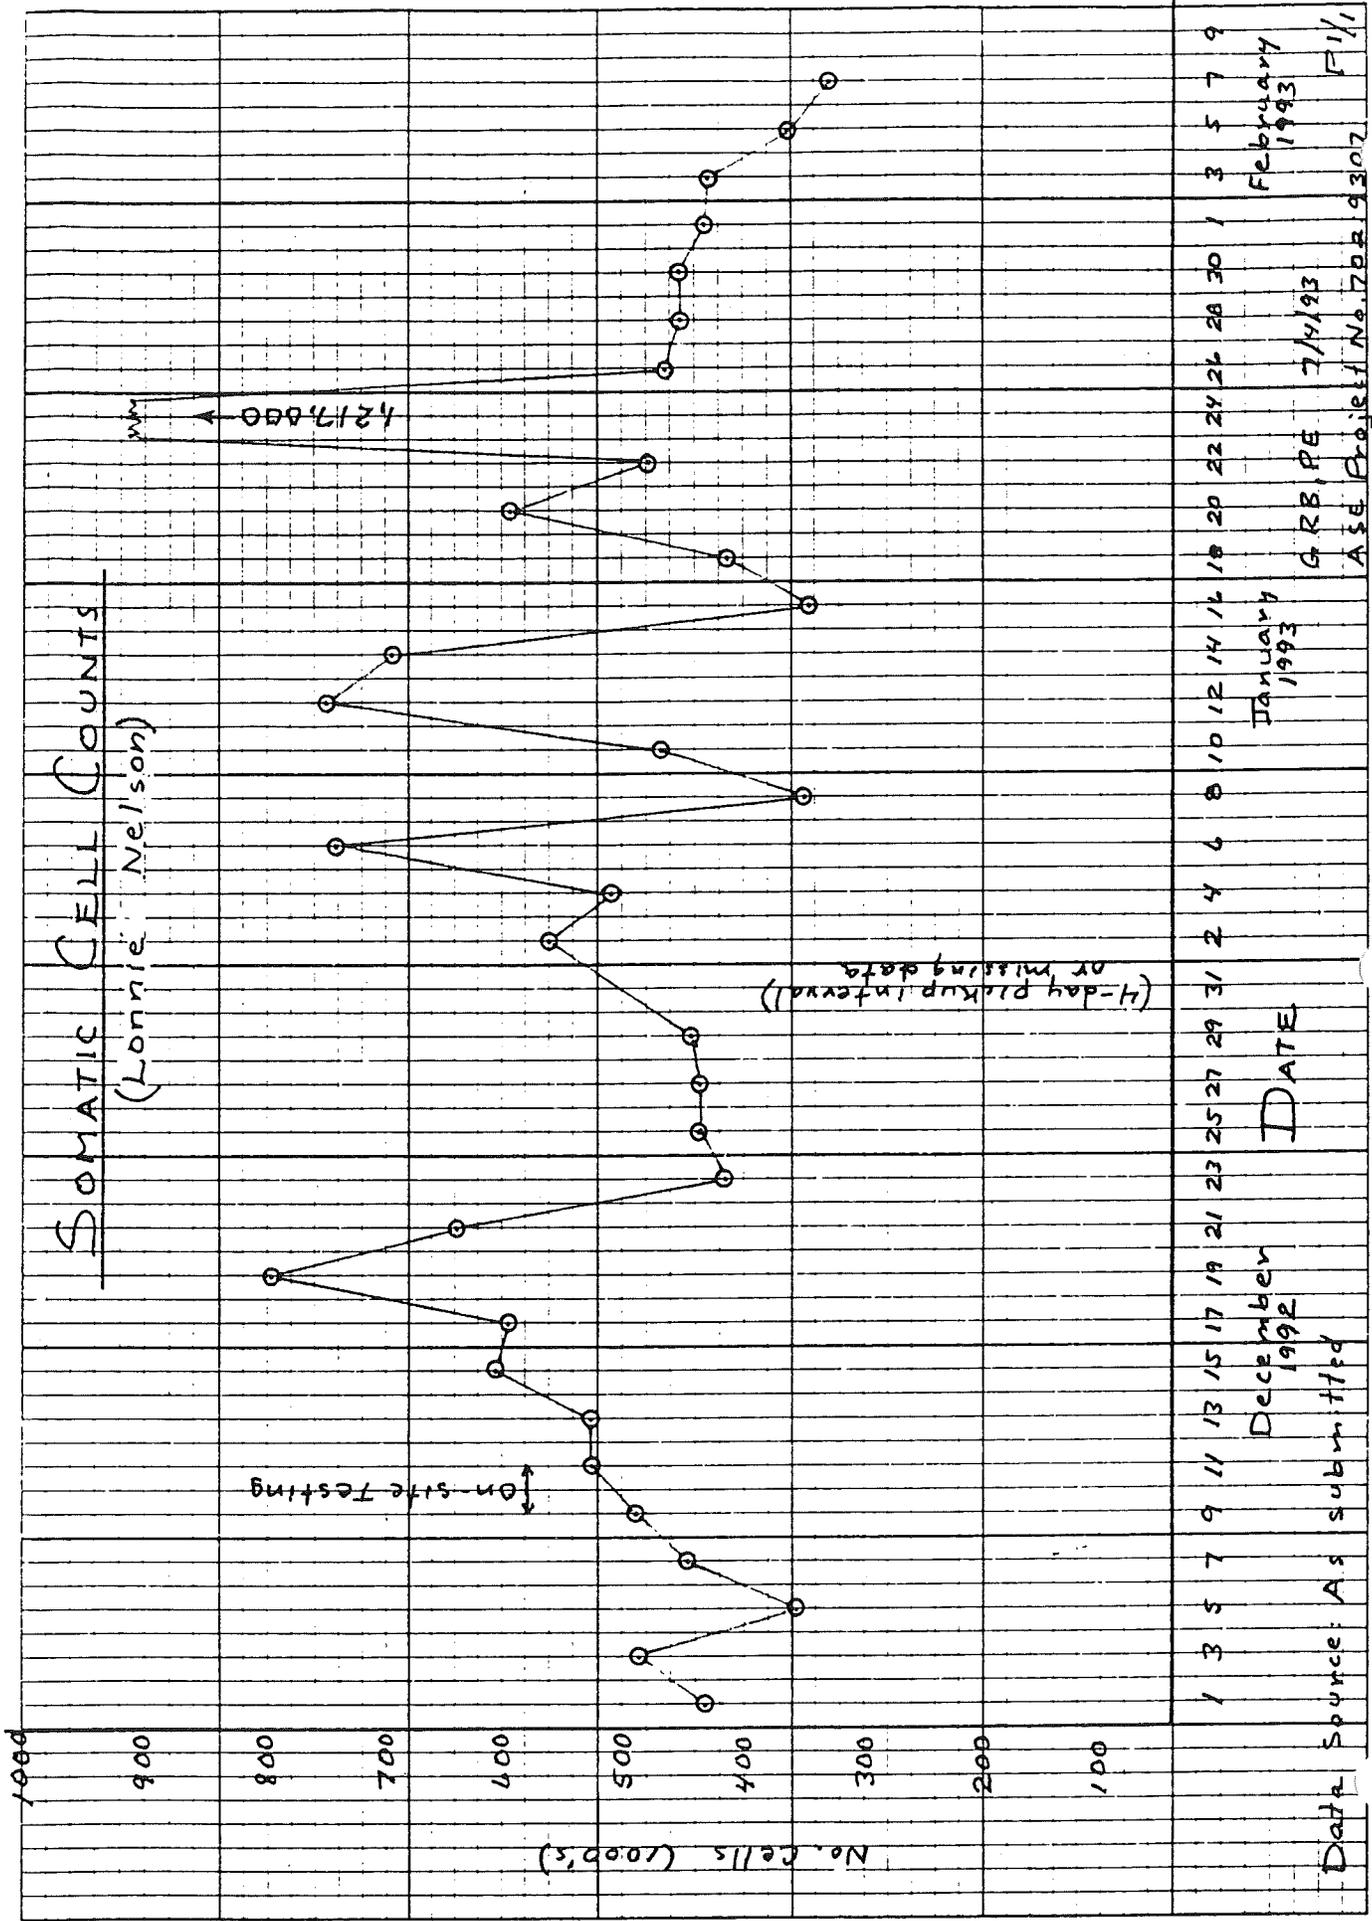
SOMATIC CELL COUNTS (Lonnie Nelson)

Data Source: As submitted

(4-day pickup interval)
or missing data

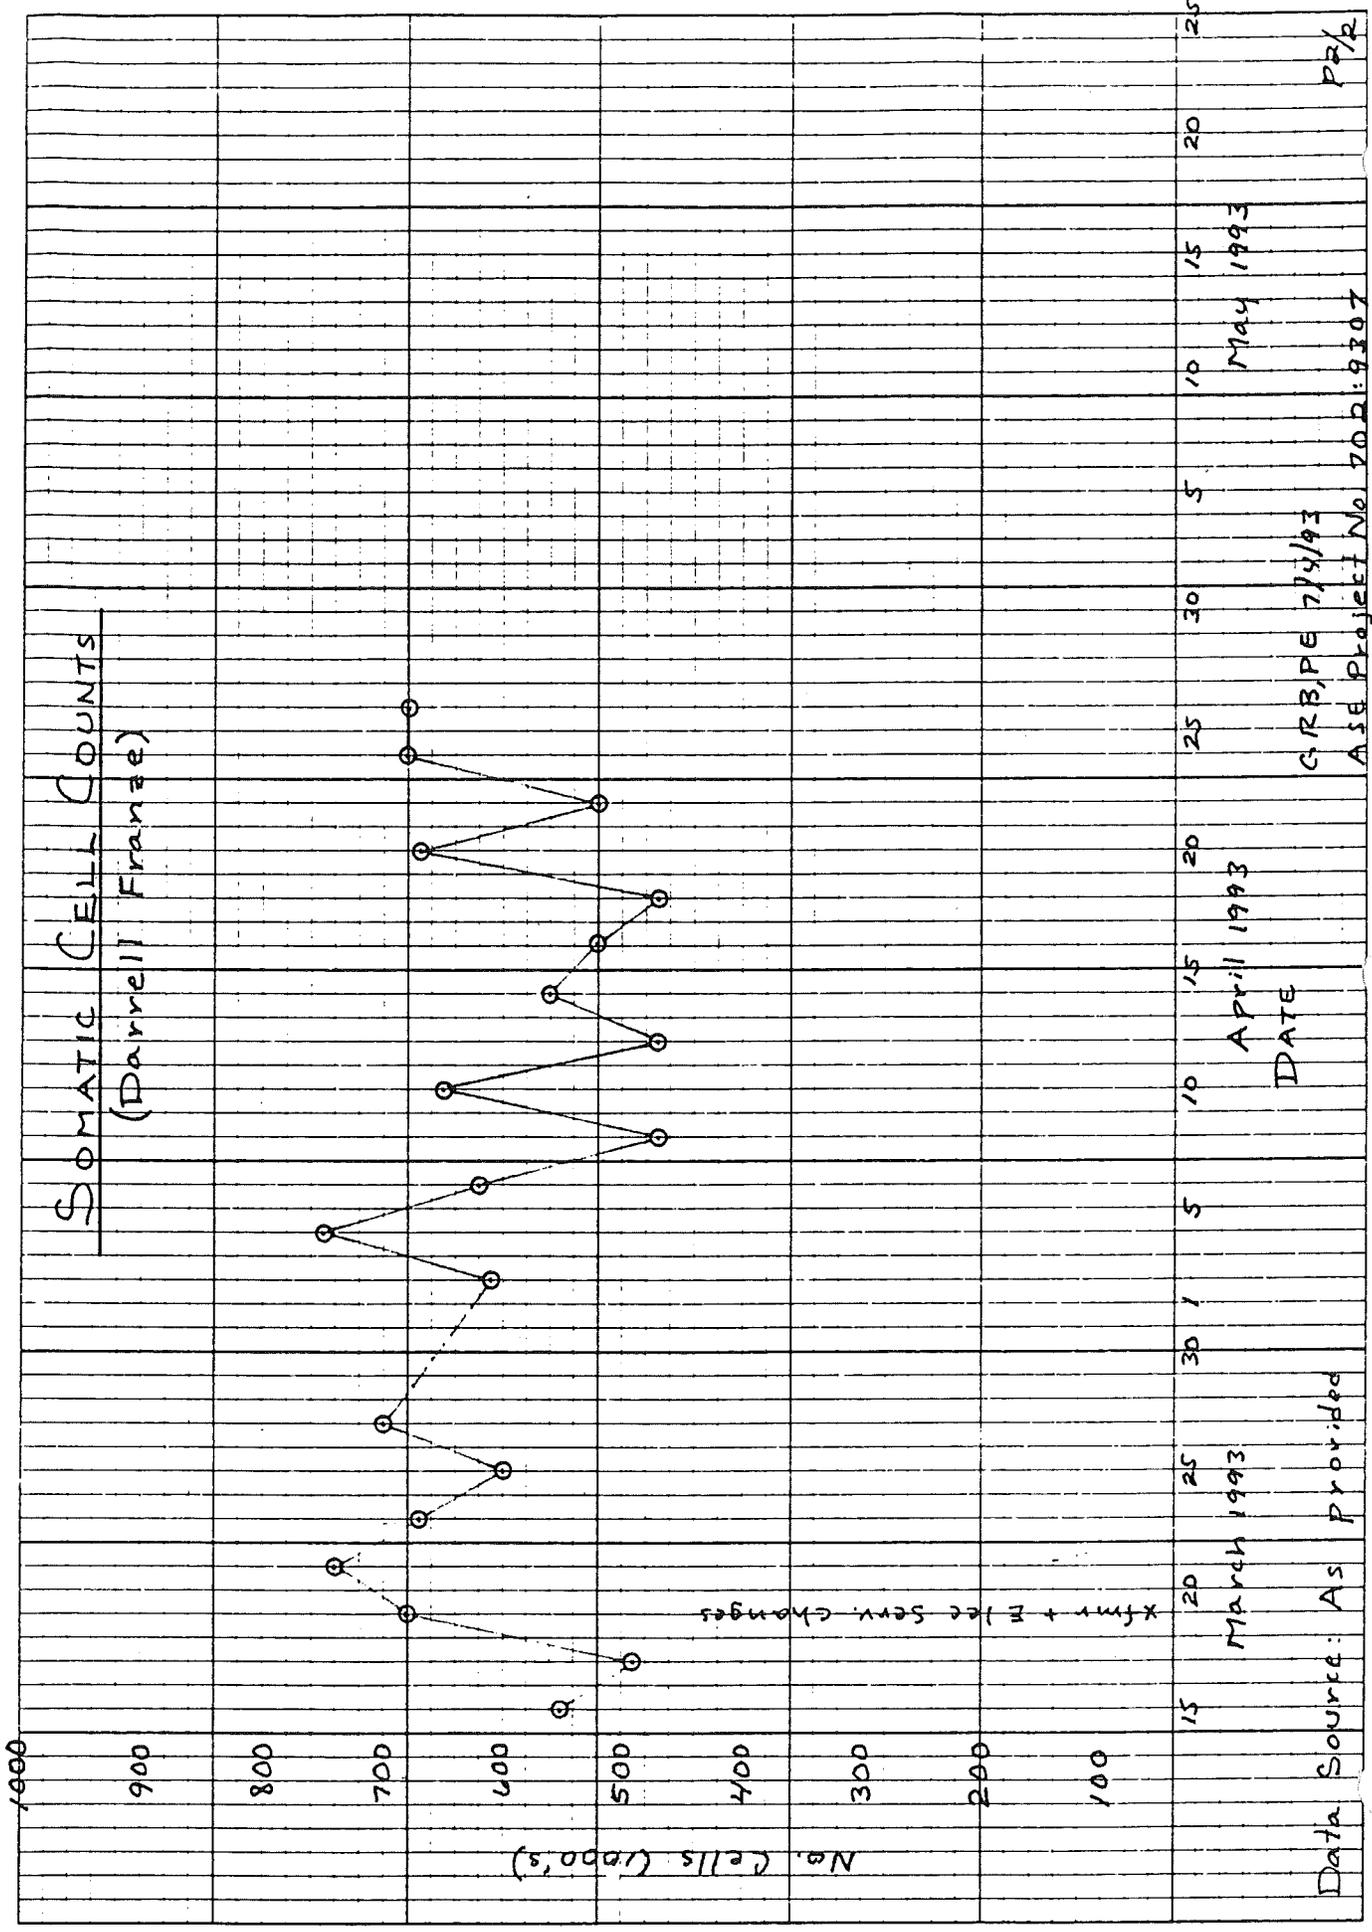
SOMATIC CELL COUNTS
(Darrell France)

Xfmr + Elec serv. changes
