Re: Facility Asset Preservation Study
Minnesota Correction Facility - St. Cloud
St. Cloud, Minnesota

Architects Project No. 1618
RECS Project ID: 78SC0053

Facility Asset Preservation Study

State Of Minnesota
Department of Corrections

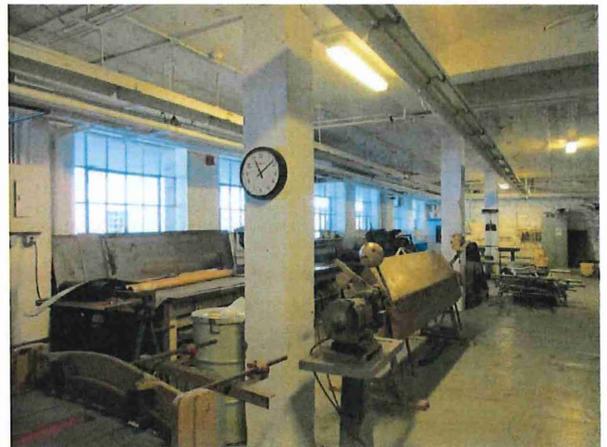
Interior view of lower level

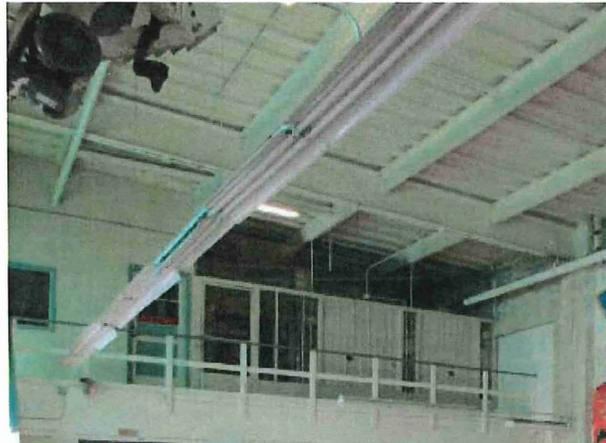
Interior view of main level

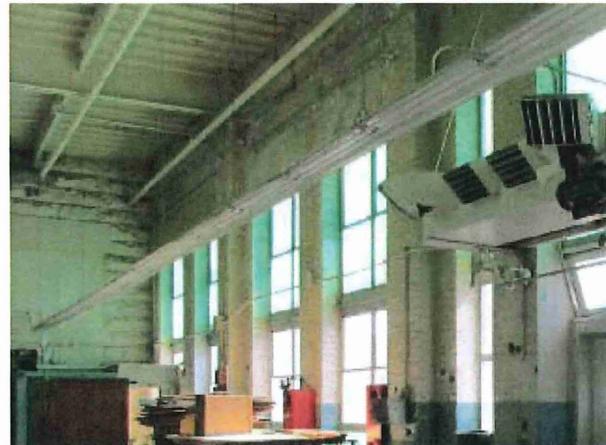
Interior view of main level

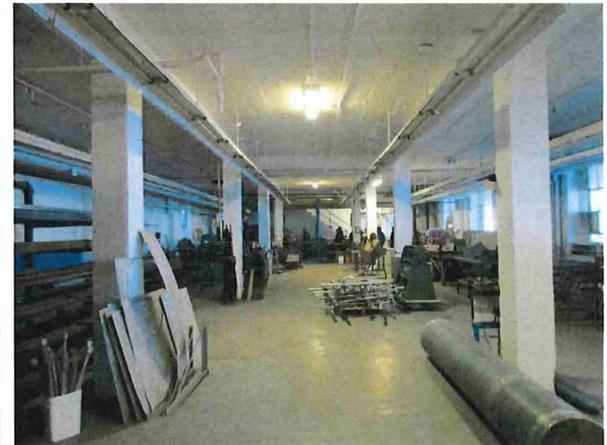
Interior view of lower level
